Radiated Emission Measurement

Site : 966A Chamber  
Condition : FCC\_part 15E RE\_Above 1GHz\_PK  
EUT : W6M22409-23739  
M/N:  
Test Mode : TX 802.11a CH189  
Note :

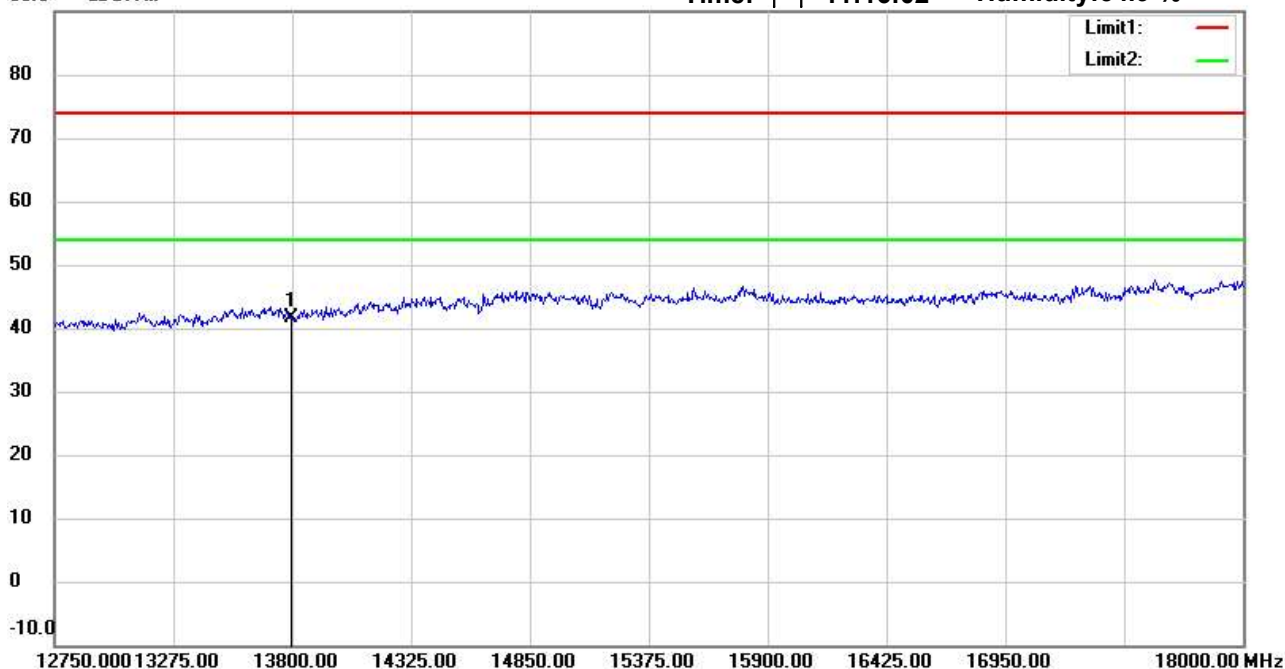
Data : #4

Polarization: **Horizontal**

| Mk. | Frequency (MHz) | Reading (dBuV) | Detector | Corr. factor (dB/m) | Result (dBuV/m) | Limit (dBuV/m) | Ant.Pos (cm) | Tab.Pos (deg.) | Margin (dB) | Comment |
|---|---|---|---|---|---|---|---|---|---|---|
| * | 13790.000 | 22.06 | peak | 19.59 | 41.65 | 74.00 | 150 | 359 | -32.35 | |

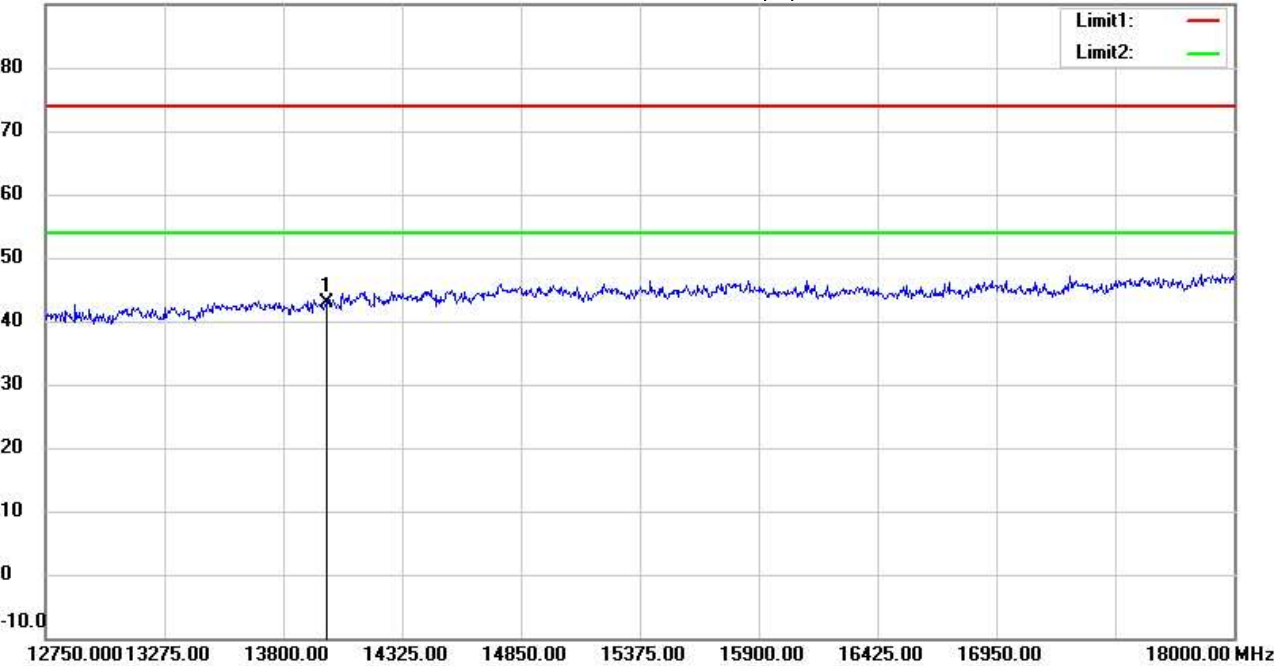
Data :#10

Polarization: Vertical  
Power : 120 Va.c.  
Distance: 3m

| Mk. | Frequency (MHz) | Reading (dBuV) | Detector | Corr. factor (dB/m) | Result (dBuV/m) | Limit (dBuV/m) | Ant.Pos (cm) | Tab.Pos (deg.) | Margin (dB) | Comment |
|---|---|---|---|---|---|---|---|---|---|---|
| * | 13990.000 | 21.92 | peak | 20.93 | 42.85 | 74.00 | 150 | 58 | -31.15 | |
