Radiated Emission Measurement

Site : 966A Chamber  
Condition : FCC\_part 15E RE\_Above 1GHz\_PK  
EUT : W6M22409-23739  
M/N:  
Test Mode : TX 802.11a CH181  
Note :

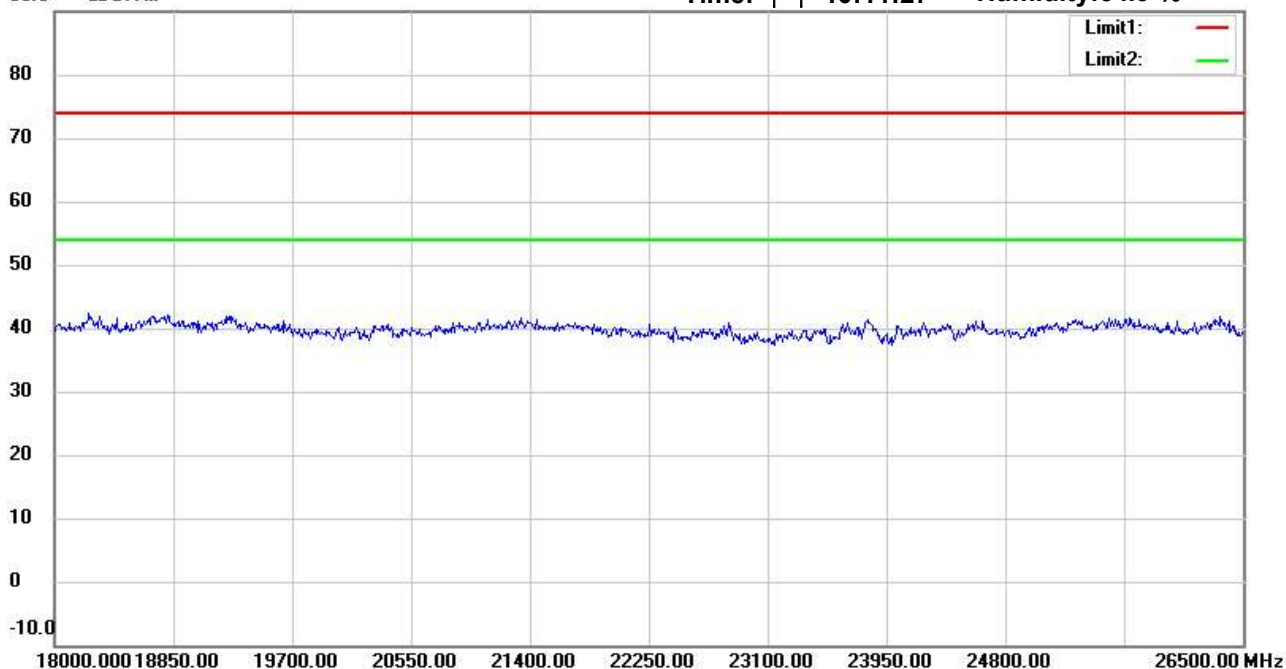
Data : #5

Condition : FCC\_part 15E RE\_Above 1GHz\_PK

Test Mode : TX 802.11a CH181

Polarization: **Horizontal**

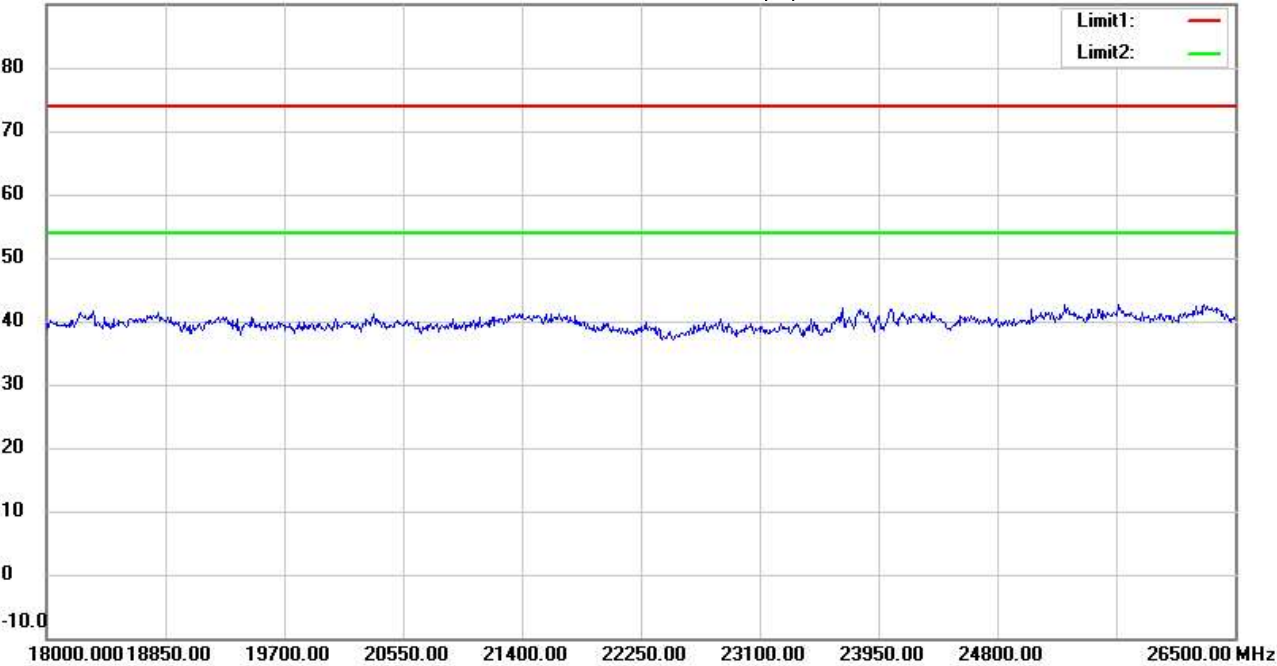
Data :#11

Site : 966A Chamber  
Condition : FCC\_part 15E RE\_Above 1GHz\_PK  
EUT : W6M22409-23739  
M/N:  
Test Mode : TX 802.11a CH181  
Note :

Polarization: Vertical  
Power : 120 Va.c.  
Distance: 3m

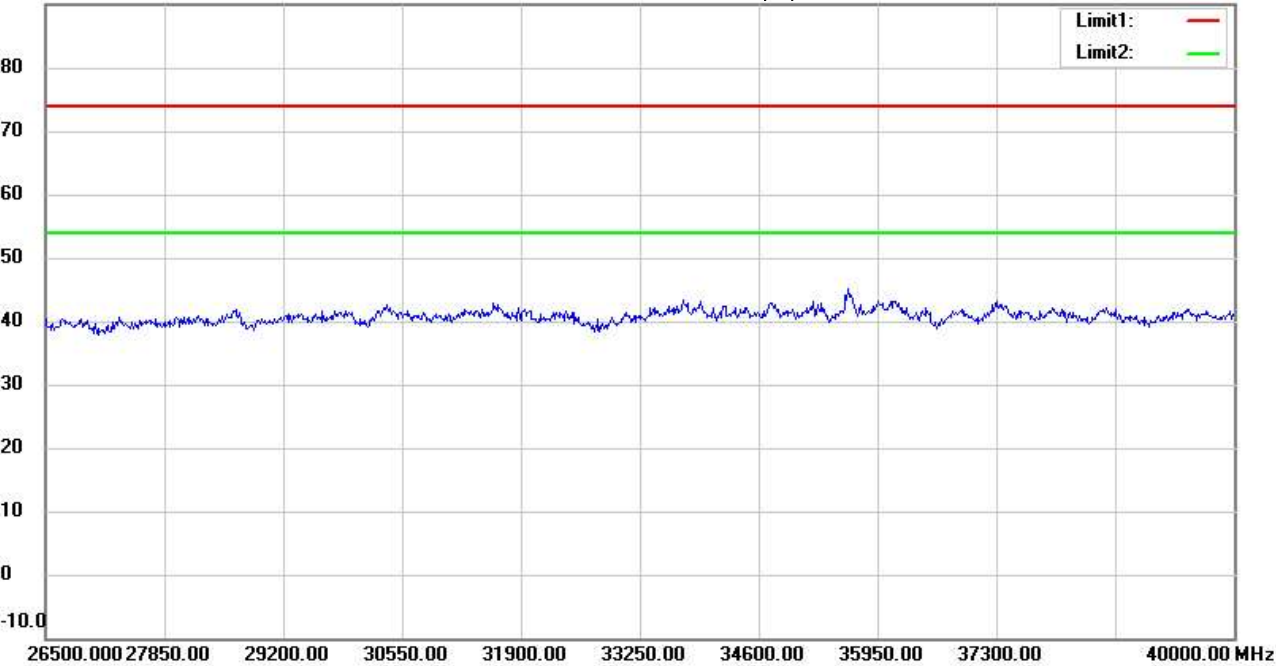
Data :#12

Condition : FCC\_part 15E RE\_Above 1GHz\_PK

Test Mode : TX 802.11a CH181

Polarization: Vertical

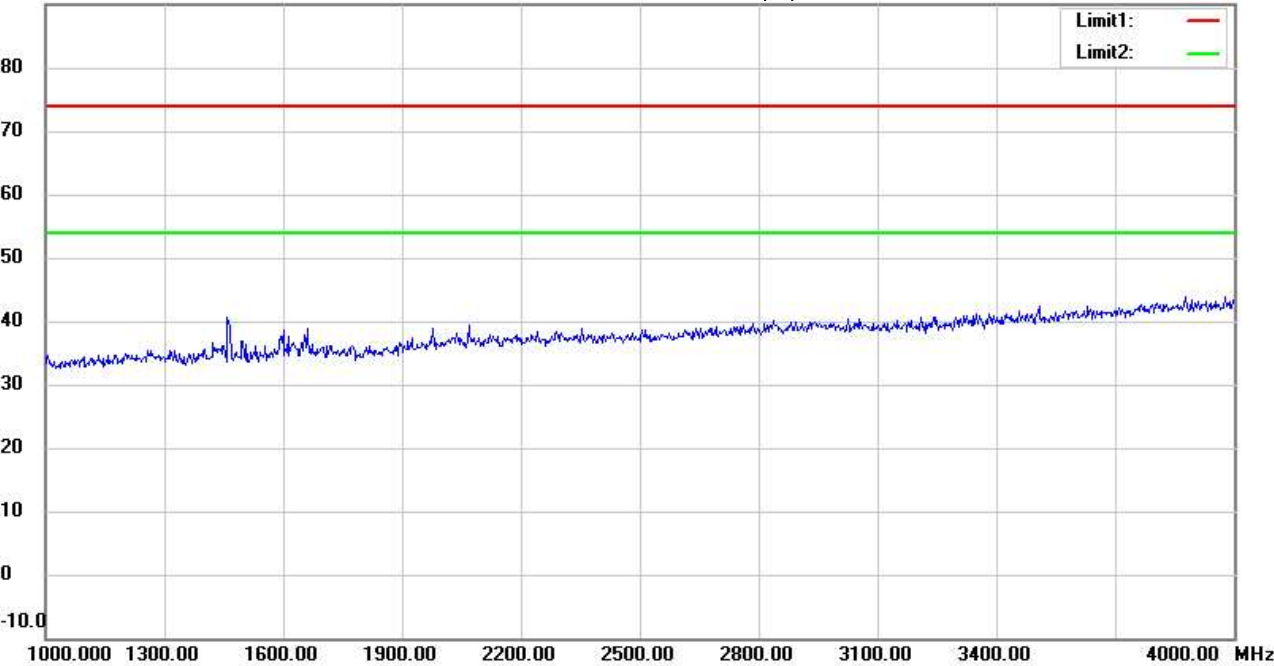
Data :#1

Site : 966A Chamber  
Condition : FCC\_part 15E RE\_Above 1GHz\_PK  
EUT : W6M22409-23739  
M/N:  
Test Mode : TX 802.11a CH117  
Note :

Polarization: Horizontal  
Power : 120 Va.c.  
Distance: 3m

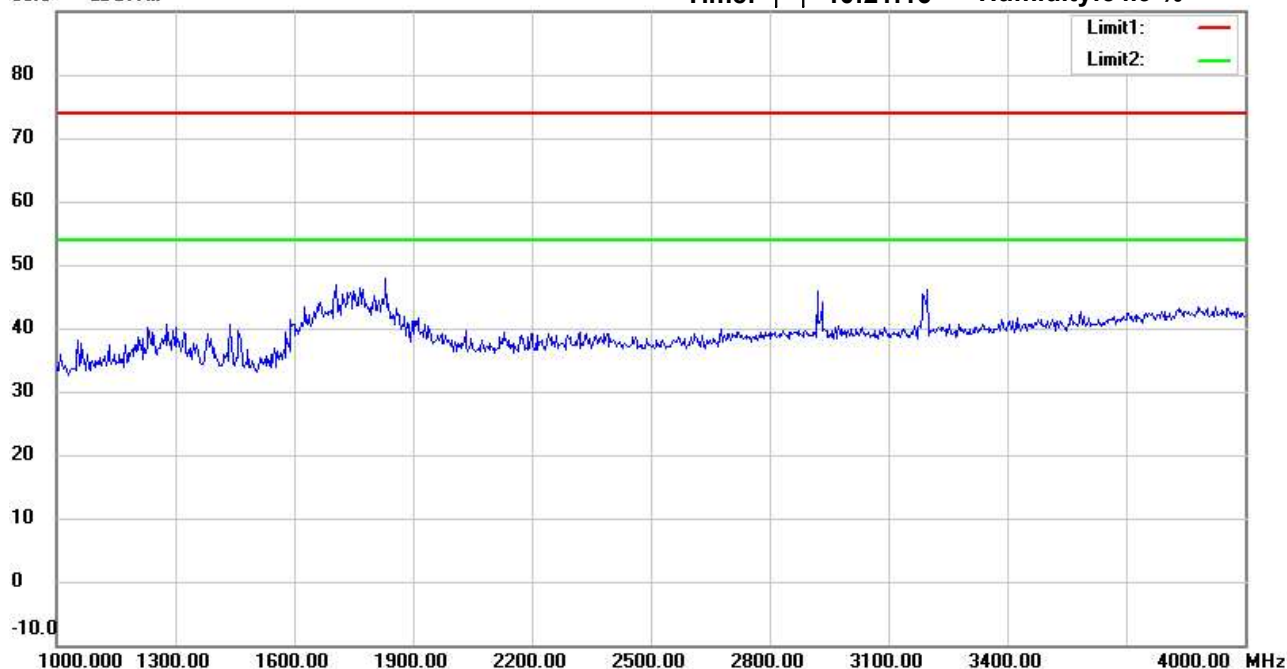
Data : #7

Condition : FCC\_part 15E RE\_Above 1GHz\_PK

Test Mode : TX 802.11a CH117

Polarization: Vertical

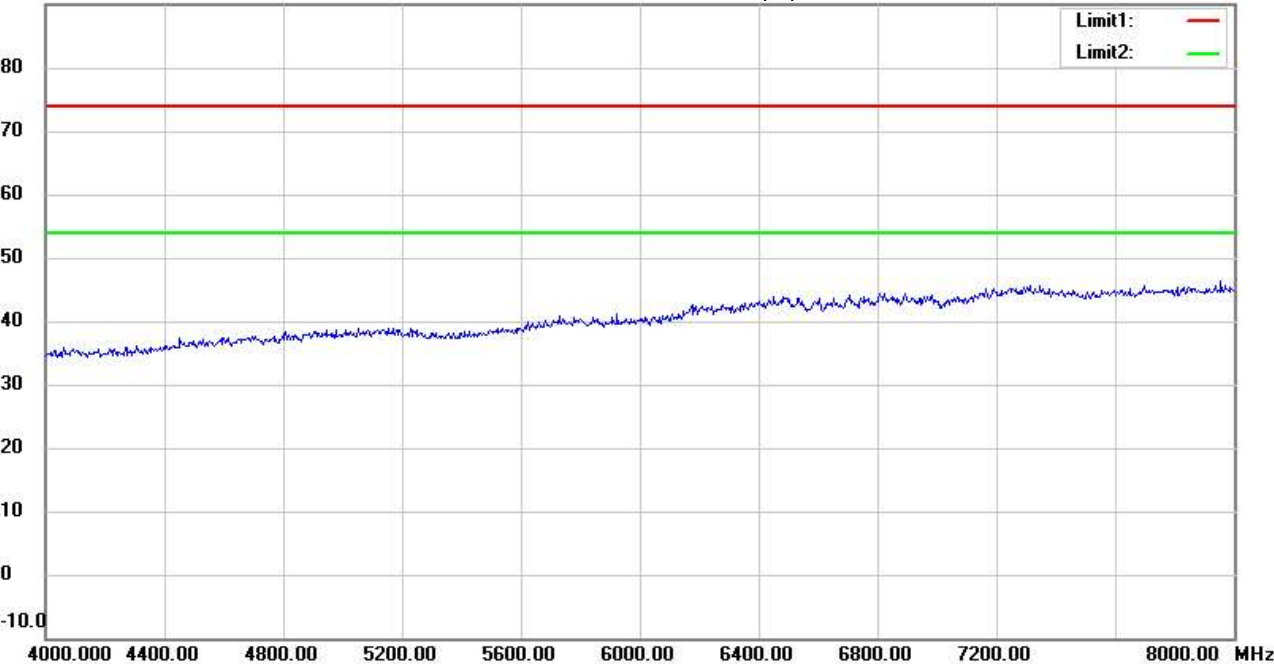
Data :#2

Condition : FCC\_part 15E RE\_Above 1GHz\_PK

Test Mode : TX 802.11a CH117

Polarization: *Horizontal*

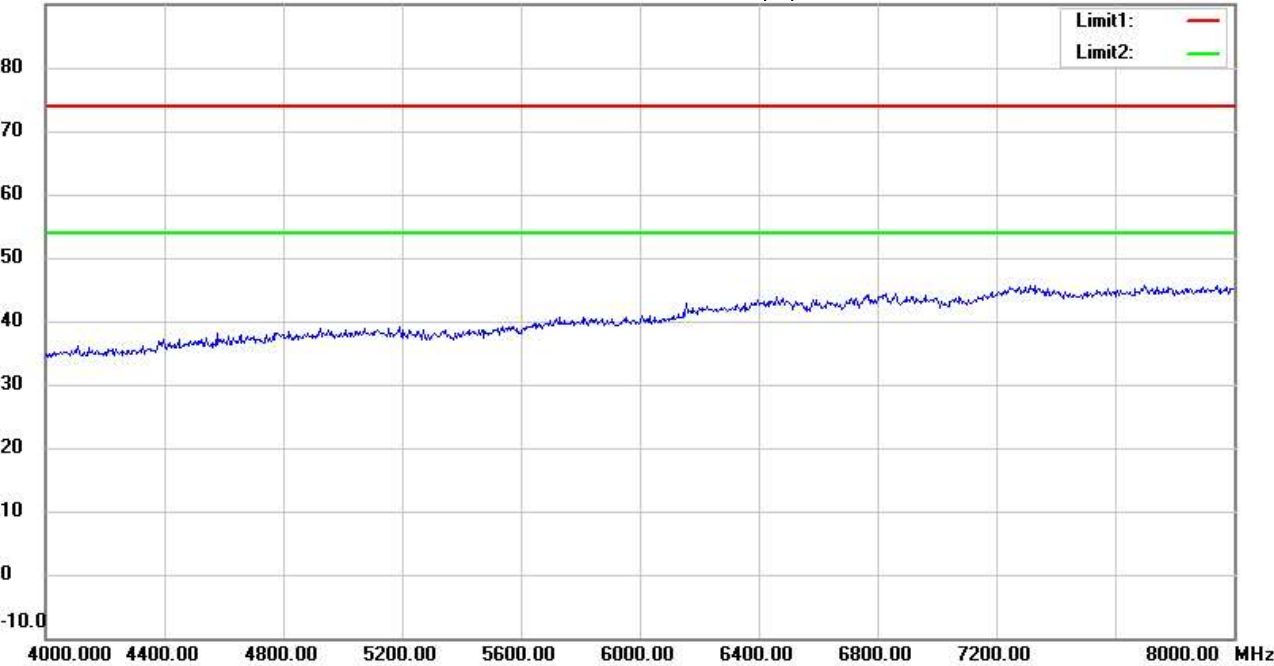
Data :#8

Site : 966A Chamber  
Condition : FCC\_part 15E RE\_Above 1GHz\_PK  
EUT : W6M22409-23739  
M/N:  
Test Mode : TX 802.11a CH117  
Note :

Polarization: Vertical  
Power : 120 Va.c.  
Distance: 3m

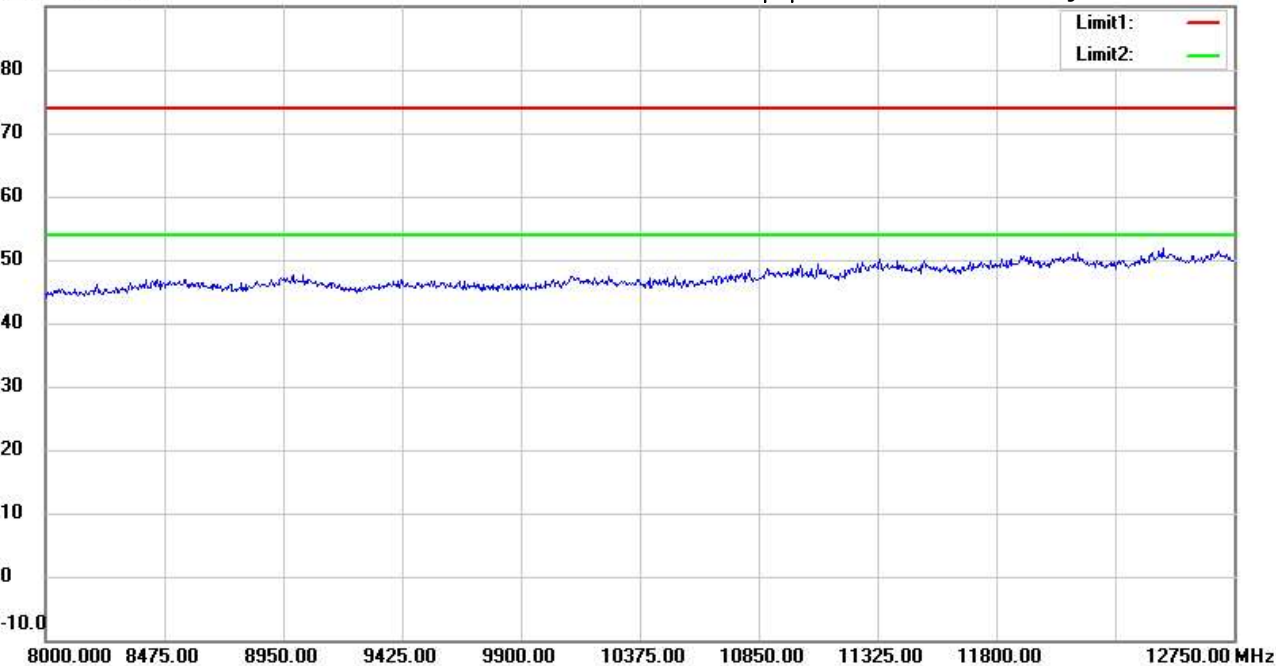
Data :#3

Condition : FCC\_part 15E RE\_Above 1GHz\_PK

Test Mode : TX 802.11a CH117

Polarization: *Horizontal*

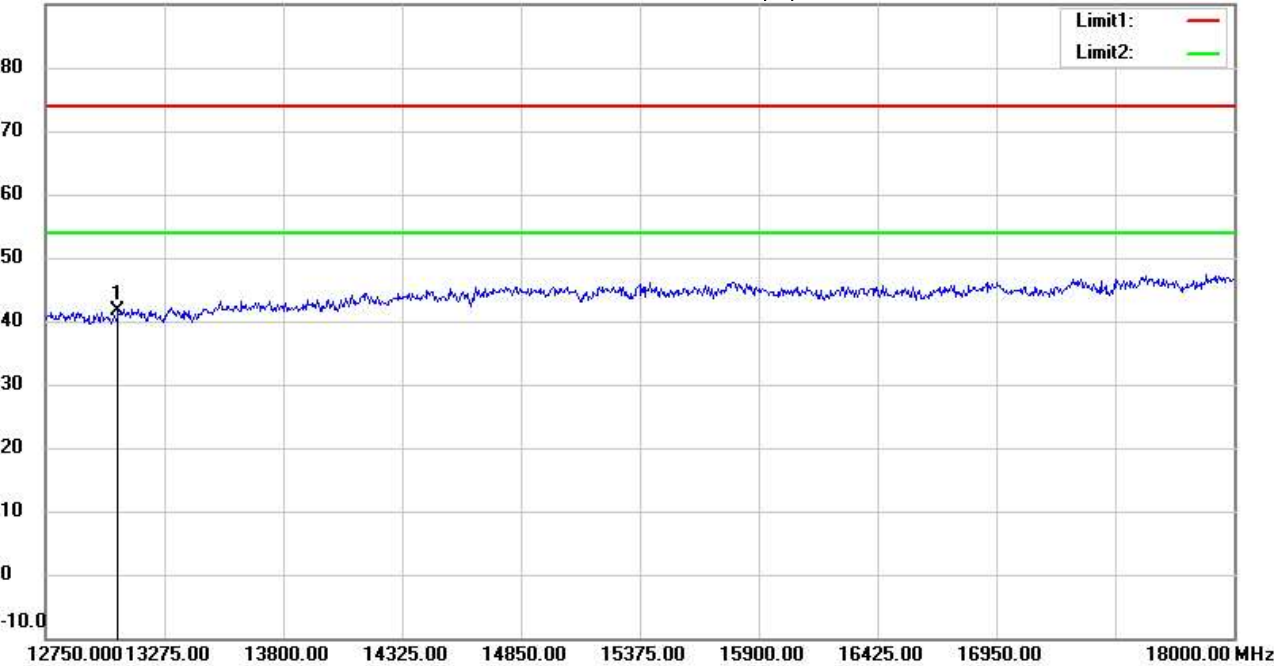
Data :#4

Site : 966A Chamber  
Condition : FCC\_part 15E RE\_Above 1GHz\_PK  
EUT : W6M22409-23739  
M/N:  
Test Mode : TX 802.11a CH117  
Note :

Polarization: *Horizontal*  
Power : 120 Va.c.  
Distance: 3m

| Mk. | Frequency (MHz) | Reading (dBuV) | Detector | Corr. factor (dB/m) | Result (dBuV/m) | Limit (dBuV/m) | Ant.Pos (cm) | Tab.Pos (deg.) | Margin (dB) | Comment |
|---|---|---|---|---|---|---|---|---|---|---|
| * | 13070.000 | 24.36 | peak | 17.21 | 41.57 | 74.00 | 150 | 28 | -32.43 | |

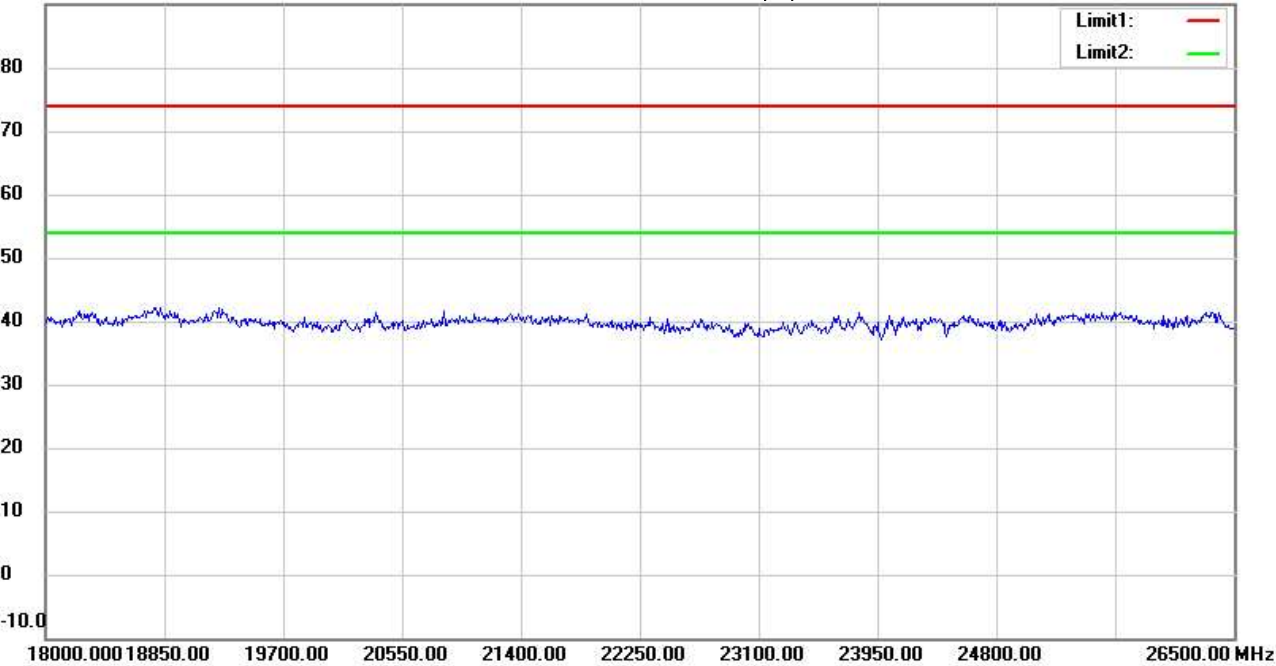
Data :#5

Site : 966A Chamber  
Condition : FCC\_part 15E RE\_Above 1GHz\_PK  
EUT : W6M22409-23739  
M/N:  
Test Mode : TX 802.11a CH117  
Note :

Polarization: *Horizontal*  
Power : 120 Va.c.  
Distance: 3m

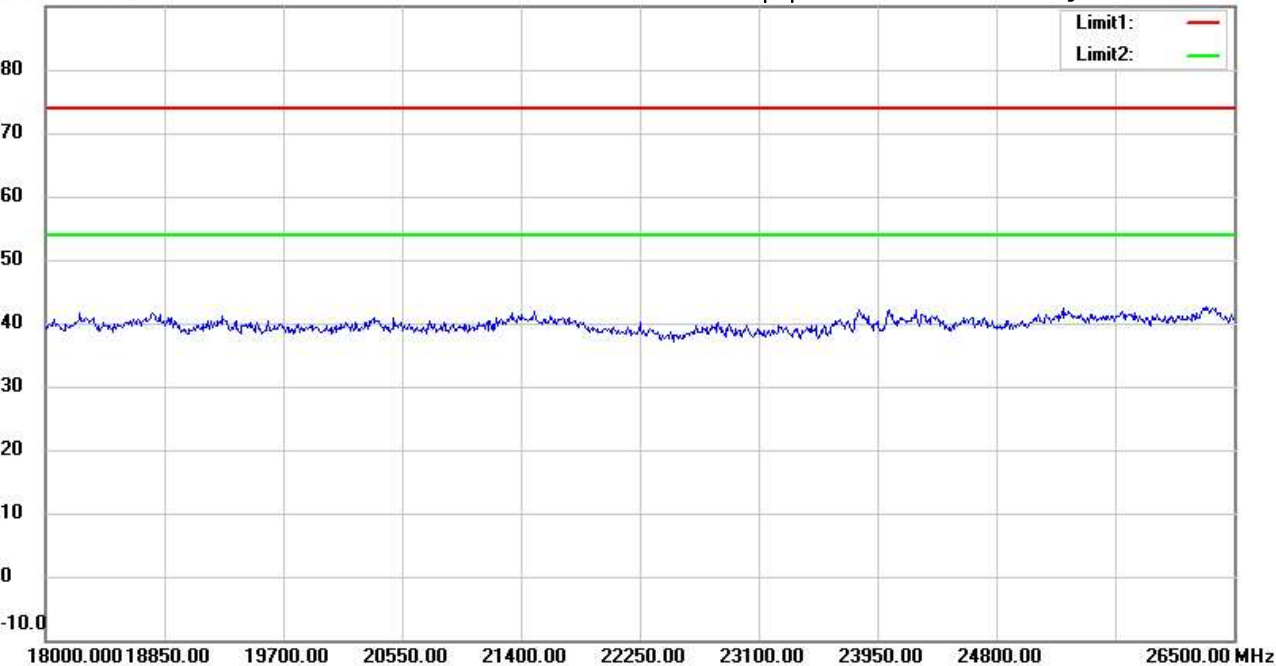
Data :#11

Condition : FCC\_part 15E RE\_Above 1GHz\_PK

Test Mode : TX 802.11a CH117

Polarization: Vertical

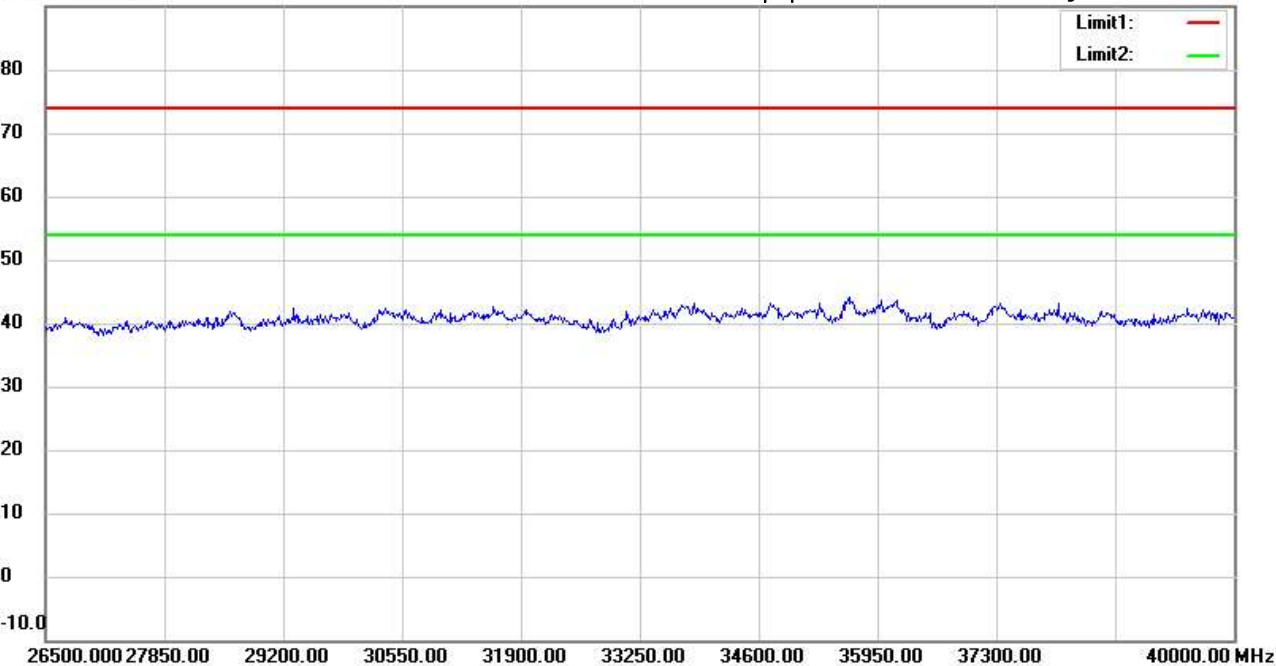
Data :#12

Condition : FCC\_part 15E RE\_Above 1GHz\_PK

Test Mode : TX 802.11a CH117

Polarization: Vertical

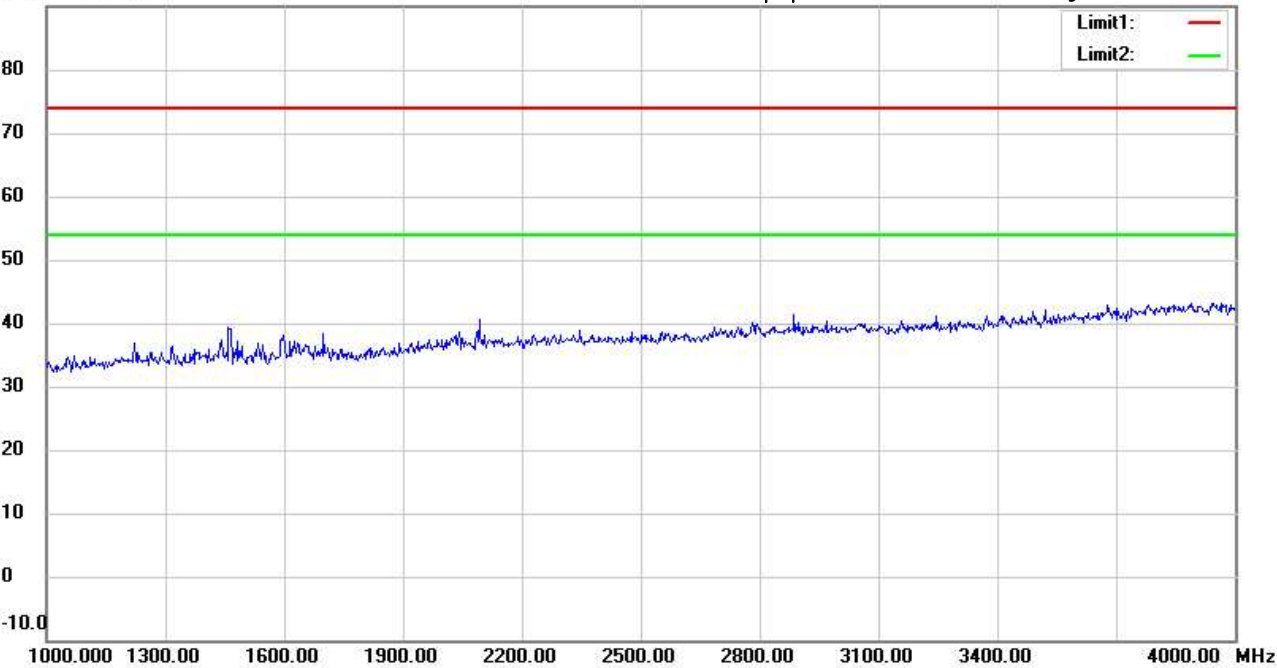
Data :#1

Condition : FCC\_part 15E RE\_Above 1GHz\_PK

Test Mode : TX 802.11a CH149

Polarization: *Horizontal*

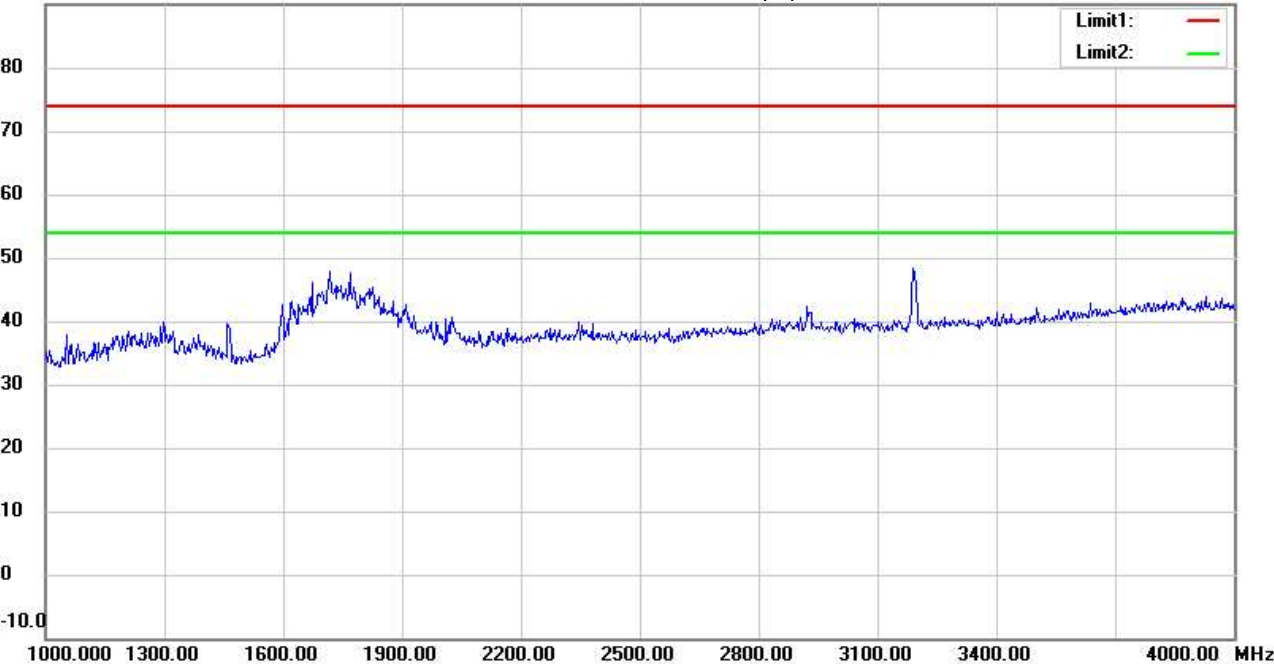
Data :#7

Condition : FCC\_part 15E RE\_Above 1GHz\_PK

Test Mode : TX 802.11a CH149

Polarization: Vertical

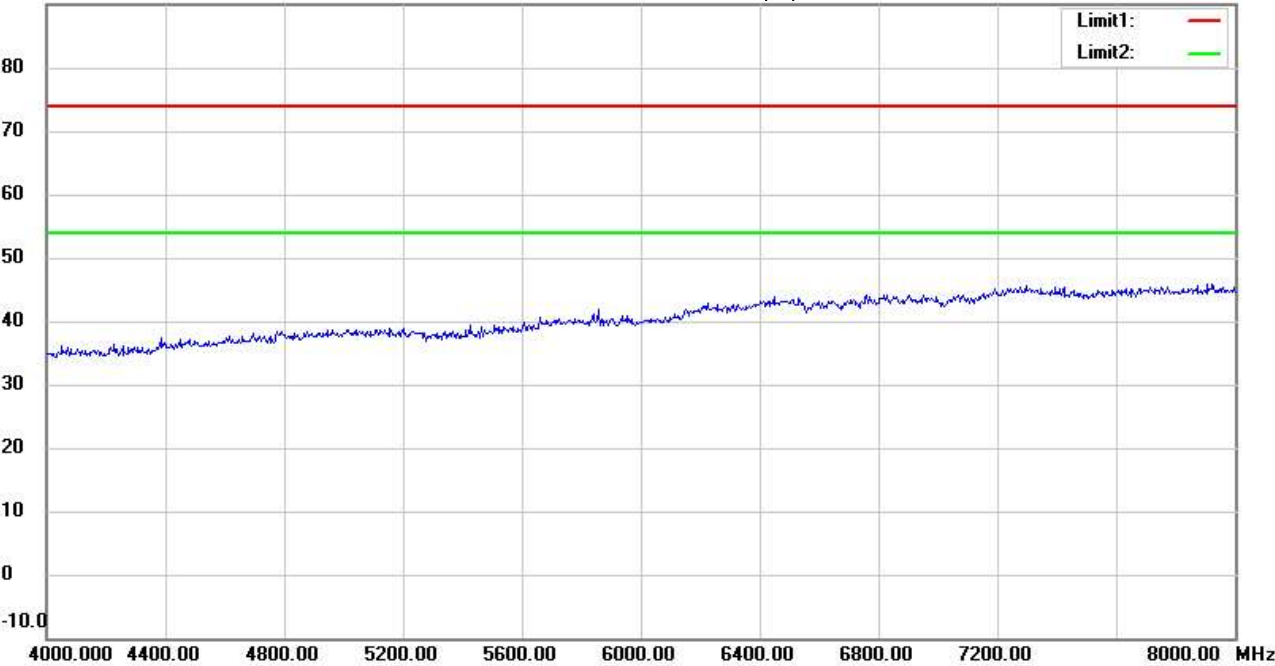
Data :#8

Site : 966A Chamber  
Condition : FCC\_part 15E RE\_Above 1GHz\_PK  
EUT : W6M22409-23739  
M/N:  
Test Mode : TX 802.11a CH149  
Note :

Polarization: Vertical  
Power : 120 Va.c.  
Distance: 3m

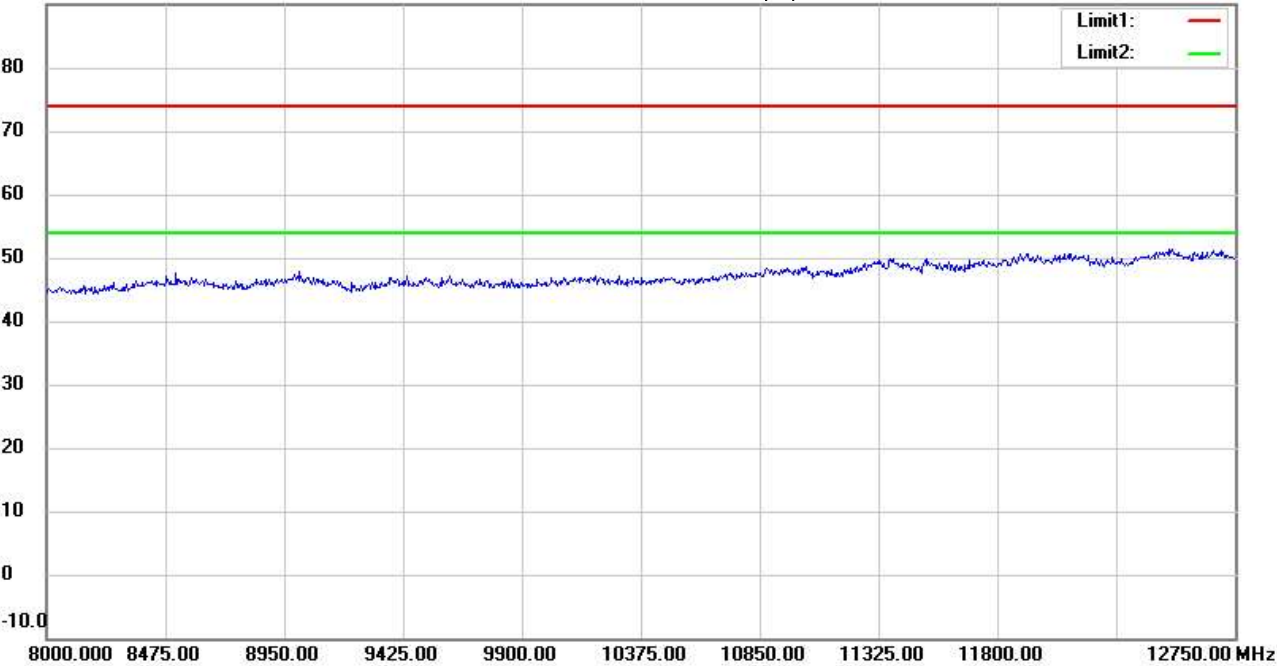
Data :#9

Site : 966A Chamber  
Condition : FCC\_part 15E RE\_Above 1GHz\_PK  
EUT : W6M22409-23739  
M/N:  
Test Mode : TX 802.11a CH149  
Note :

Polarization: Vertical  
Power : 120 Va.c.  
Distance: 3m

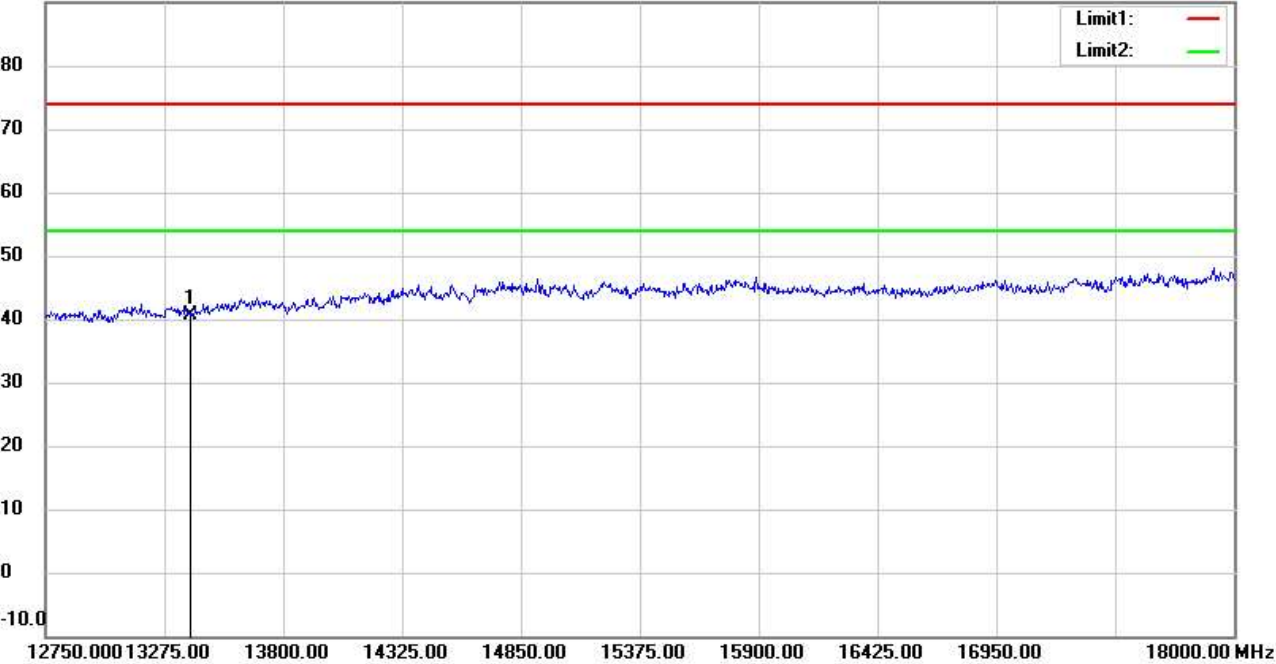
Data :#4

Condition : FCC\_part 15E RE\_Above 1GHz\_PK

Test Mode : TX 802.11a CH149

Polarization: **Horizontal**

| Mk. | Frequency (MHz) | Reading (dBuV) | Detector | Corr. factor (dB/m) | Result (dBuV/m) | Limit (dBuV/m) | Ant.Pos (cm) | Tab.Pos (deg.) | Margin (dB) | Comment |
|---|---|---|---|---|---|---|---|---|---|---|
| * | 13390.000 | 22.41 | peak | 18.10 | 40.51 | 74.00 | 150 | 64 | -33.49 | |

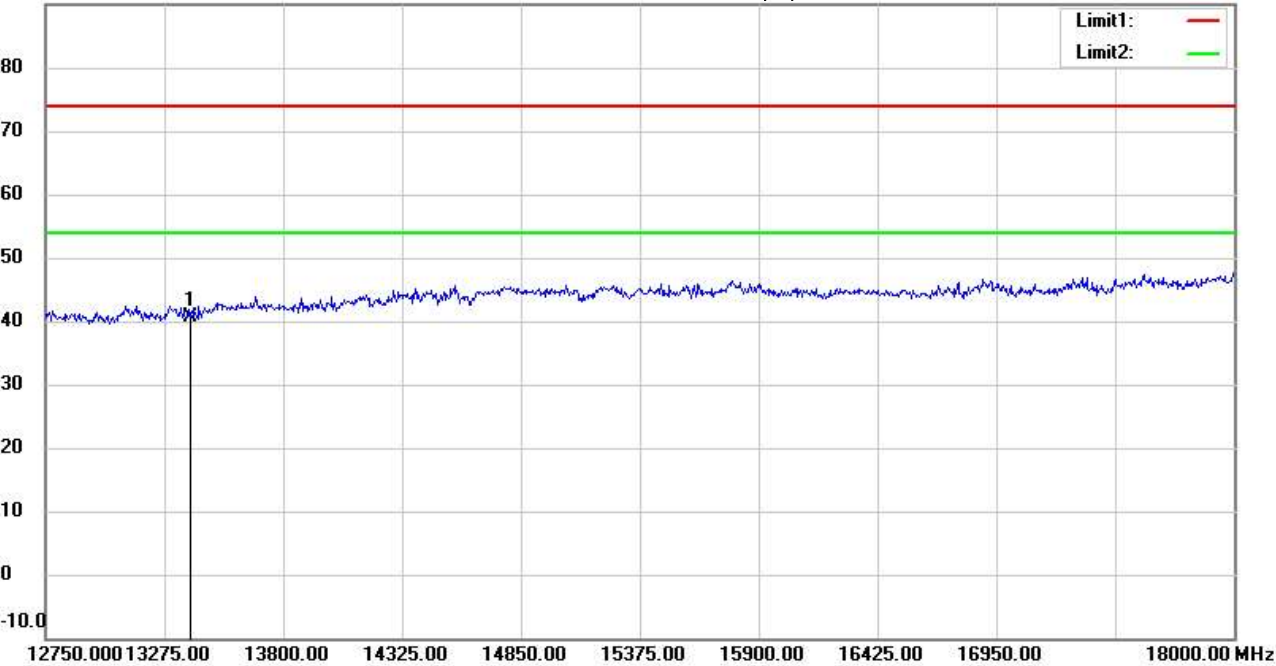
Data :#10

Site : 966A Chamber  
Condition : FCC\_part 15E RE\_Above 1GHz\_PK  
EUT : W6M22409-23739  
M/N:  
Test Mode : TX 802.11a CH149  
Note :

Polarization: Vertical  
Power : 120 Va.c.  
Distance: 3m

| Mk. | Frequency (MHz) | Reading (dBuV) | Detector | Corr. factor (dB/m) | Result (dBuV/m) | Limit (dBuV/m) | Ant.Pos (cm) | Tab.Pos (deg.) | Margin (dB) | Comment |
|---|---|---|---|---|---|---|---|---|---|---|
| * | 13390.000 | 22.46 | peak | 18.10 | 40.56 | 74.00 | 150 | 359 | -33.44 | |

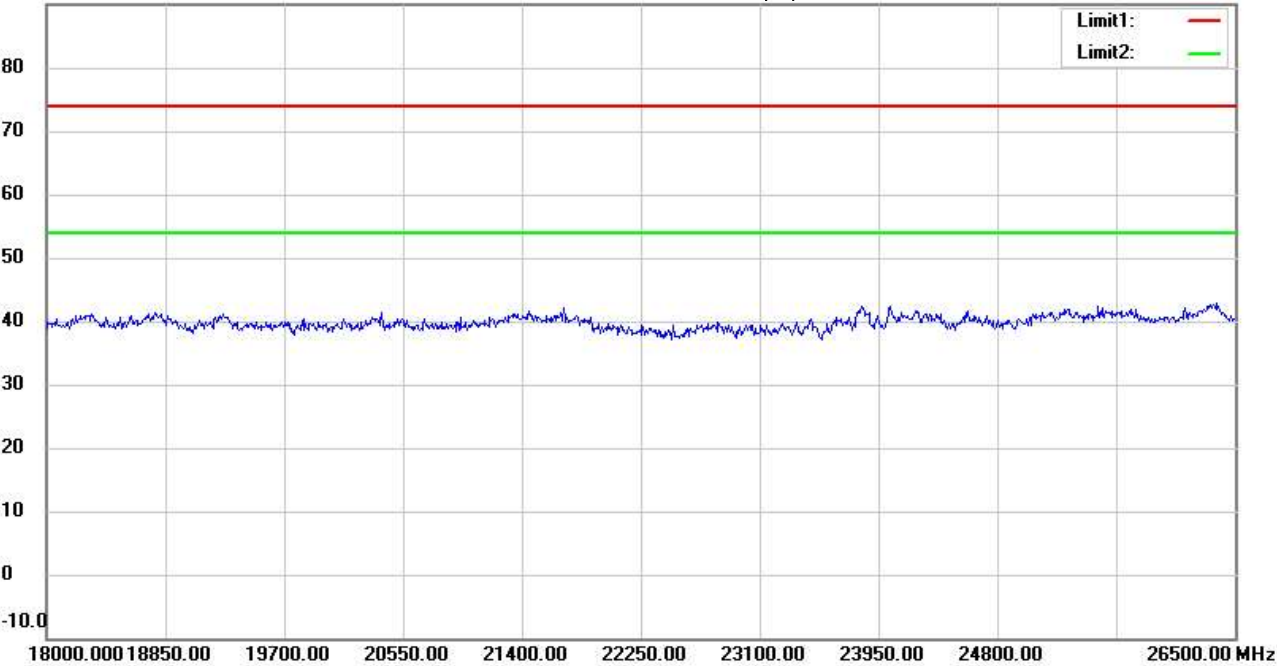
Data :#11

Site : 966A Chamber  
Condition : FCC\_part 15E RE\_Above 1GHz\_PK  
EUT : W6M22409-23739  
M/N:  
Test Mode : TX 802.11a CH149  
Note :

Polarization: Vertical  
Power : 120 Va.c.  
Distance: 3m
