### **APPENDIX 3: Photographs of test setup**

#### **Radiated Emission**

### Worst Case Position

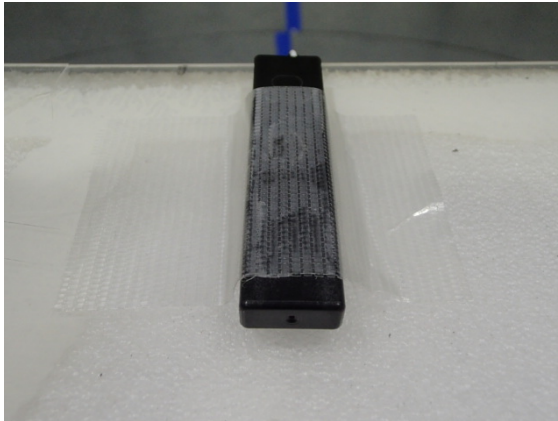
**X-axis**

**LF Antenna**  
Below 30MHz: X-axis  
Above 30MHz  
Horizontal: X-axis / Vertical: X-axis

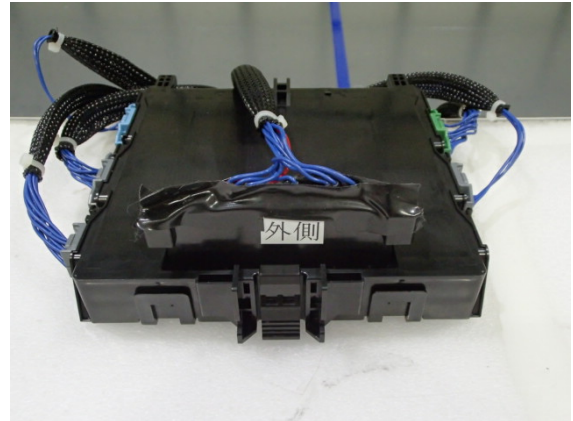
**X-axis**

**ECU**  
Below 30MHz: X-axis  
Above 30MHz  
Horizontal: X-axis / Vertical: X-axis
