## 12 COMPLIANCE WITH THE RESTRICTED BAND EDGE TEST DATA

## 15 BANDEDGE PLOTS

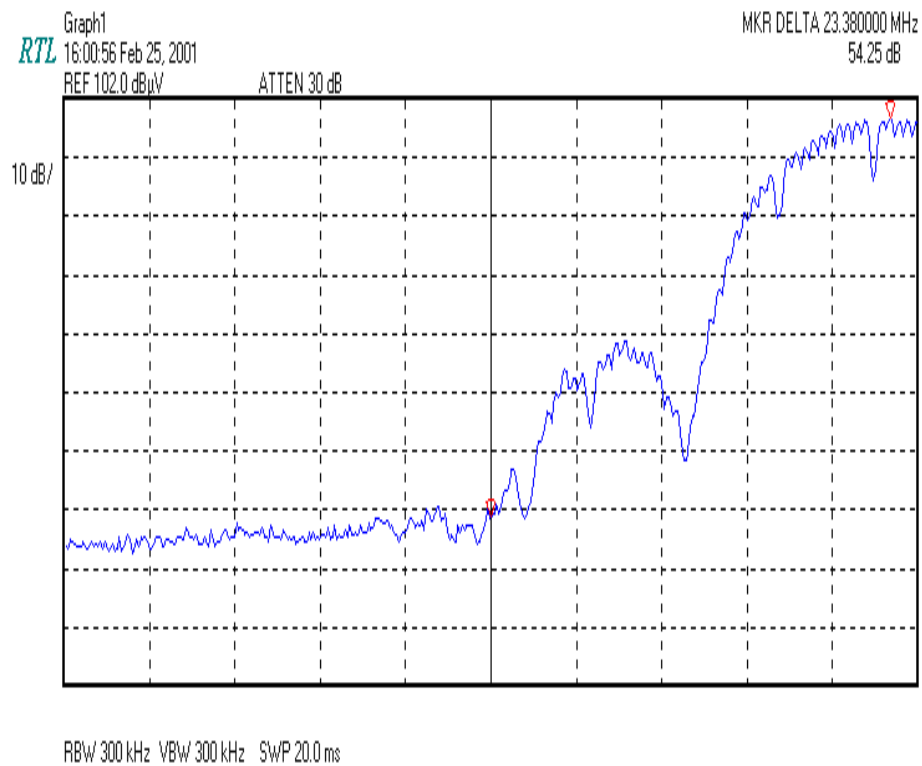
PLOT 1: CHANNEL 1 CISCO DIPOLE ANTENNA 1MHZ/10HZ

| Band edge Measurement | | | | | |
|---|---|---|---|---|---|
| Cisco Dipole | 1 | 2390.0 | 53.1 | 54.0 | -0.9 |

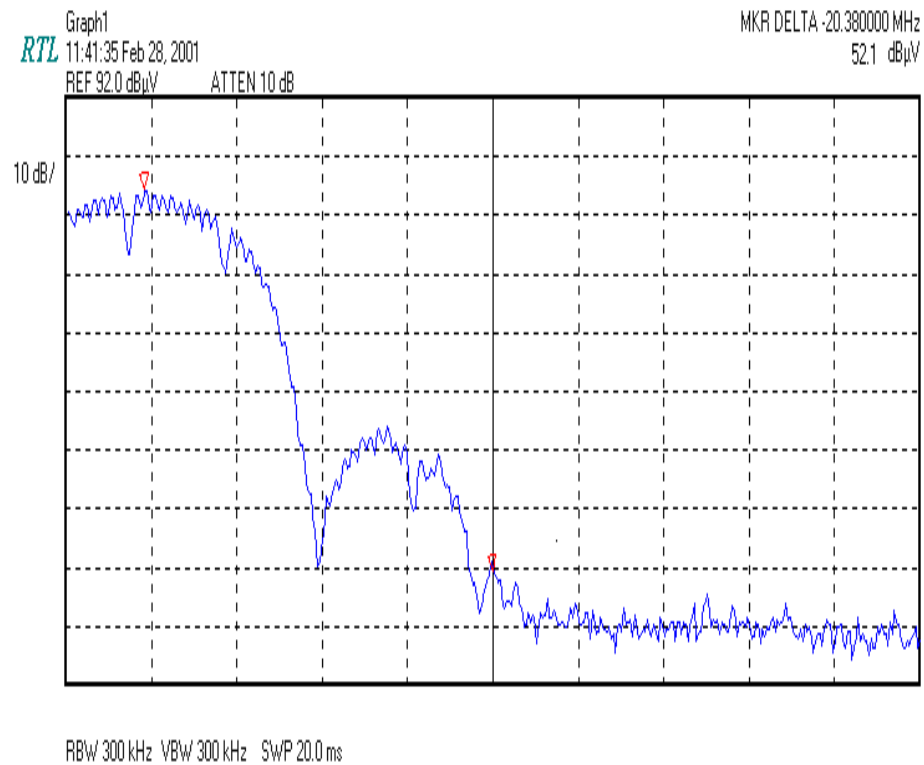
PLOT 3: CHANNEL 11 CISCO DIPOLEANTENNA

| Band edge Measurement | | | | | |
|---|---|---|---|---|---|
| | 11 | 2483.5 | 53.9 | 54.0 | -0.1 |

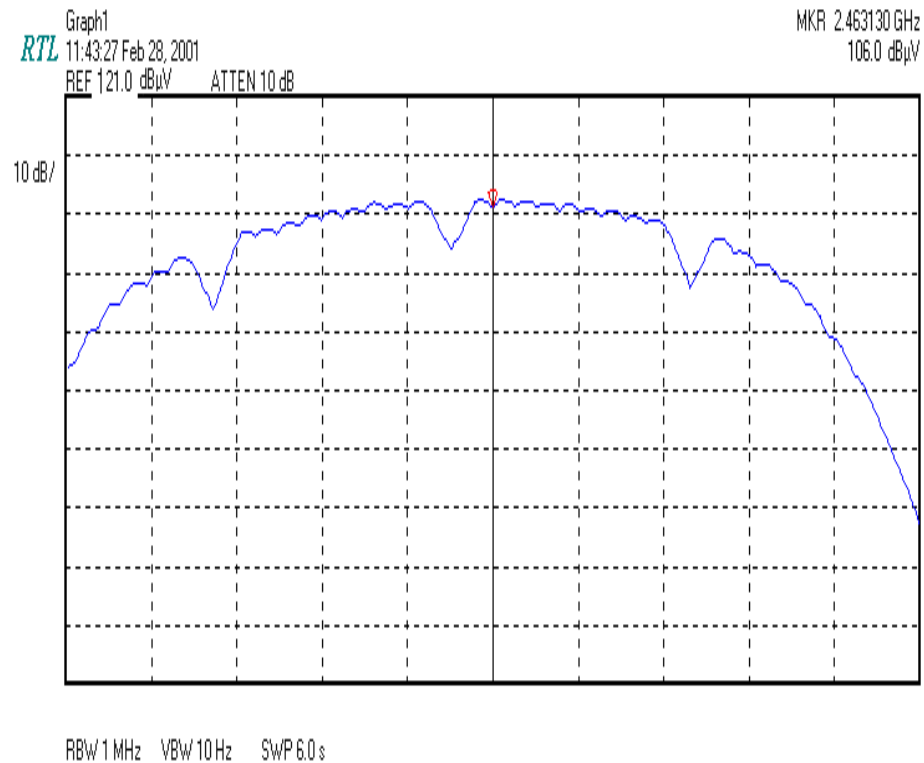
PLOT 4: CHANNEL 11 CISCO DIPOLE ANTENNA

**Note site factor entered into analyzer register for corrected final result.**

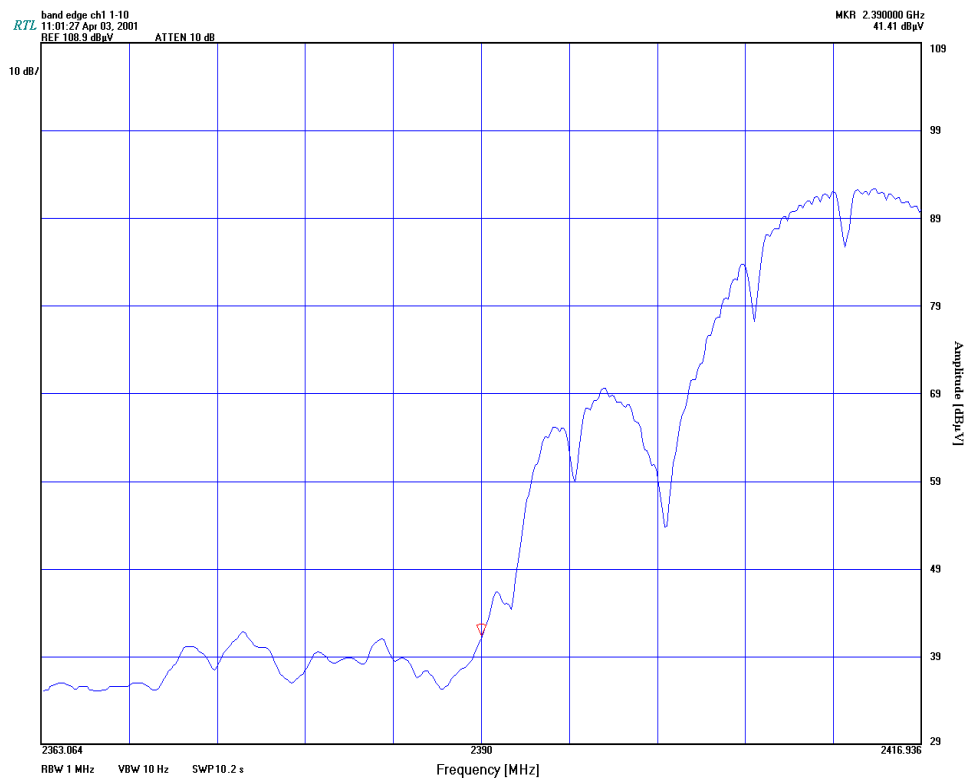
PLOT 5: CHANNEL 1 DELL DIPOLE ANTENNA 1MHZ/10HZ

| Band edge Measurement | | | | | |
|---|---|---|---|---|---|
| Dell Dipole | 1 | 2390.0 | 41.4 | 54.0 | -12.6 |

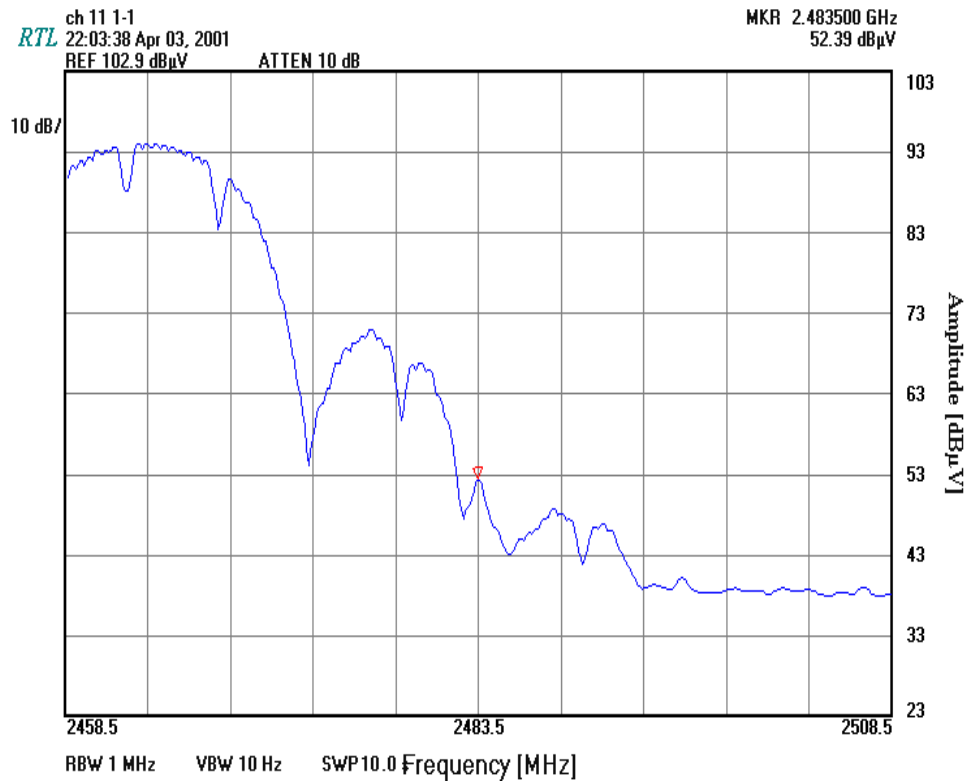
PLOT 7 CHANNEL 11 DELL DIPOLE ANTENNA 1MHZ/10HZ

| Band edge Measurement | | | | | |
|---|---|---|---|---|---|
| | 11 | 2483.5 | 52.4 | 54.0 | -1.6 |

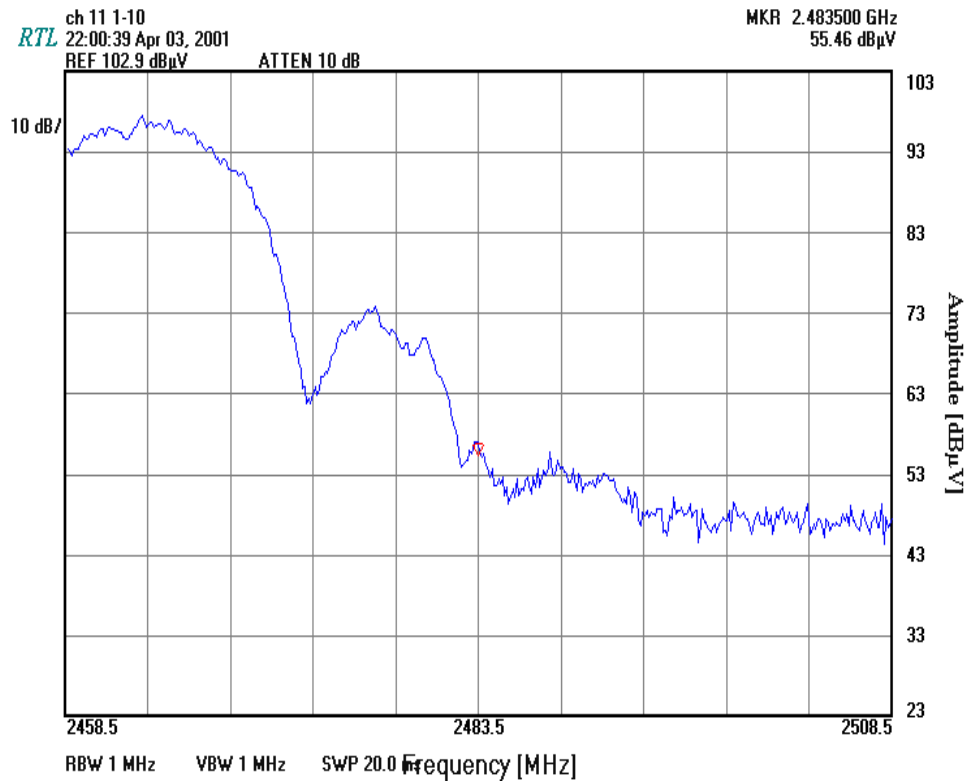
PLOT 8

CHANNEL 11 DELL DIPOLE ANTENNA 1MHZ/1MHZ

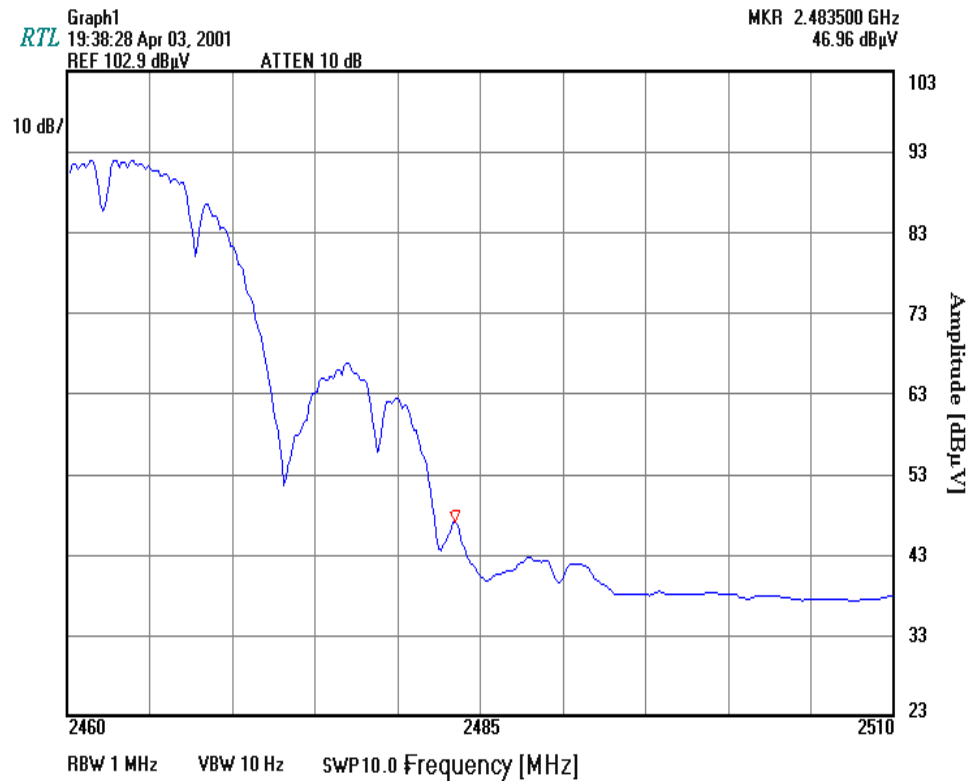
PLOT 11 CHANNEL 11 DELL INVERTED F ANTENNA 1MHZ/10HZ

| Band edge Measurement | | | | | |
|---|---|---|---|---|---|
| | 11 | 2483.5 | 46.9 | 54.0 | -7.1 |

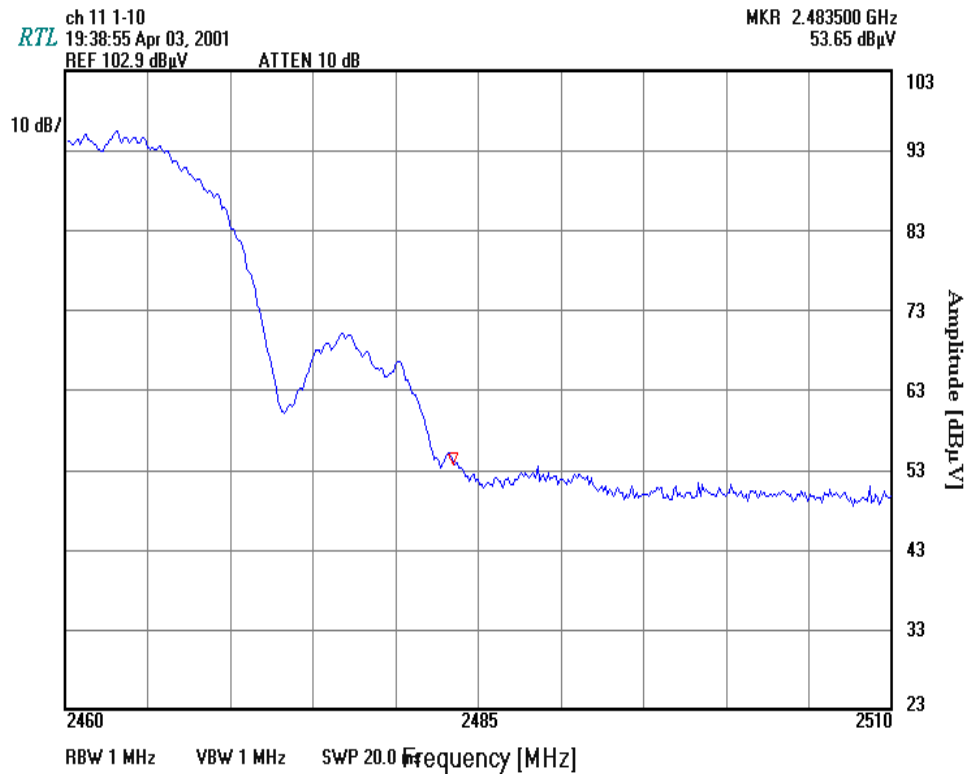
PLOT 12 CHANNEL 11 DELL INVERTED F ANTENNA 1MHZ/1MHZ

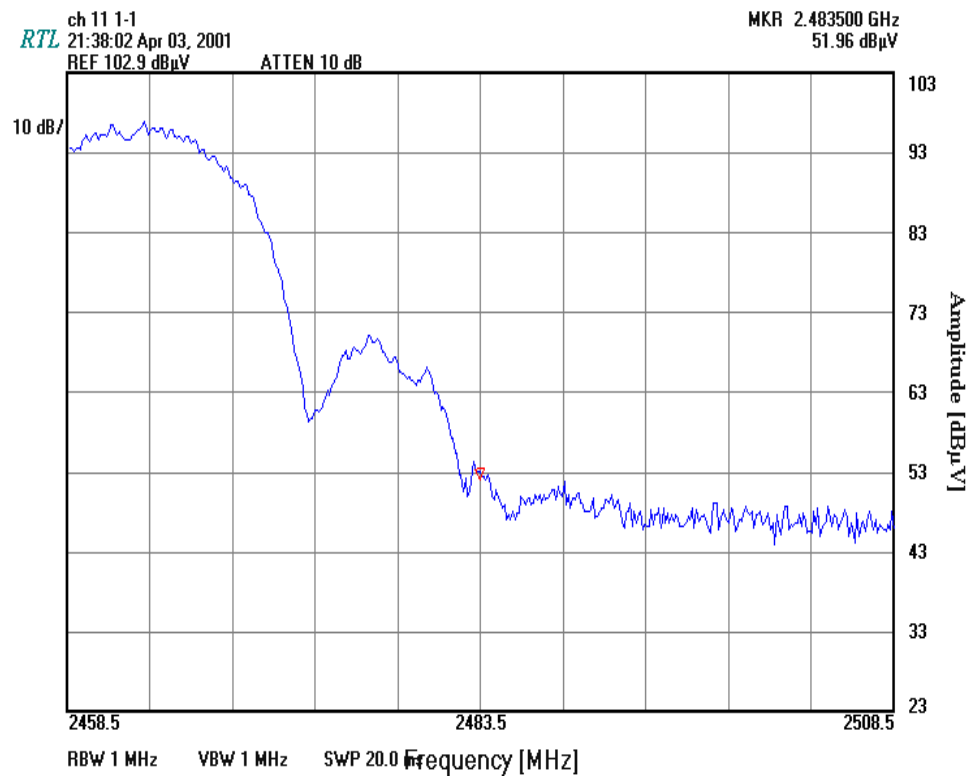
PLOT 16 CHANNEL 11 TOSHIBA CHIP ANTENNA 1MHZ/1MHZ

| Band edge Measurement | | | | | |
|---|---|---|---|---|---|
| | 11 | 2483.5 | 47.2 | 54.0 | -6.8 |

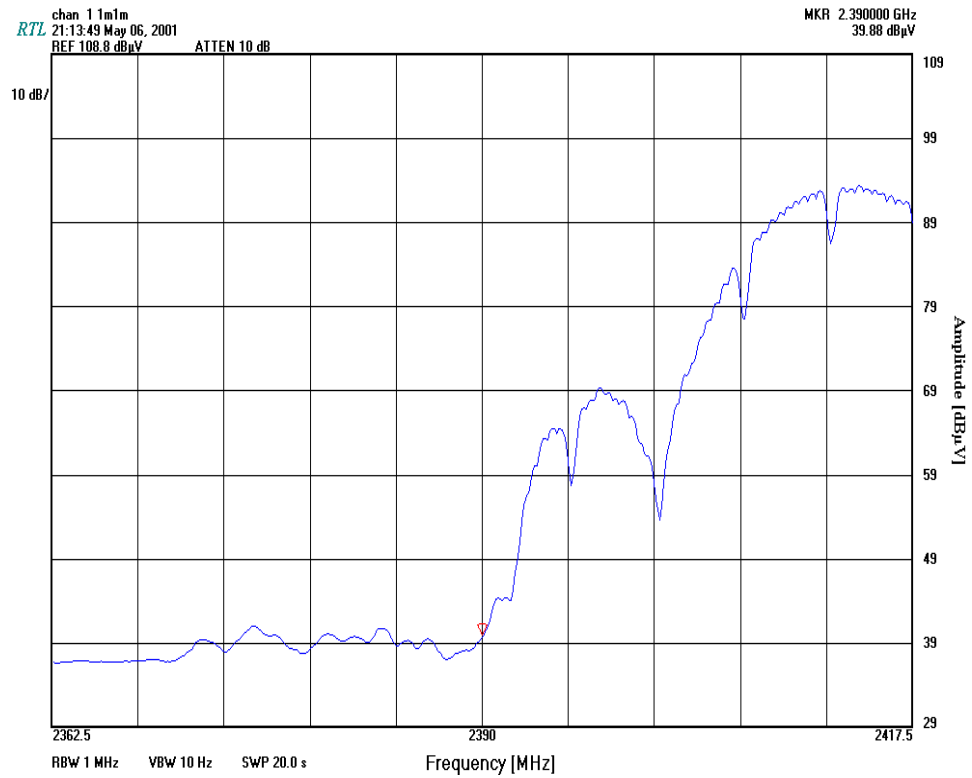
PLOT 17 CHANNEL 1 INVERTED F TOSHIBA ANTENNA 1MHZ/10HZ

| Band edge Measurement | | | | | |
|---|---|---|---|---|---|
| Toshiba Inverted F | 1 | 2390.0 | 39.8 | 54.0 | -14.2 |

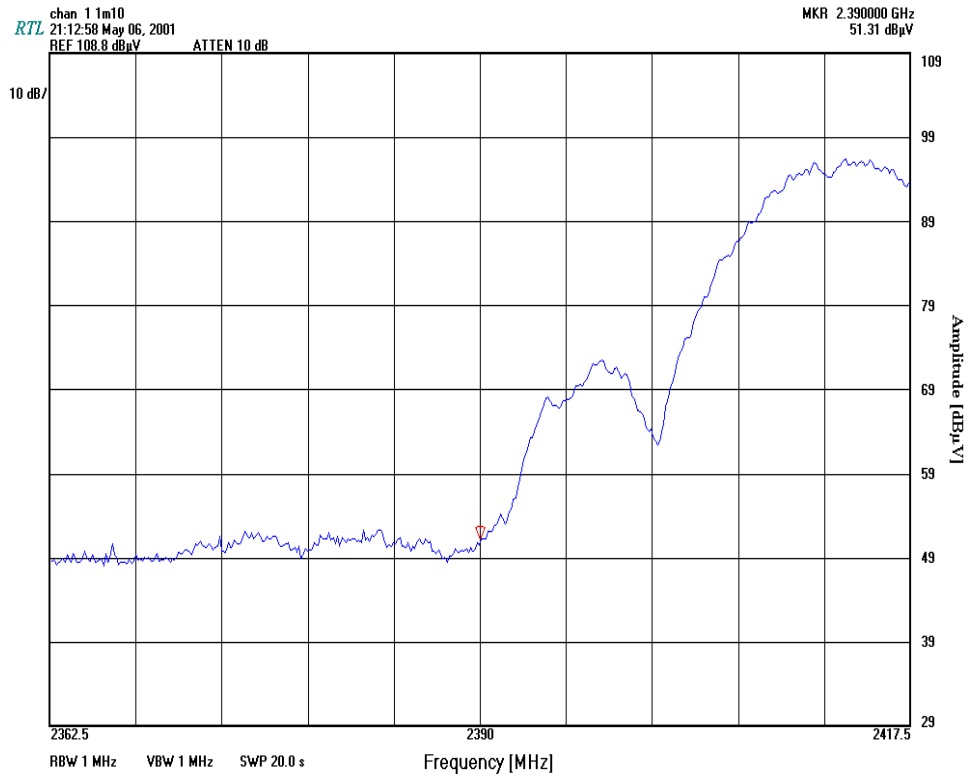
PLOT 18 CHANNEL 1 INVERTED F TOSHIBA ANTENNA 1MHZ/1MHZ

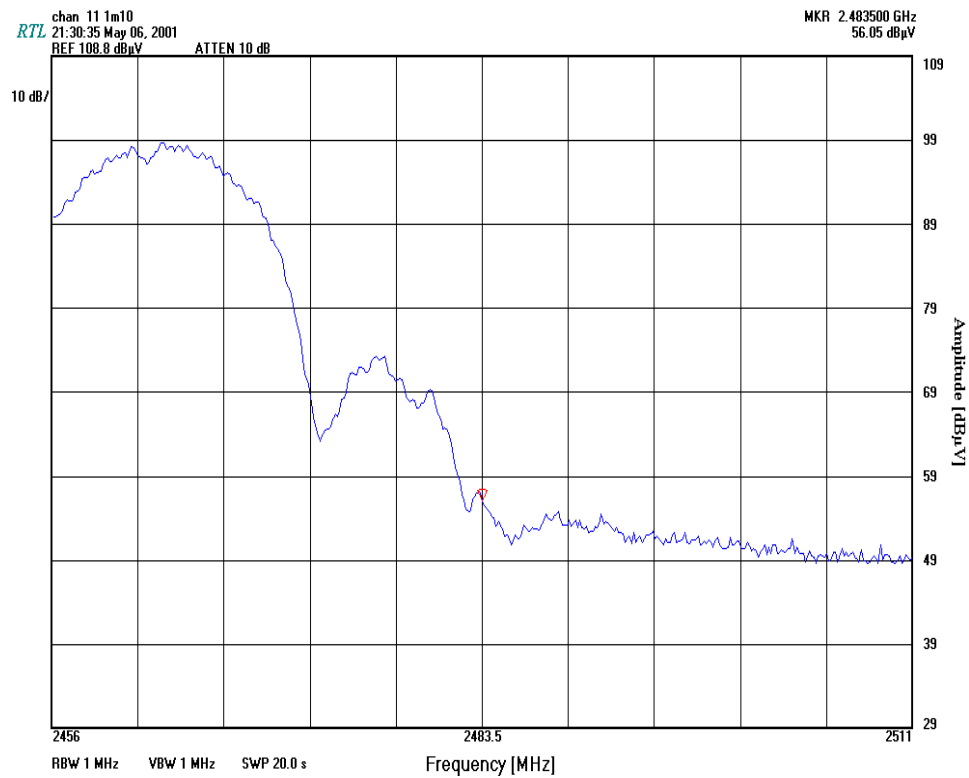
PLOT 20 CHANNEL 11 INVERTED F TOSHIBA ANTENNA 1MHZ/1MHZ

| Band edge Measurement | | | | | |
|---|---|---|---|---|---|
| | 11 | 2483.5 | 50.2 | 54.0 | -3.8 |
