Radiated Emission Measurement

Site : 966A Chamber  
Condition : FCC\_part 15E RE\_Above 1GHz\_PK  
EUT : W6M22409-23739  
M/N:  
Test Mode : TX 802.11a CH105  
Note :

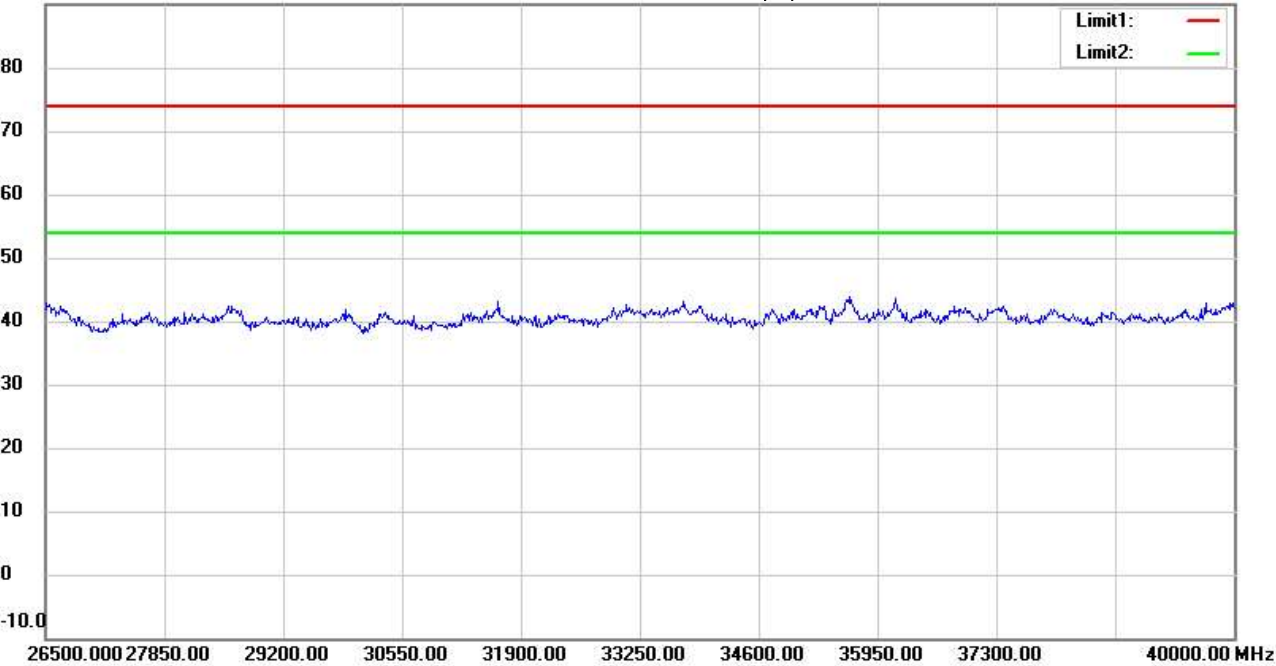
Polarization: Horizontal  
Power : 120 Va.c.  
Distance: 3m

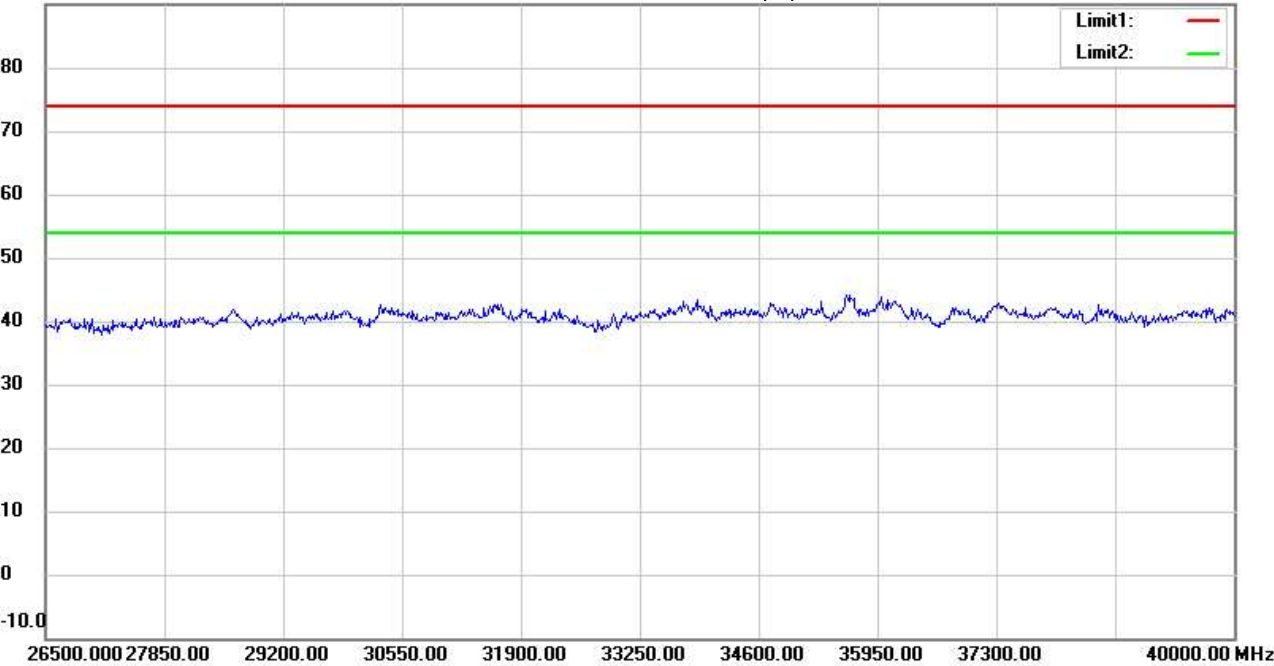
Test Mode : TX 802.11a CH105

Polarization: Vertical

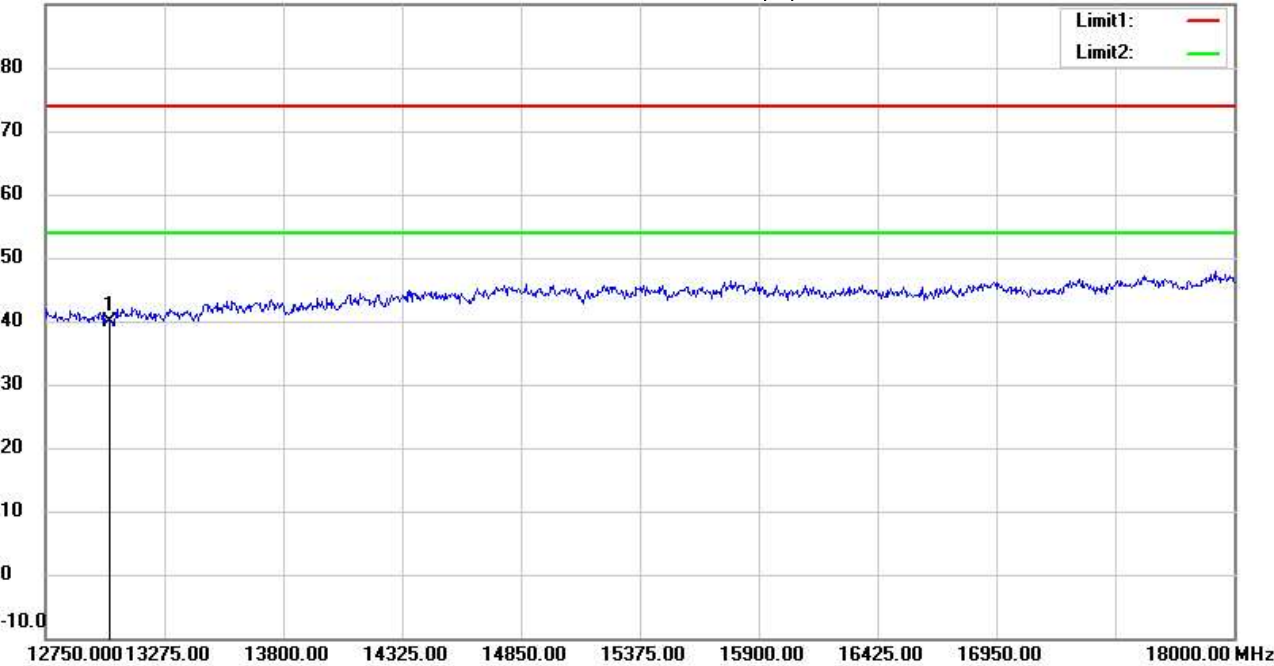
Site : 966A Chamber  
Condition : FCC\_part 15E RE\_Above 1GHz\_PK  
EUT : W6M22409-23739  
M/N:  
Test Mode : TX 802.11a CH113  
Note :

Polarization: Vertical  
Power : 120 Va.c.  
Distance: 3m

| Mk. | Frequency (MHz) | Reading (dBuV) | Detector | Corr. factor (dB/m) | Result (dBuV/m) | Limit (dBuV/m) | Ant.Pos (cm) | Tab.Pos (deg.) | Margin (dB) | Comment |
|---|---|---|---|---|---|---|---|---|---|---|
| * | 13030.000 | 22.83 | peak | 17.10 | 39.93 | 74.00 | 150 | 317 | -34.07 | |

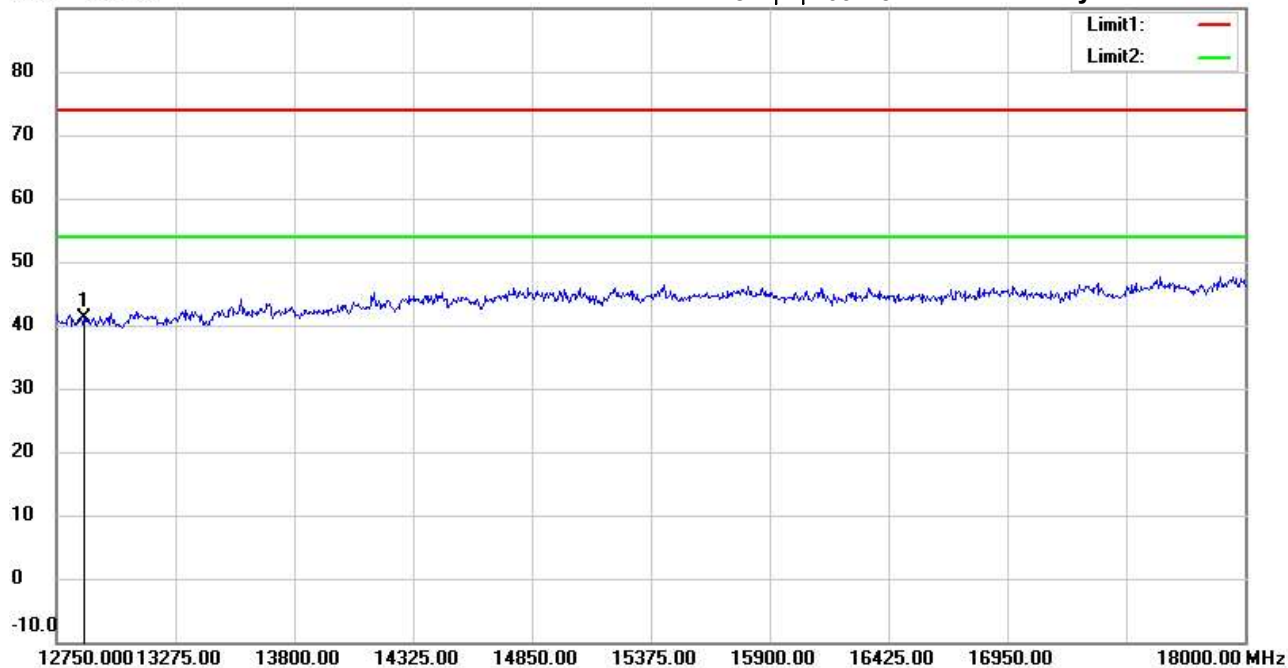
Test Mode : TX 802.11a CH97

Polarization: **Horizontal**

| Mk. | Frequency (MHz) | Reading (dBuV) | Detector | Corr. factor (dB/m) | Result (dBuV/m) | Limit (dBuV/m) | Ant.Pos (cm) | Tab.Pos (deg.) | Margin (dB) | Comment |
|---|---|---|---|---|---|---|---|---|---|---|
| * | 12870.000 | 23.78 | peak | 17.37 | 41.15 | 74.00 | 150 | 0 | -32.85 | |

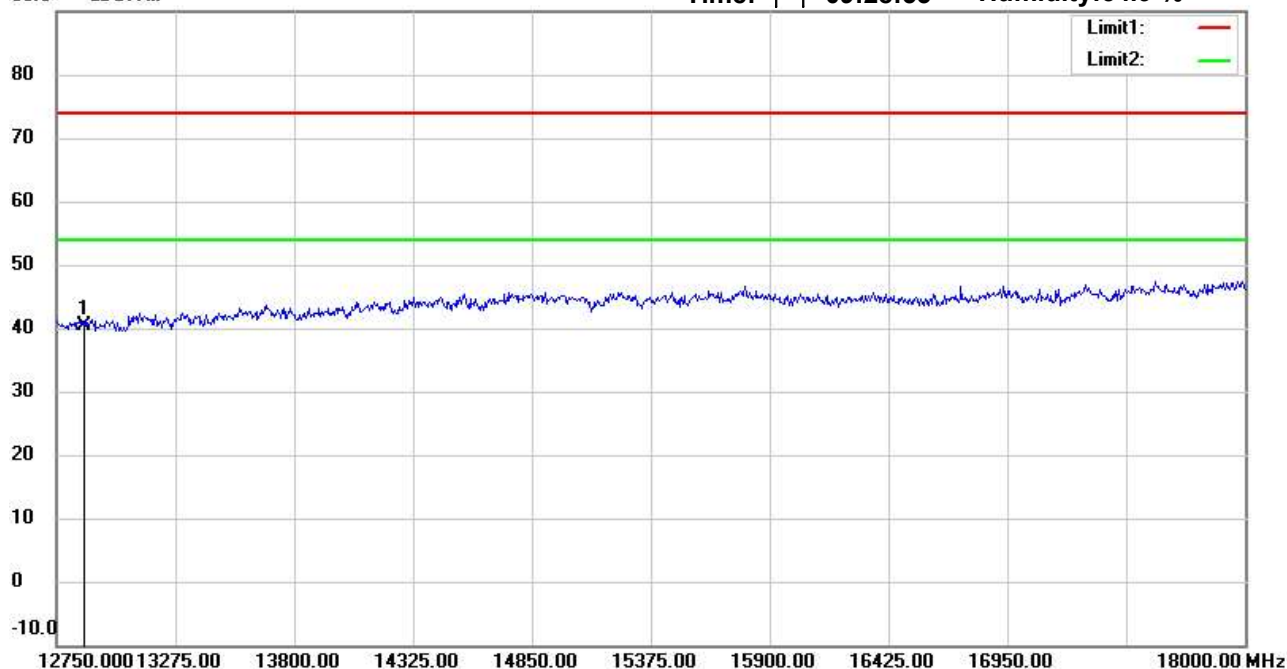
Test Mode : TX 802.11a CH97

Polarization: **Vertical**

| Mk. | Frequency (MHz) | Reading (dBuV) | Detector | Corr. factor (dB/m) | Result (dBuV/m) | Limit (dBuV/m) | Ant.Pos (cm) | Tab.Pos (deg.) | Margin (dB) | Comment |
|---|---|---|---|---|---|---|---|---|---|---|
| * | 12870.000 | 23.05 | peak | 17.37 | 40.42 | 74.00 | 150 | 357 | -33.58 | |

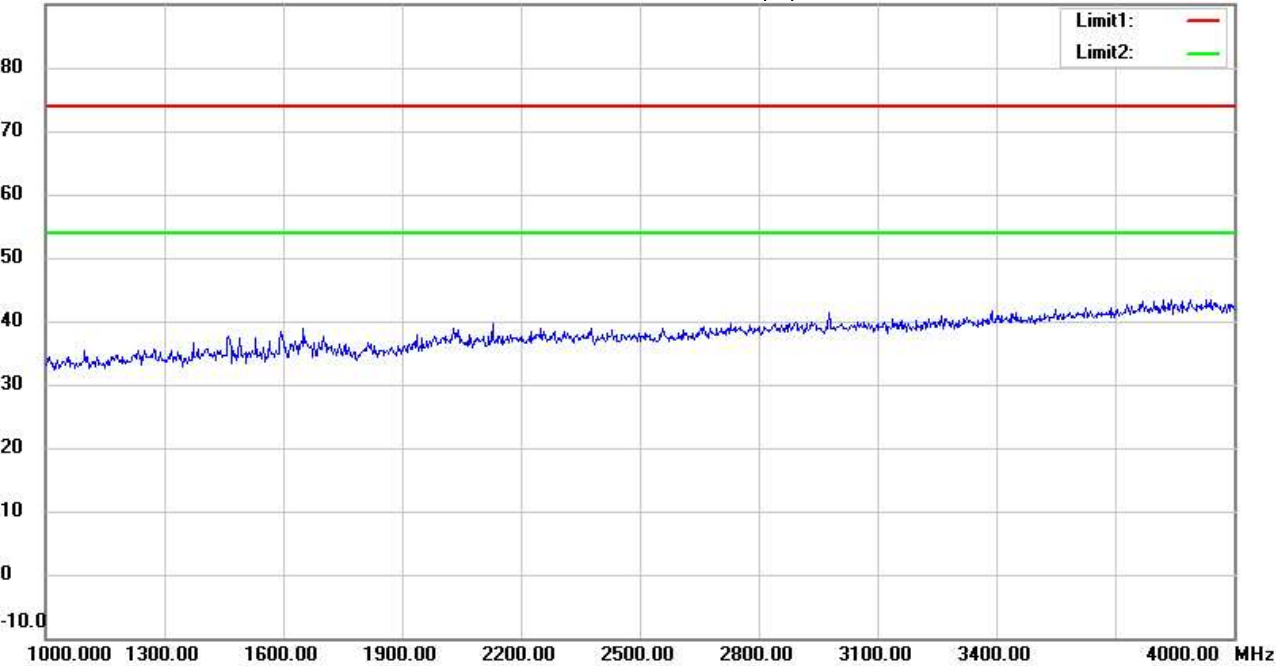
Test Mode : TX 802.11a CH105

Polarization: Horizontal
