## ANNEX 1 - TEST SETUP PHOTOS

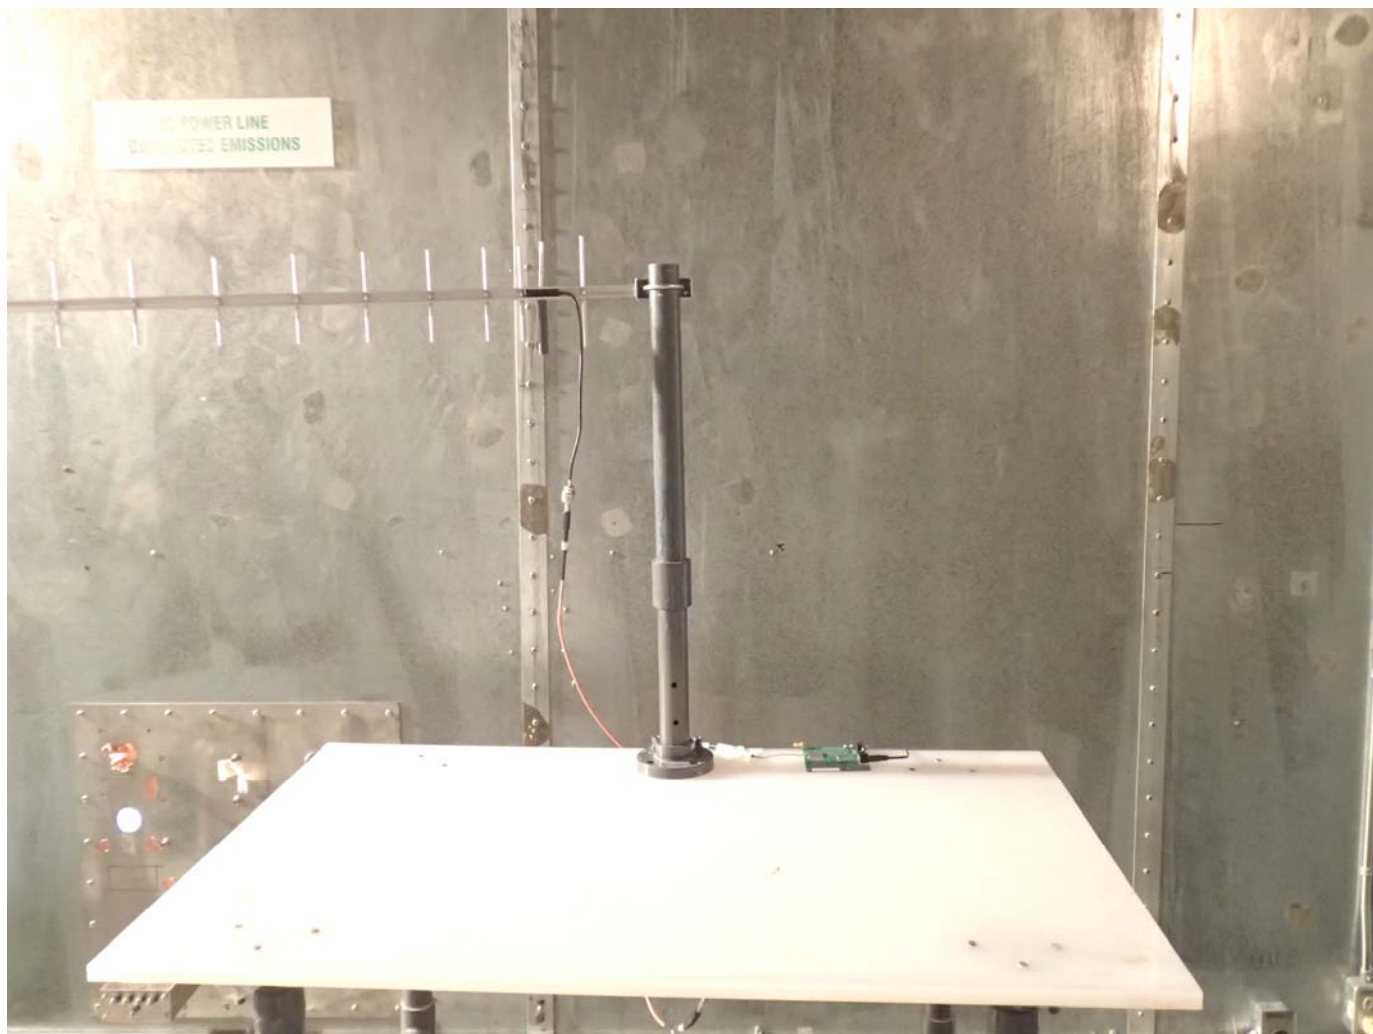
### Power Line Conducted Emissions

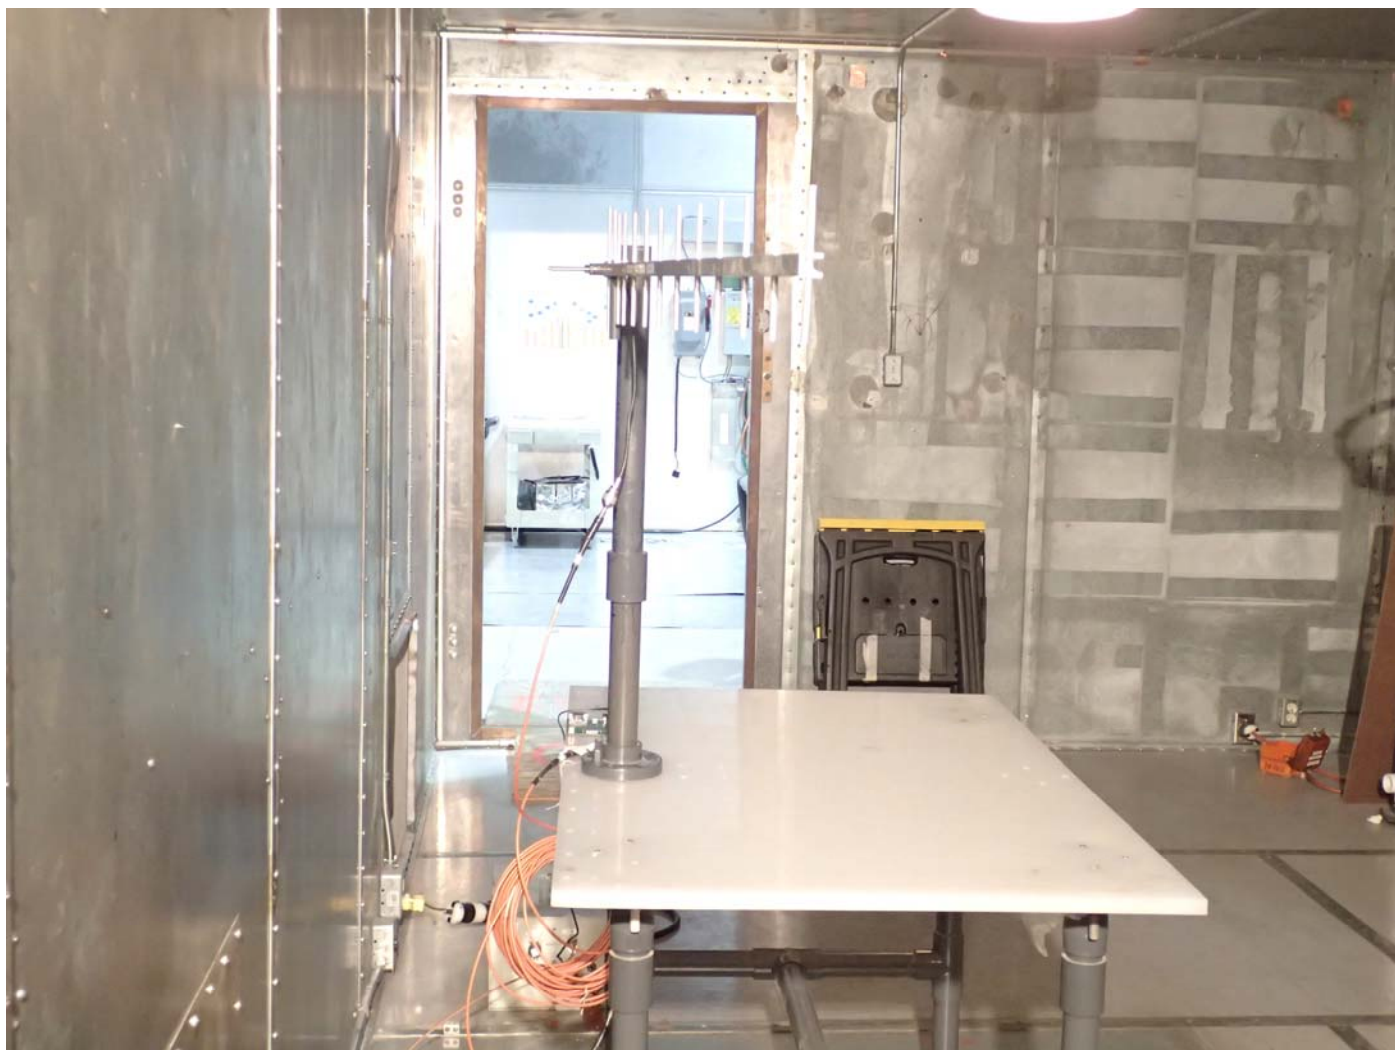
### Power Line Conducted Emissions

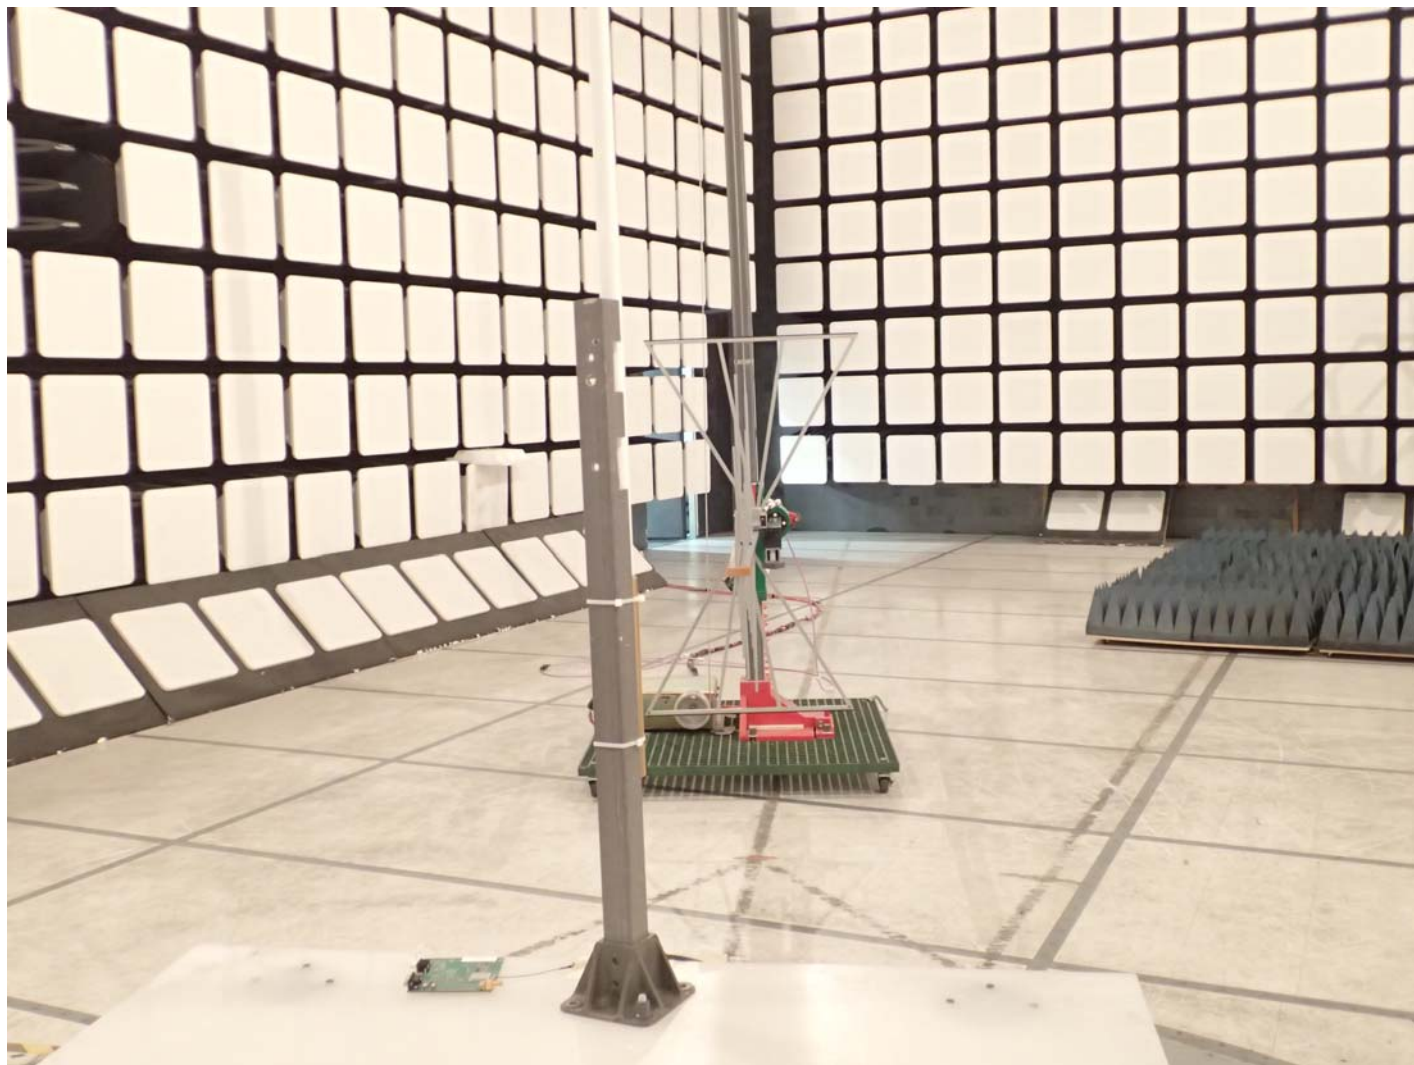
**Radiated Emissions @ 3 m, Orthogonal Position 1  
EUT with 8.1 dBi Omni-directional Antenna and 0.65 dB Assembly Cable Loss**

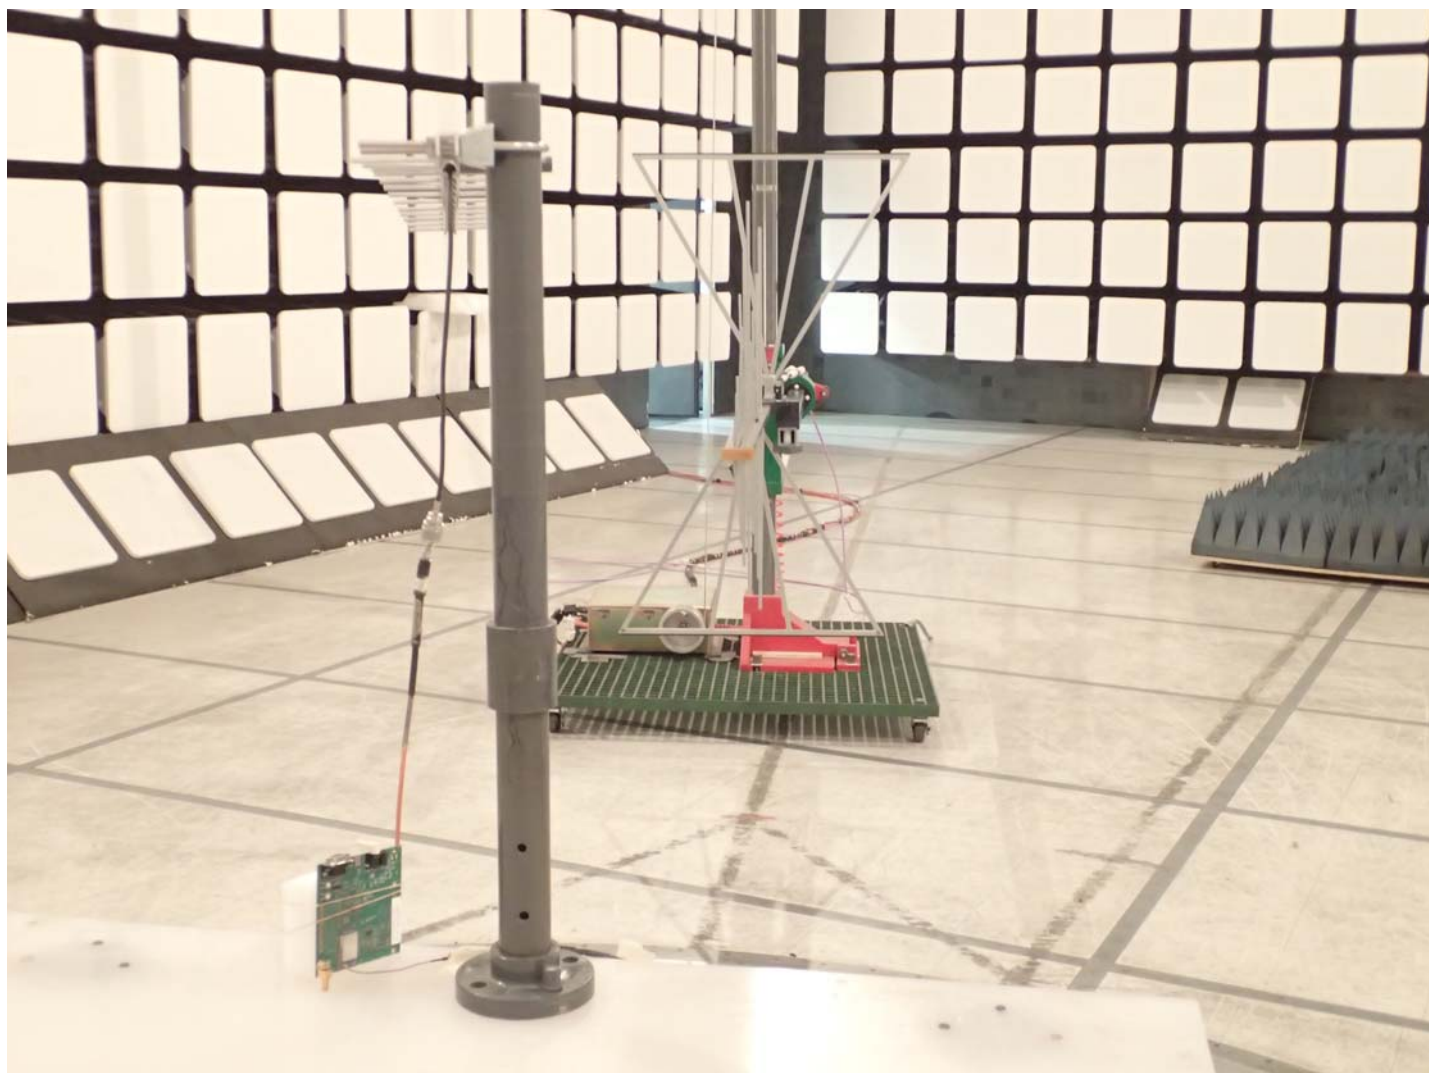
**Radiated Emissions @ 3 m, Orthogonal Position 2  
EUT with 15.1 dBi Yagi Antenna and 0.65 dB Assembly Cable Loss**

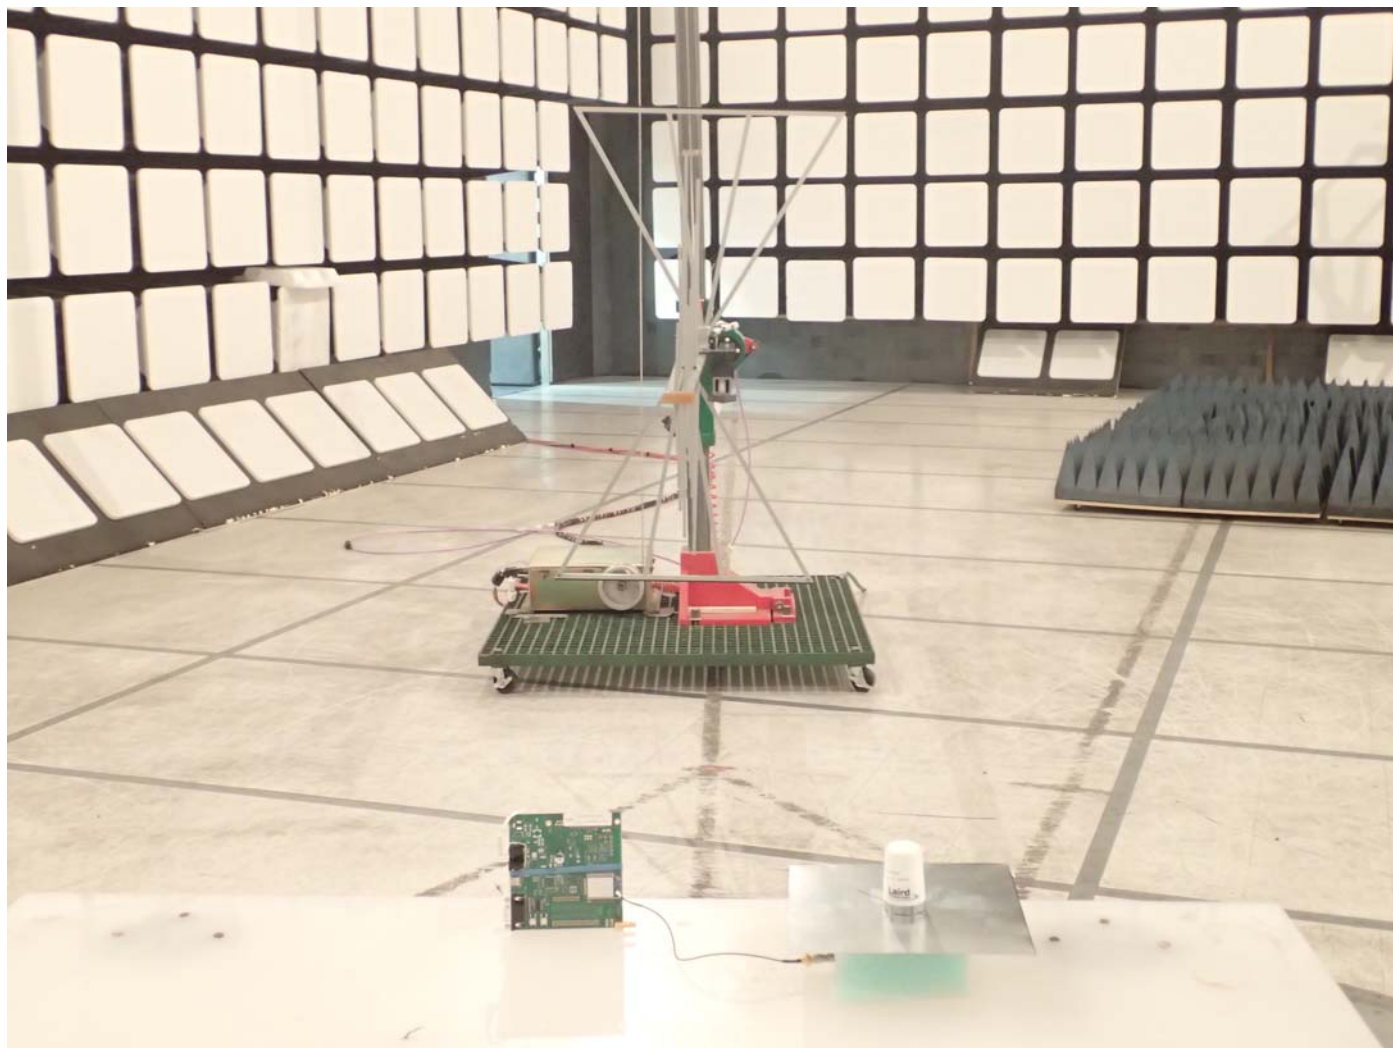
**Radiated Emissions @ 3 m, Orthogonal Position 3  
EUT with 3.0 dBi Dome Antenna and 0.44 dB Assembly Cable Loss**

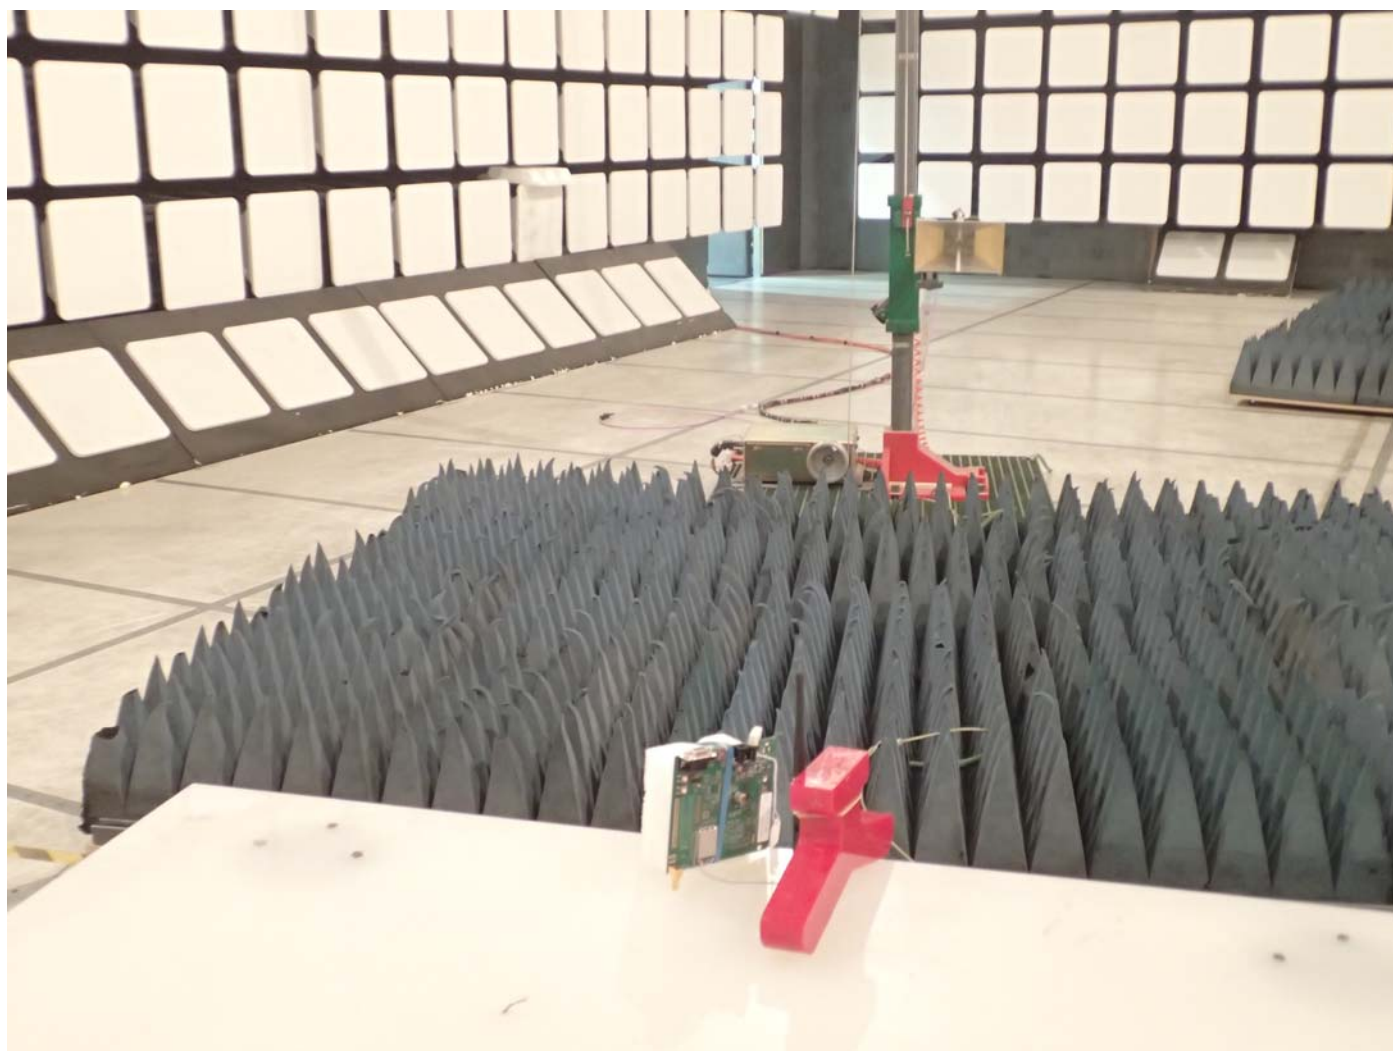
**Radiated Emissions @ 3 m**  
**EUT with 2.1 dBi Dipole Antenna and 0.36 dB Assembly Cable Loss**

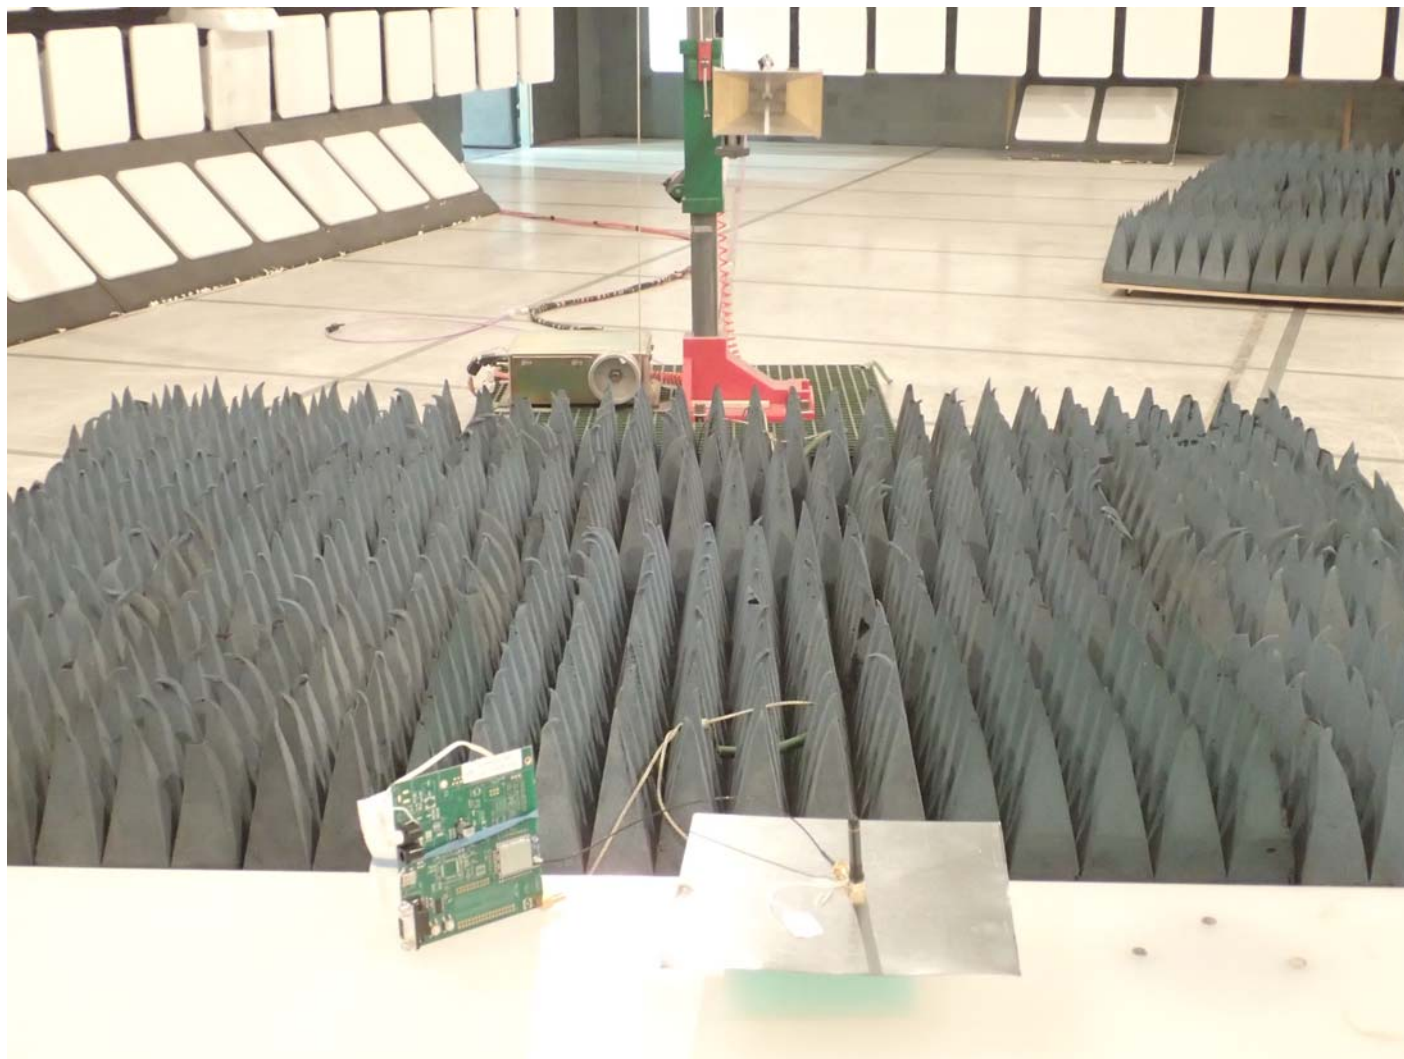
**Radiated Emissions @ 3 m**  
**EUT with 3.3 dBi Monopole (Integrated Whip) Antenna and 0.44 dB Assembly Cable Loss**
