# Radiated Emission Measurement

Condition : FCC\_part 15E RE\_Above 1GHz\_PK

EUT : W6M22311-23090

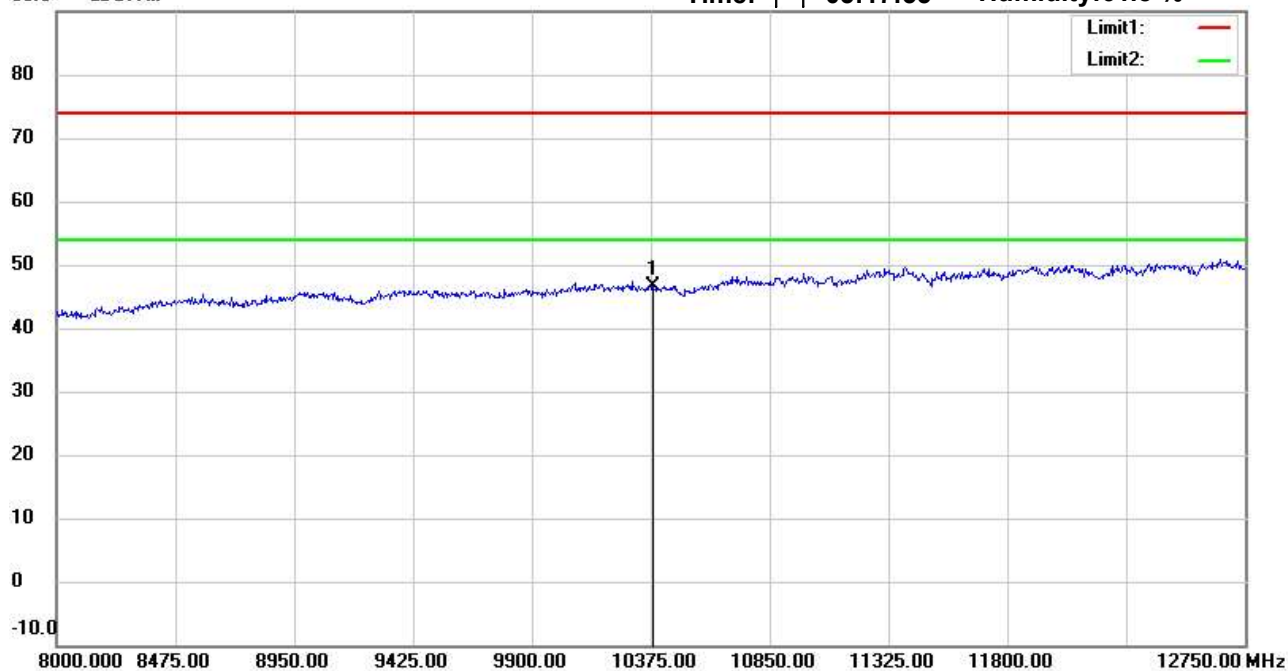
Condition : FCC\_part 15E RE\_Above 1GHz\_PK

Test Mode : TX 802.11n40 CH38

Polarization: **Horizontal**

| Mk. | Frequency (MHz) | Reading (dBuV) | Detector | Corr. factor (dB/m) | Result (dBuV/m) | Limit (dBuV/m) | Ant.Pos (cm) | Tab.Pos (deg.) | Margin (dB) | Comment |
|---|---|---|---|---|---|---|---|---|---|---|
| * | 10380.000 | 32.40 | peak | 14.15 | 46.55 | 74.00 | 150 | 328 | -27.45 | |

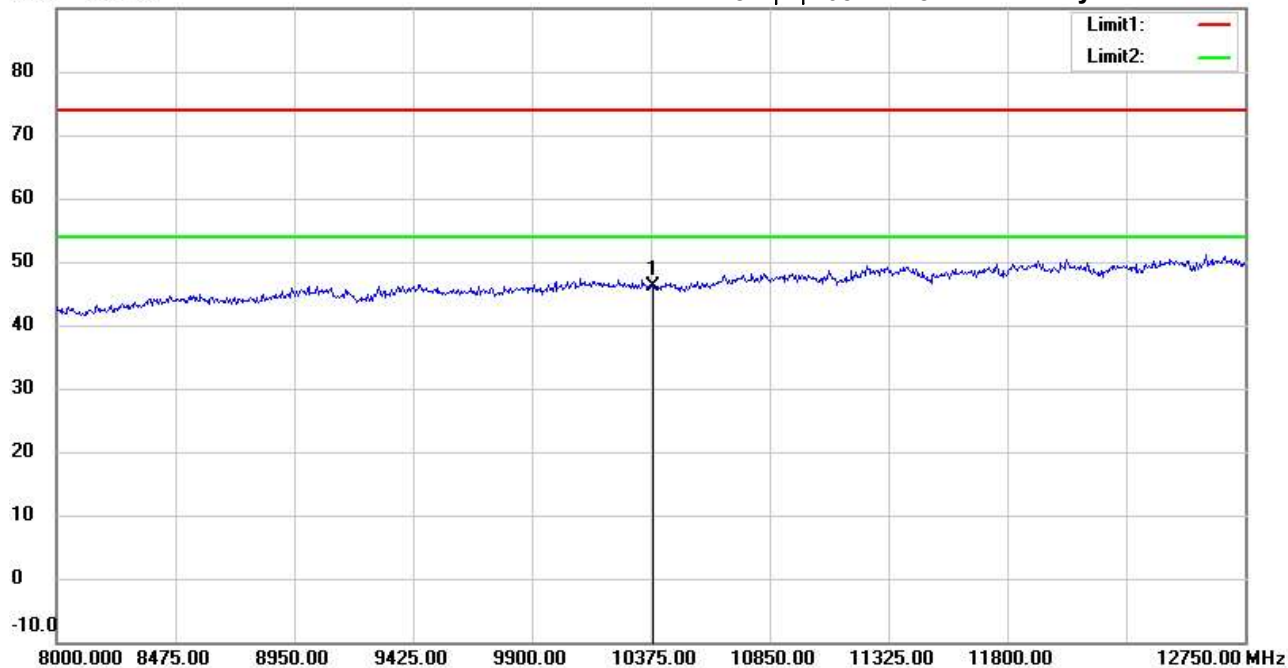
Condition : FCC\_part 15E RE\_Above 1GHz\_PK

Test Mode : TX 802.11n40 CH38

Polarization: Vertical

| Mk. | Frequency (MHz) | Reading (dBuV) | Detector | Corr. factor (dB/m) | Result (dBuV/m) | Limit (dBuV/m) | Ant.Pos (cm) | Tab.Pos (deg.) | Margin (dB) | Comment |
|---|---|---|---|---|---|---|---|---|---|---|
| * | 10380.000 | 32.02 | peak | 14.15 | 46.17 | 74.00 | 150 | 199 | -27.83 | |

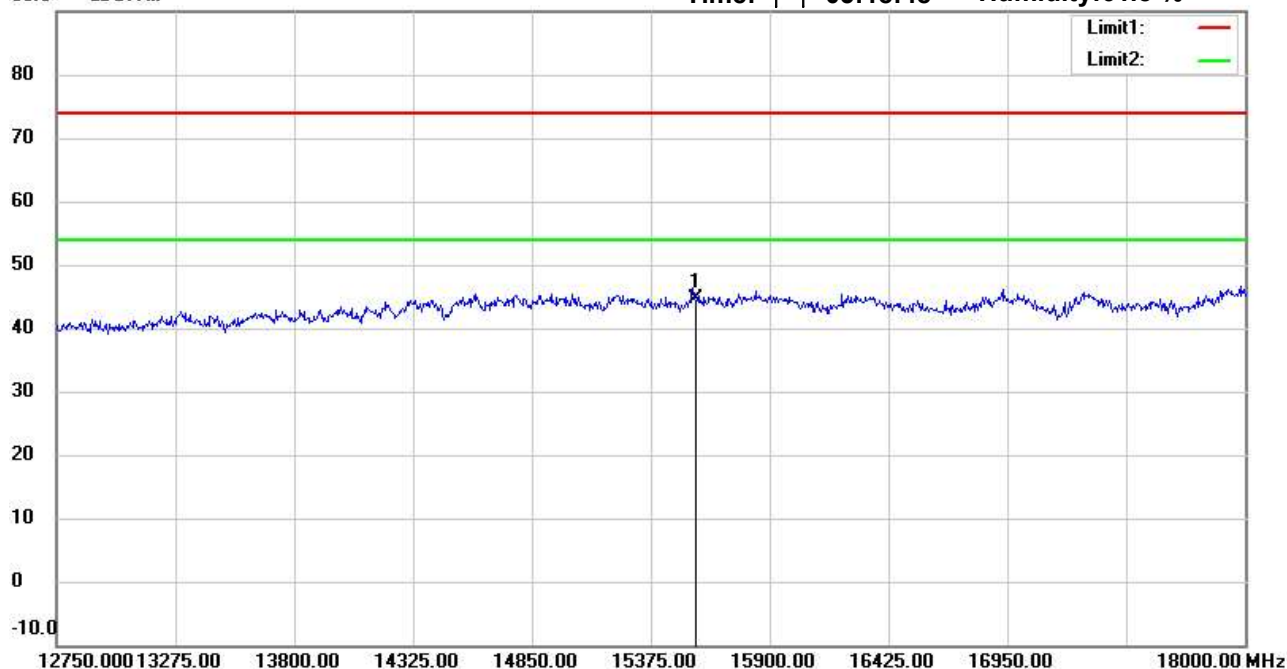
Condition : FCC\_part 15E RE\_Above 1GHz\_PK

Test Mode : TX 802.11n40 CH38

Polarization: **Horizontal**

| Mk. | Frequency (MHz) | Reading (dBuV) | Detector | Corr. factor (dB/m) | Result (dBuV/m) | Limit (dBuV/m) | Ant.Pos (cm) | Tab.Pos (deg.) | Margin (dB) | Comment |
|---|---|---|---|---|---|---|---|---|---|---|
| * | 15570.000 | 21.04 | peak | 23.52 | 44.56 | 74.00 | 150 | 304 | -29.44 | |

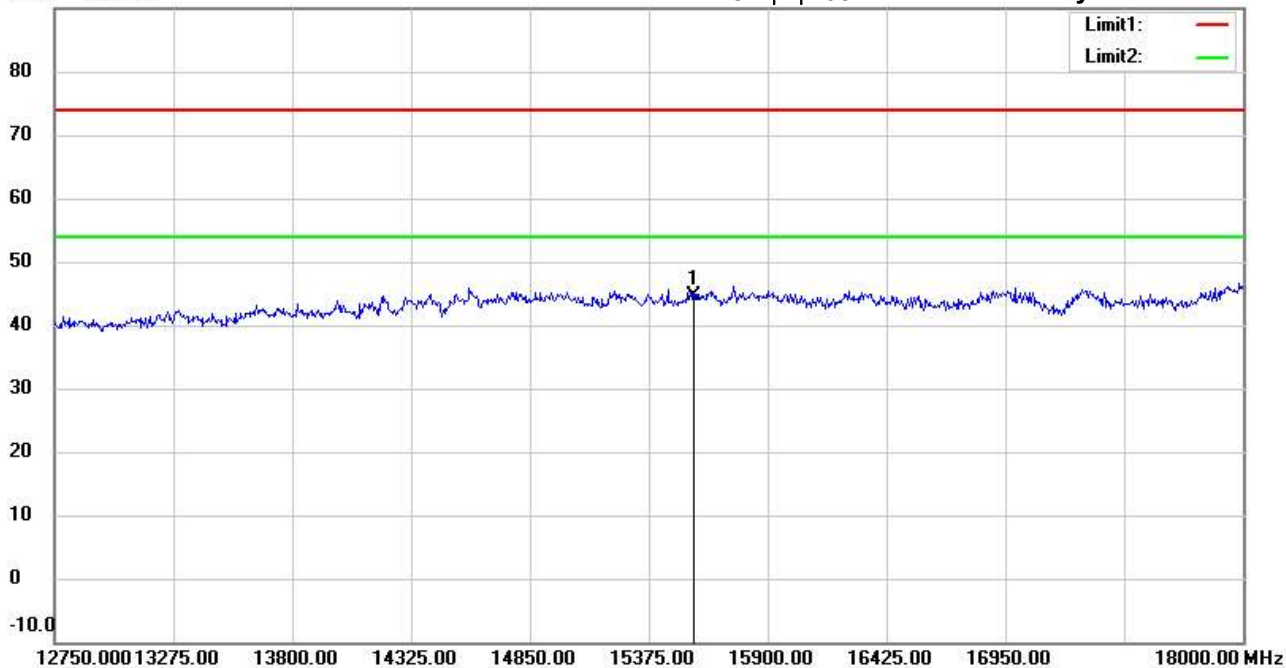
Condition : FCC\_part 15E RE\_Above 1GHz\_PK

Test Mode : TX 802.11n40 CH38

Polarization: **Vertical**

| Mk. | Frequency (MHz) | Reading (dBuV) | Detector | Corr. factor (dB/m) | Result (dBuV/m) | Limit (dBuV/m) | Ant.Pos (cm) | Tab.Pos (deg.) | Margin (dB) | Comment |
|---|---|---|---|---|---|---|---|---|---|---|
| * | 15570.000 | 21.08 | peak | 23.52 | 44.60 | 74.00 | 150 | 237 | -29.40 | |

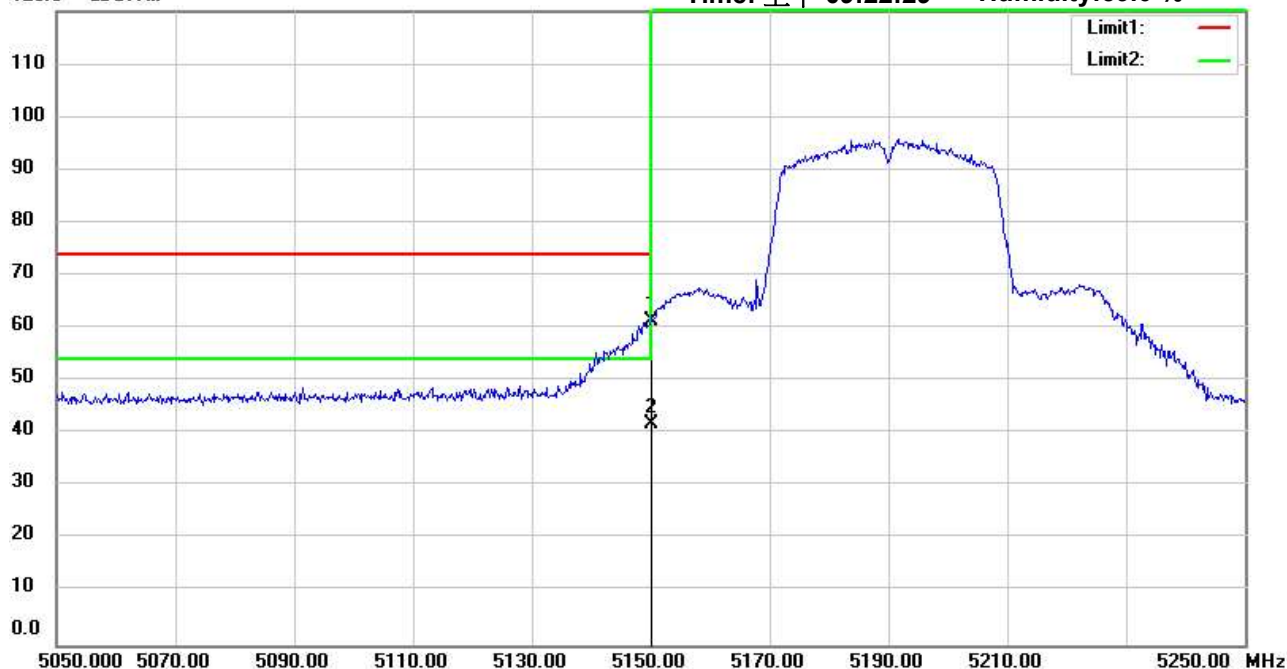
Condition : FCC 15.407 PK (Bandedge)(B1\_5150\_5250)

Polarization: **Horizontal**

| Mk. | Frequency (MHz) | Reading (dBuV) | Detector | Corr. factor (dB/m) | Result (dBuV/m) | Limit (dBuV/m) | Ant.Pos (cm) | Tab.Pos (deg.) | Margin (dB) | Comment |
|---|---|---|---|---|---|---|---|---|---|---|
| | 5150.000 | 56.01 | peak | 5.31 | 61.32 | 74.00 | 150 | 318 | -12.68 | |
| * | 5150.000 | 36.45 | AVG | 5.31 | 41.76 | 54.00 | 150 | 318 | -12.24 | |

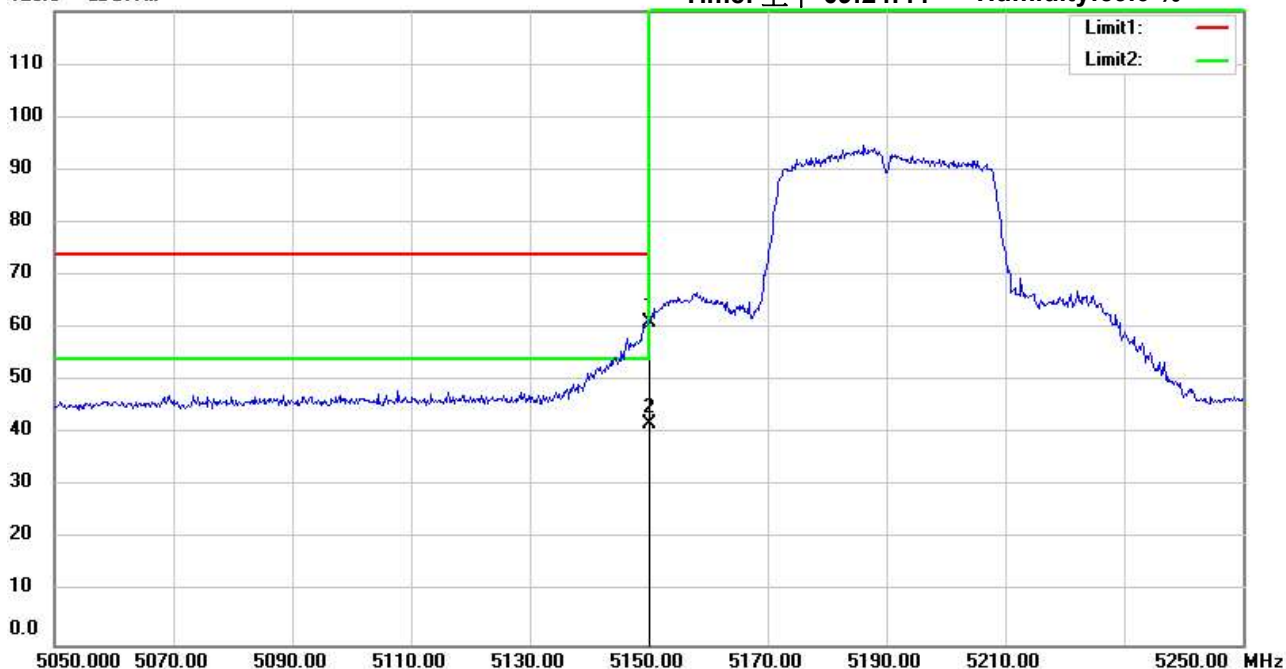
Condition : FCC 15.407 PK (Bandedge)(B1\_5150\_5250)

Polarization: Vertical

| Mk. | Frequency (MHz) | Reading (dBuV) | Detector | Corr. factor (dB/m) | Result (dBuV/m) | Limit (dBuV/m) | Ant.Pos (cm) | Tab.Pos (deg.) | Margin (dB) | Comment |
|---|---|---|---|---|---|---|---|---|---|---|
| | 5150.000 | 55.79 | peak | 5.31 | 61.10 | 74.00 | 150 | 81 | -12.90 | |
| * | 5150.000 | 36.40 | AVG | 5.31 | 41.71 | 54.00 | 150 | 81 | -12.29 | |

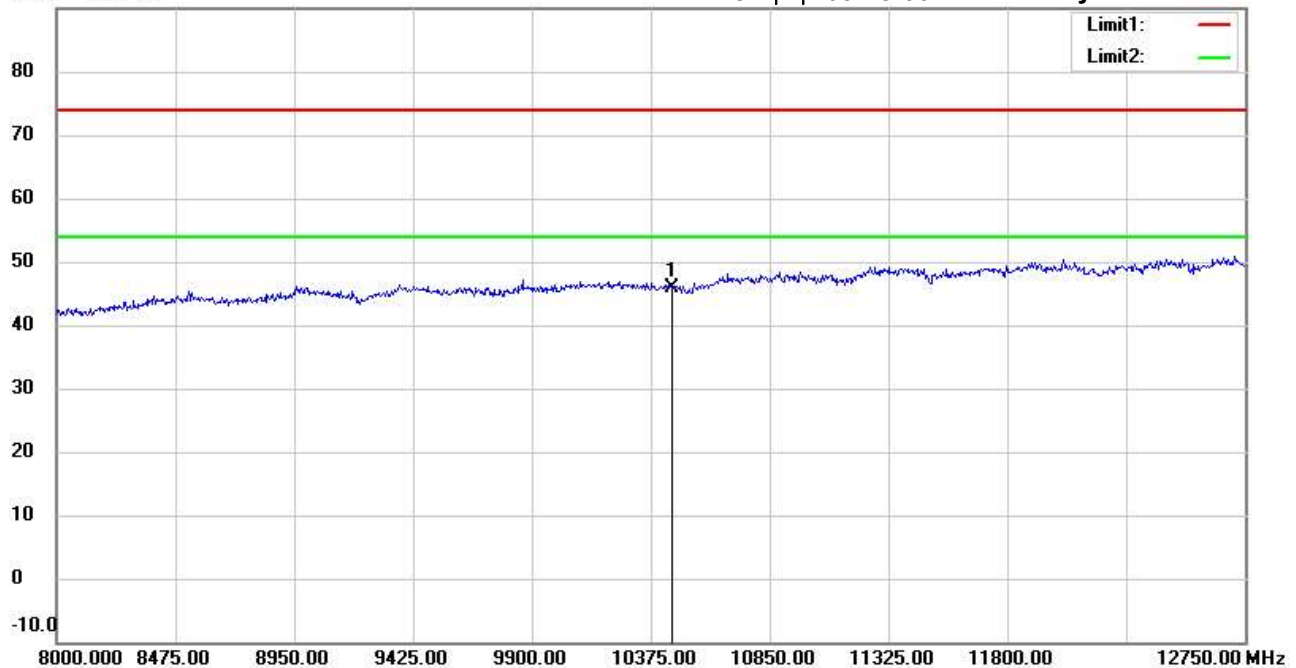
Condition : FCC\_part 15E RE\_Above 1GHz\_PK

Test Mode : TX 802.11n40 CH46

Polarization: **Horizontal**

| Mk. | Frequency (MHz) | Reading (dBuV) | Detector | Corr. factor (dB/m) | Result (dBuV/m) | Limit (dBuV/m) | Ant.Pos (cm) | Tab.Pos (deg.) | Margin (dB) | Comment |
|---|---|---|---|---|---|---|---|---|---|---|
| * | 10460.000 | 31.79 | peak | 14.10 | 45.89 | 74.00 | 150 | 166 | -28.11 | |

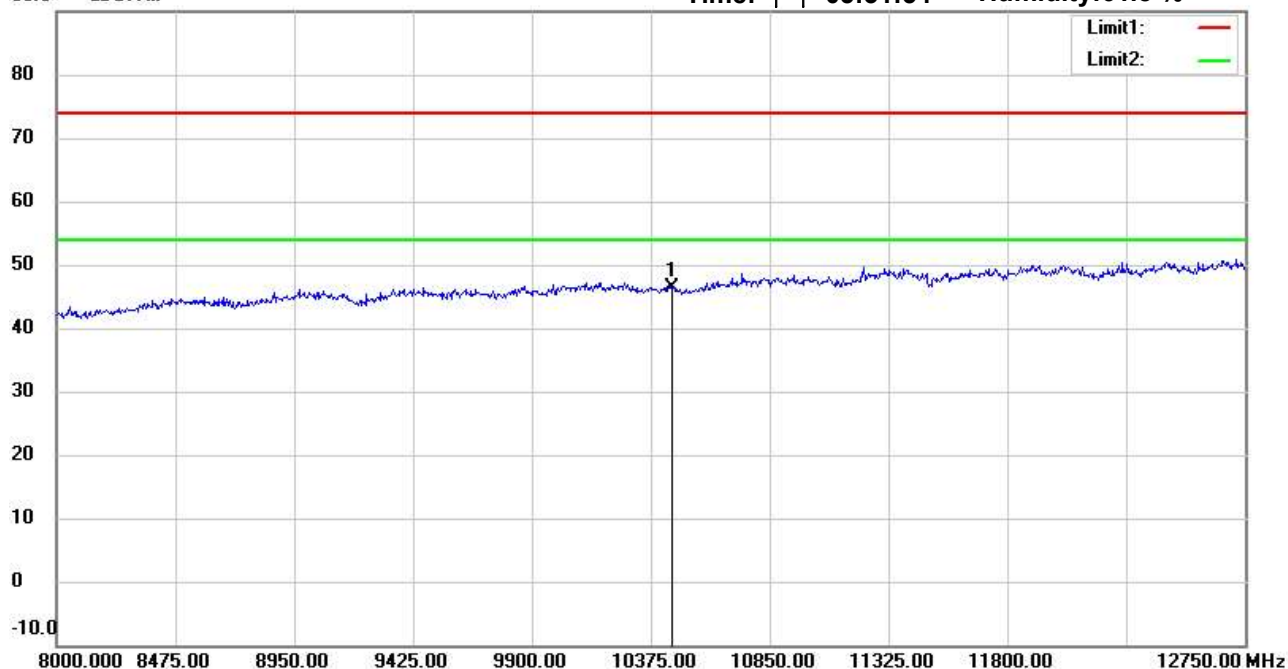
Condition : FCC\_part 15E RE\_Above 1GHz\_PK

Test Mode : TX 802.11n40 CH46

Polarization: **Vertical**

| Mk. | Frequency (MHz) | Reading (dBuV) | Detector | Corr. factor (dB/m) | Result (dBuV/m) | Limit (dBuV/m) | Ant.Pos (cm) | Tab.Pos (deg.) | Margin (dB) | Comment |
|---|---|---|---|---|---|---|---|---|---|---|
| * | 10460.000 | 32.18 | peak | 14.10 | 46.28 | 74.00 | 150 | 48 | -27.72 | |

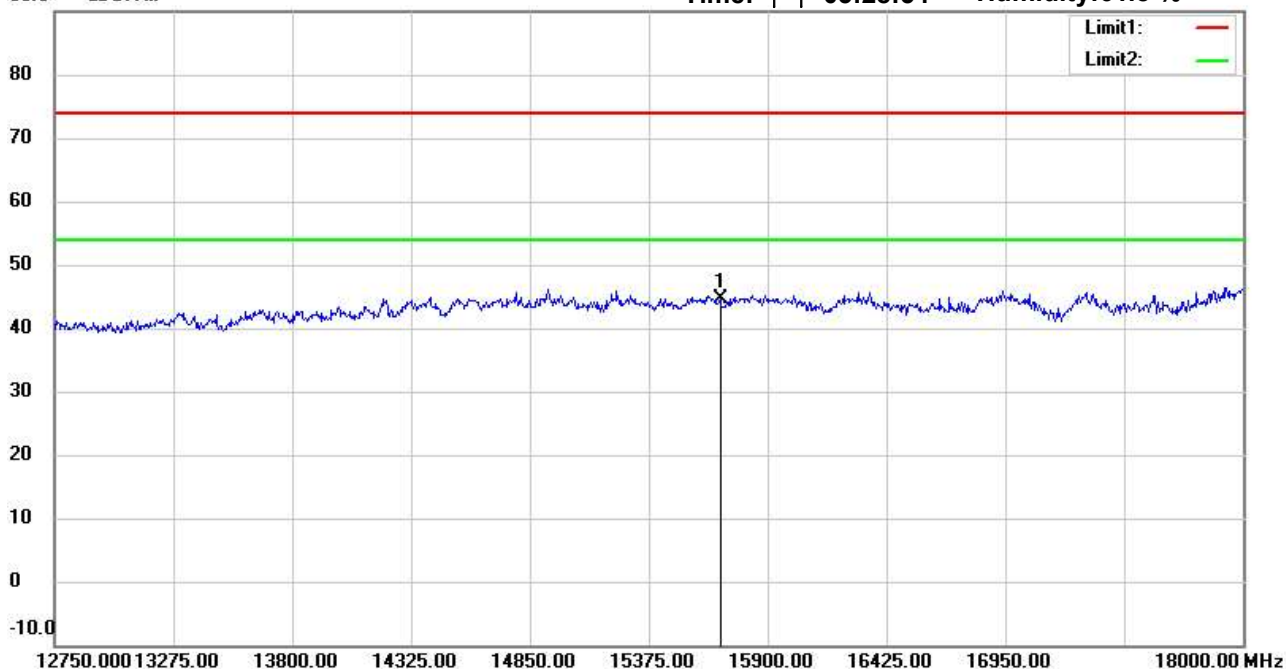
Condition : FCC\_part 15E RE\_Above 1GHz\_PK

Test Mode : TX 802.11n40 CH46

Polarization: **Horizontal**

| Mk. | Frequency (MHz) | Reading (dBuV) | Detector | Corr. factor (dB/m) | Result (dBuV/m) | Limit (dBuV/m) | Ant.Pos (cm) | Tab.Pos (deg.) | Margin (dB) | Comment |
|---|---|---|---|---|---|---|---|---|---|---|
| * | 15690.000 | 21.72 | peak | 22.91 | 44.63 | 74.00 | 150 | 203 | -29.37 | |

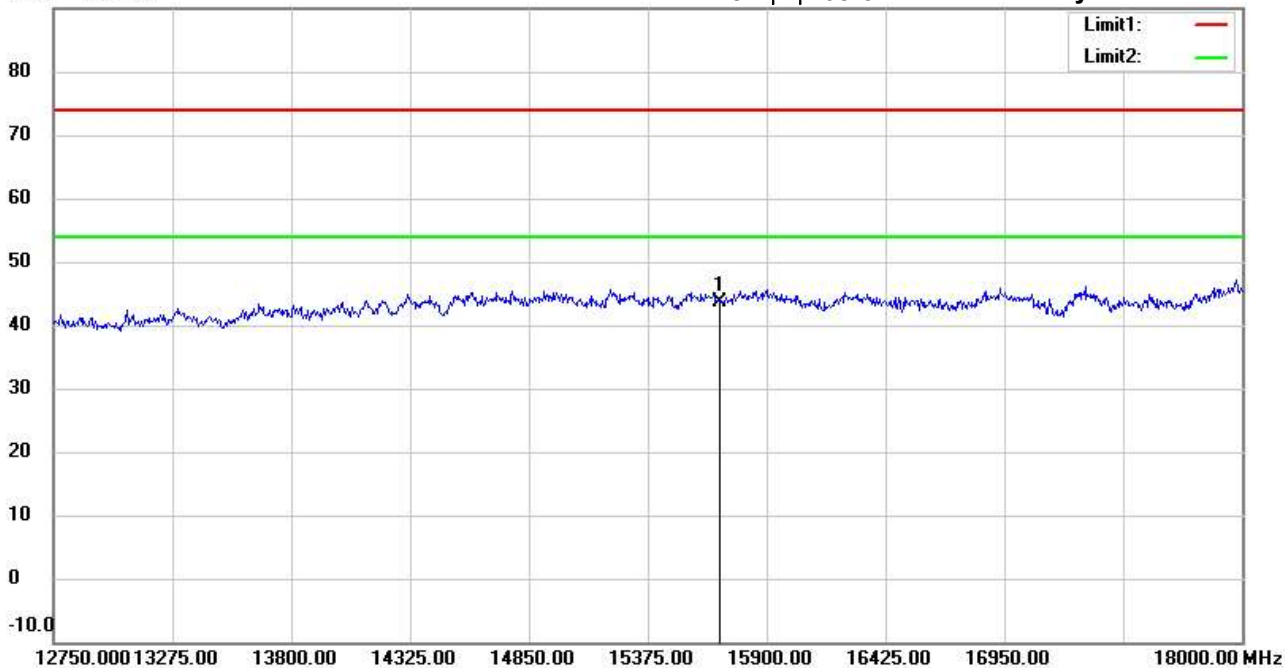
Condition : FCC\_part 15E RE\_Above 1GHz\_PK

Test Mode : TX 802.11n40 CH46

Polarization: **Vertical**

| Mk. | Frequency (MHz) | Reading (dBuV) | Detector | Corr. factor (dB/m) | Result (dBuV/m) | Limit (dBuV/m) | Ant.Pos (cm) | Tab.Pos (deg.) | Margin (dB) | Comment |
|---|---|---|---|---|---|---|---|---|---|---|
| * | 15690.000 | 20.71 | peak | 22.91 | 43.62 | 74.00 | 150 | 25 | -30.38 | |
