FCC Part 27N&IC RSS 130

B71, Normal  
1RB was the worst case

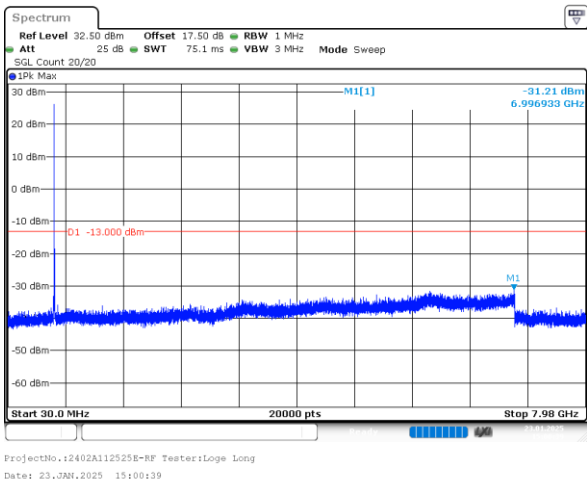
5MHz\_Low\_QPSK\_1@0(30MHz~7.98GHz)

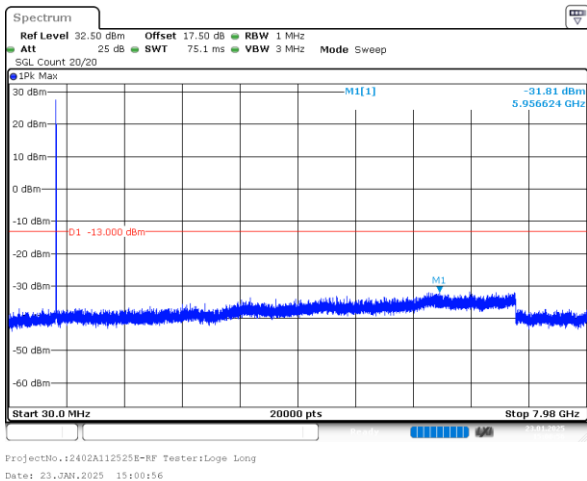
5MHz\_Middle\_QPSK\_1@0(30MHz~7.98GHz)

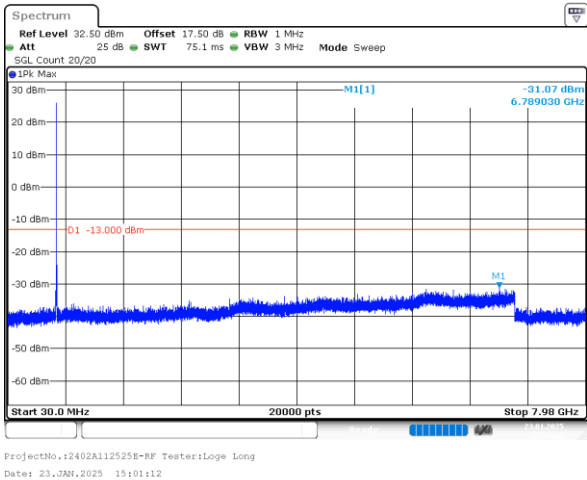
5MHz\_High\_QPSK\_1@0(30MHz~7.98GHz)

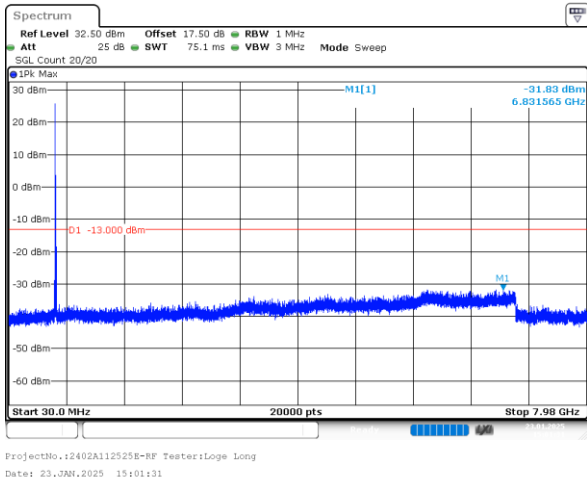
10MHz\_Low\_QPSK\_1@0(30MHz~7.98GHz)

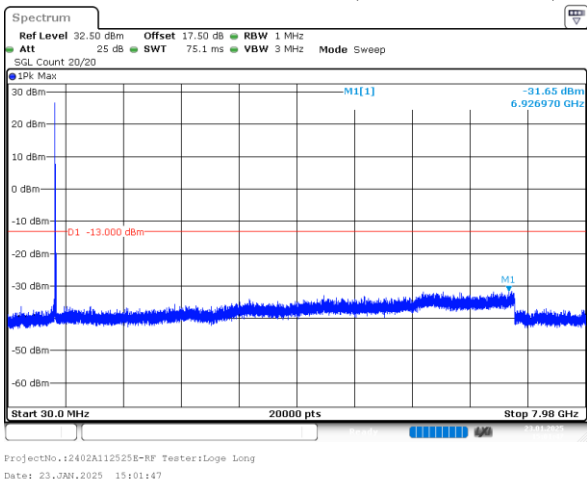
10MHz\_Middle\_QPSK\_1@0(30MHz~7.98GHz)

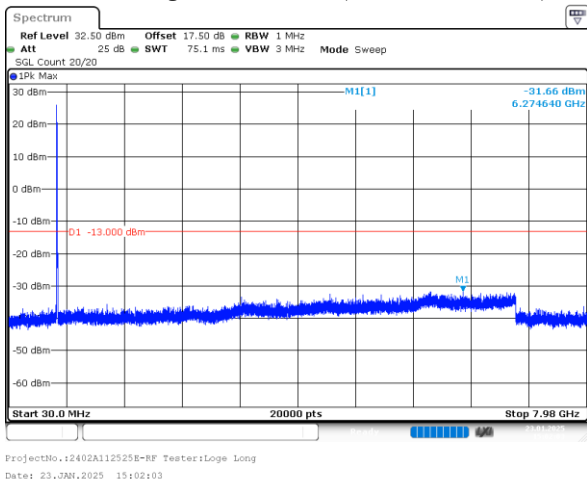
10MHz\_High\_QPSK\_1@0(30MHz~7.98GHz)

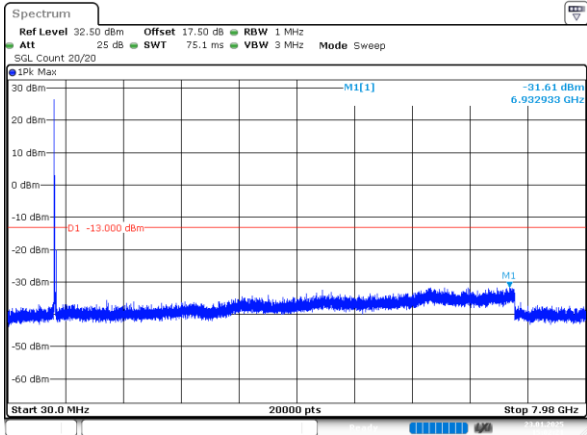
15MHz\_Low\_QPSK\_1@0(30MHz~7.98GHz)

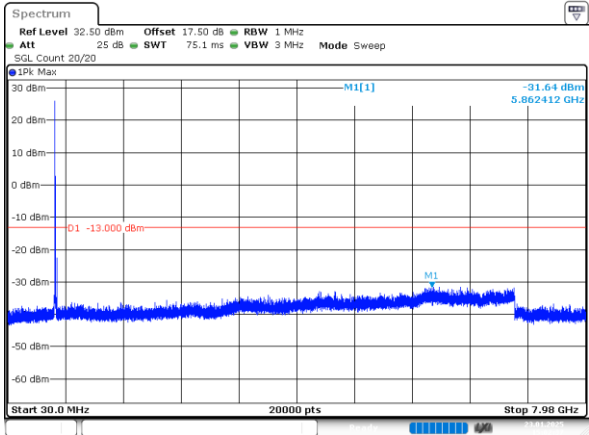
15MHz\_Middle\_QPSK\_1@0(30MHz~7.98GHz)

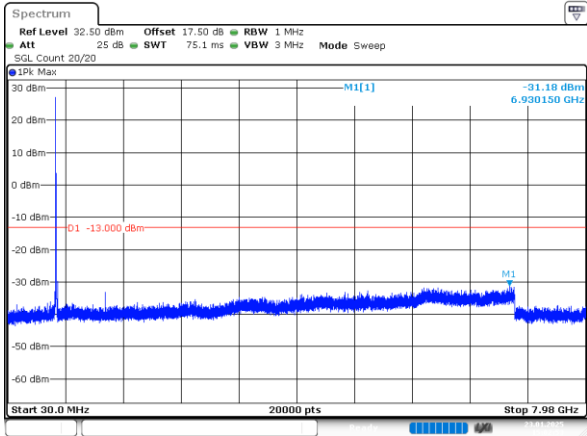
15MHz\_High\_QPSK\_1@0(30MHz~7.98GHz)

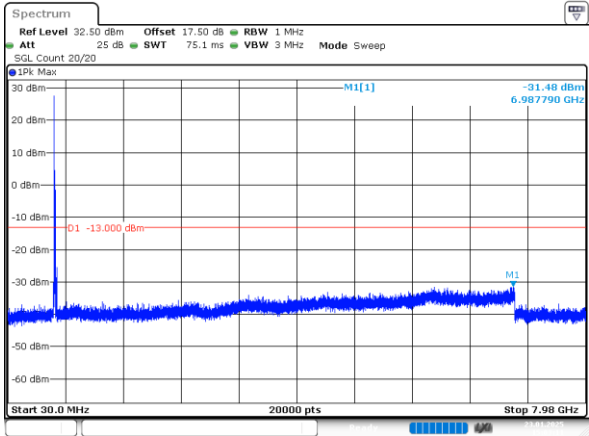
20MHz\_Low\_QPSK\_1@0(30MHz~7.98GHz)

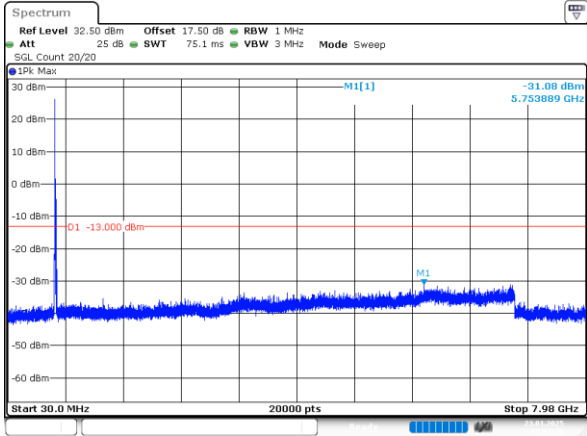
20MHz\_Middle\_QPSK\_1@0(30MHz~7.98GHz)

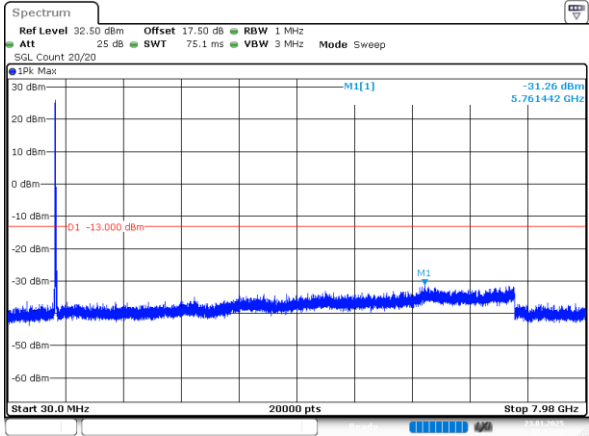
20MHz\_High\_QPSK\_1@0(30MHz~7.98GHz)
