13. FREQUENCY SEPARATION

14. FCC LINE CONDUCTED EMISSION TEST

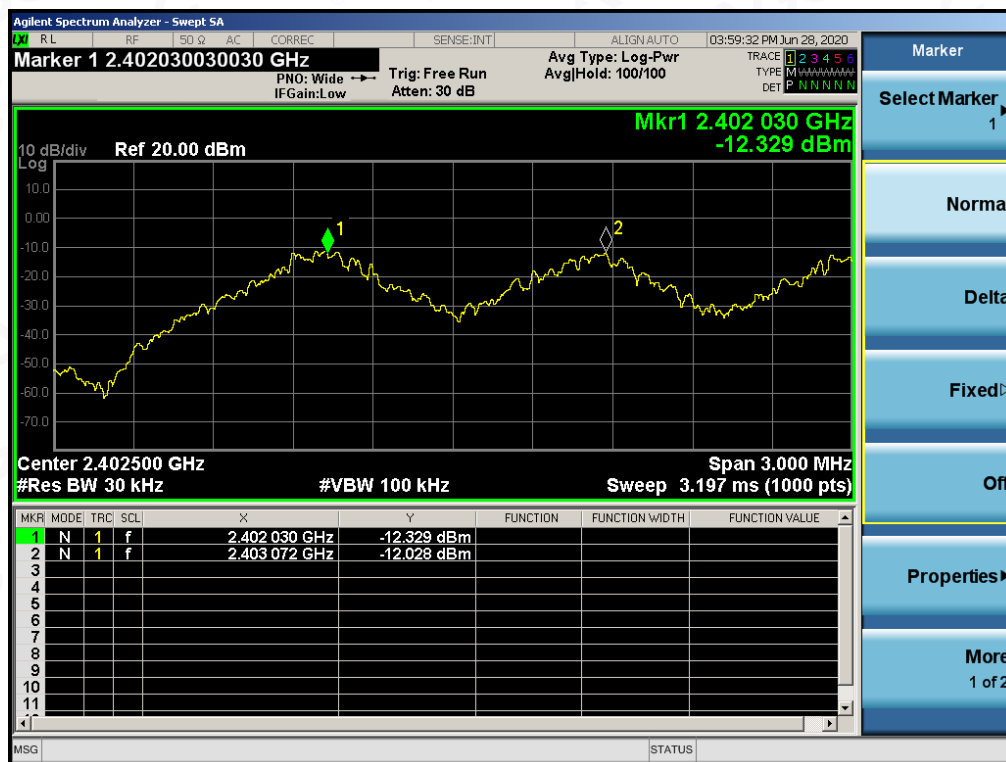
TEST PLOT FOR FREQUENCY SEPARATION

CHANNEL	CHANNEL SEPARATION	LIMIT	RESULT
	MHz	KHz	
CH01-CH02	1.042	$\geq 2/3$ 20 dB BW	Pass

Note: The Low channel GFSK modulation is the worst case and recorded in the report.

Use the marker-delta function to determine the separation between the peaks of the adjacent channels.

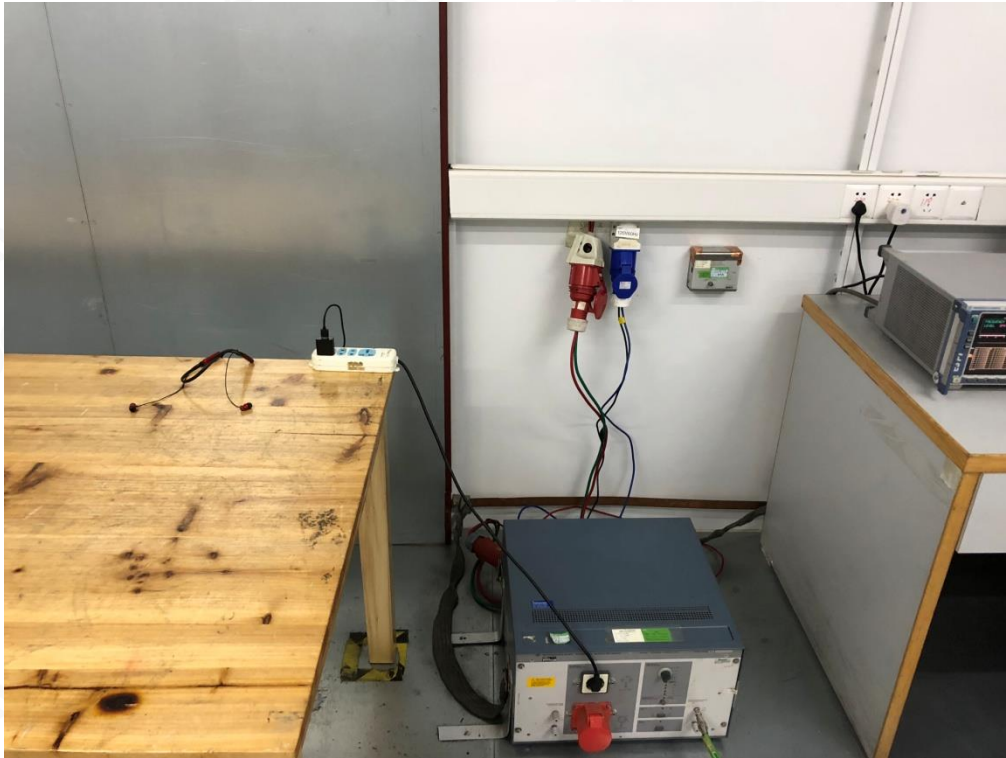
CONDUCTED EMISSION TEST SETUP
