**Exhibit 7B MPE Test Report Photographs****Motorola Solutions Inc.****EME Test Laboratory**

## 1.0 Antenna Photograph(s)

## 2.0 Test Measurement Setup Photos

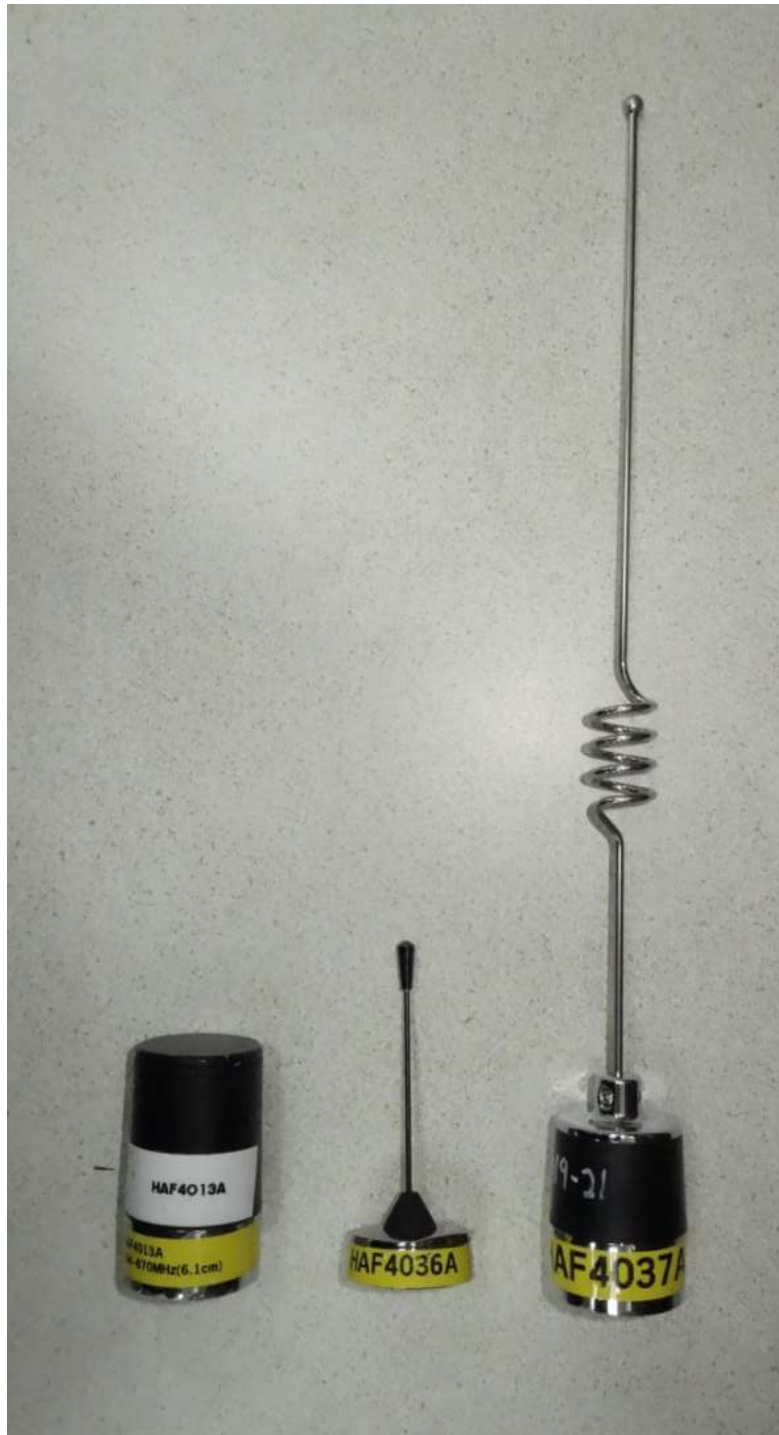
8/900MHz Antenna kit numbers, from left to right  
HAF4013A, HAF4036A, HAF4037A

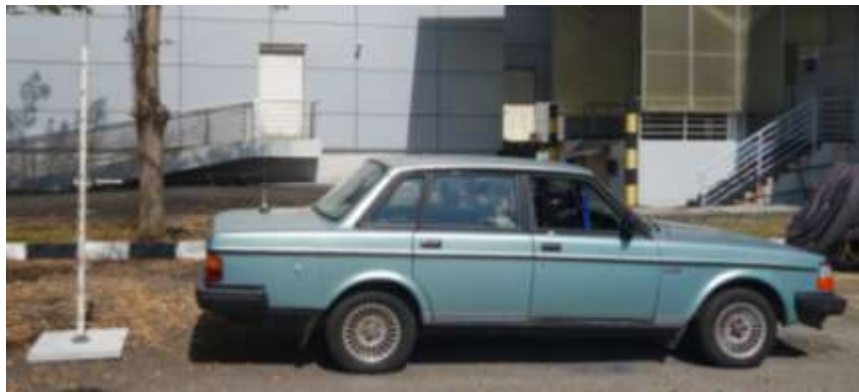
Test measurement setup for Bystander, trunk mount antenna behind vehicle

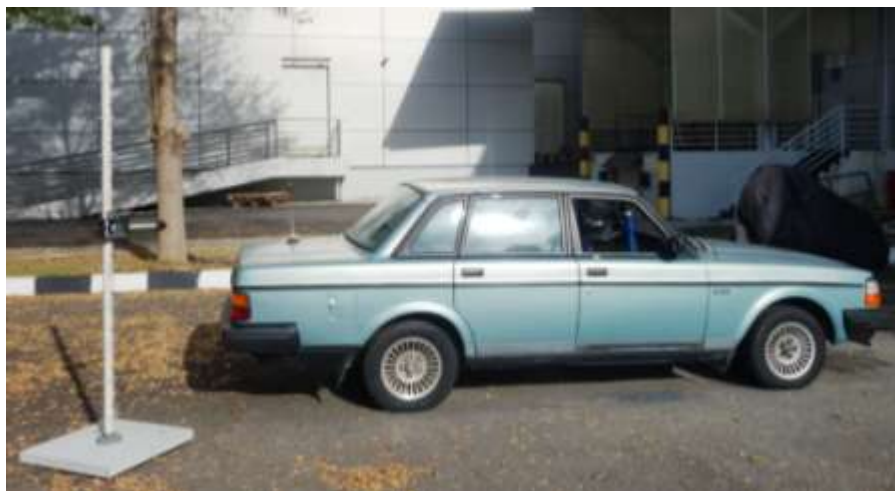
Test measurement setup for Bystander 45 degree (diagonal) trunk mount antenna

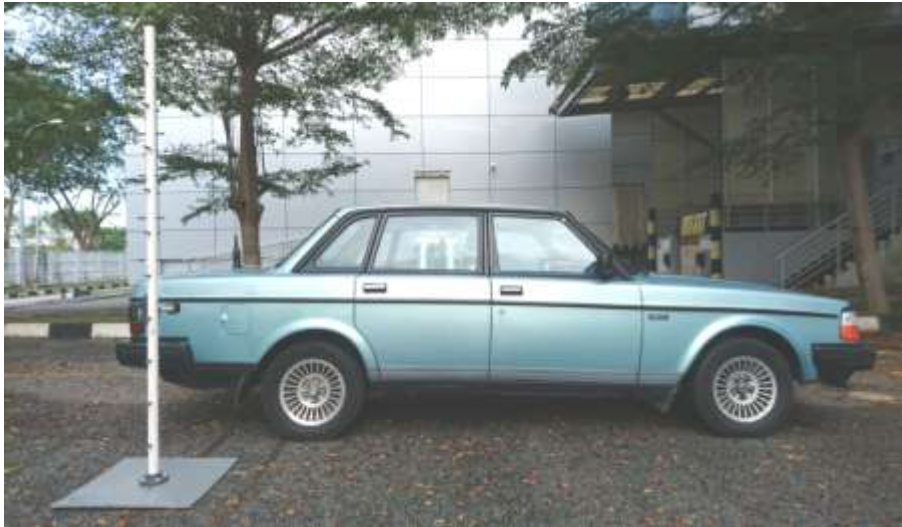
Test measurement setup for Bystander 90 degree (side) trunk mount antenna

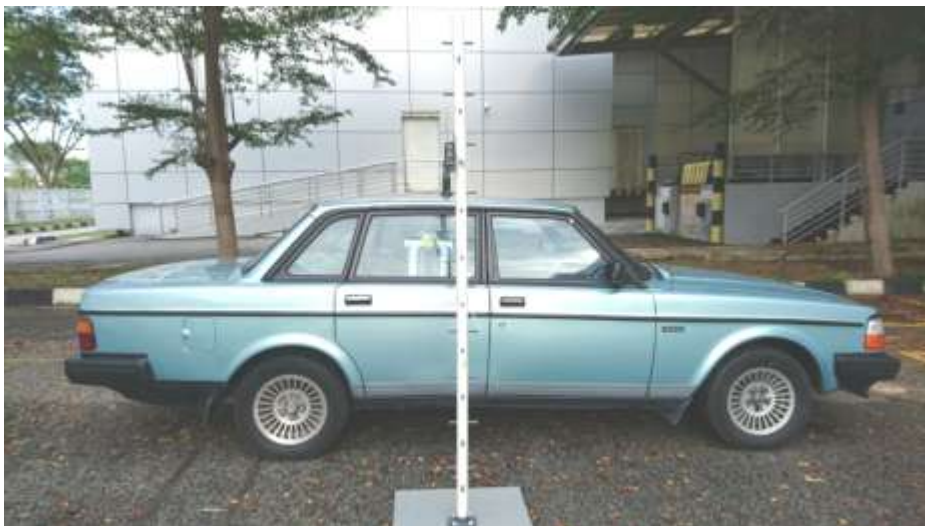
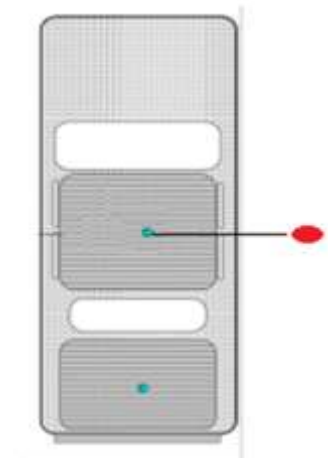
Test measurement setup for Bystander roof mount antenna

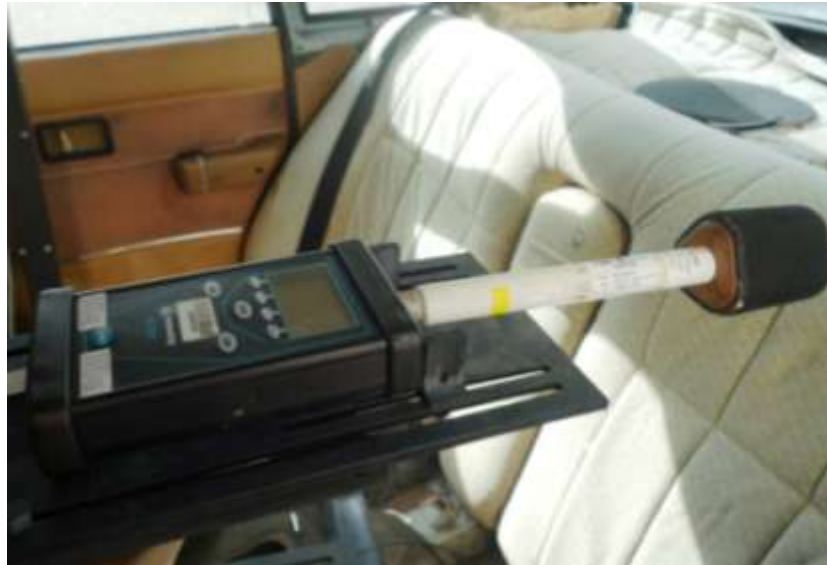
Test measurement setup for Passenger Back

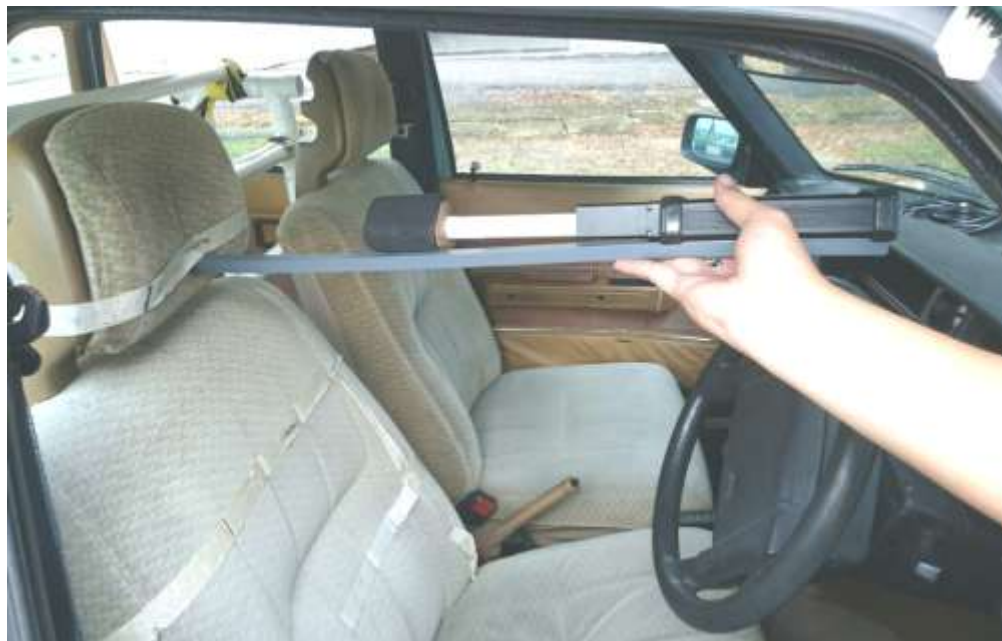
Test measurement setup for Passenger Front

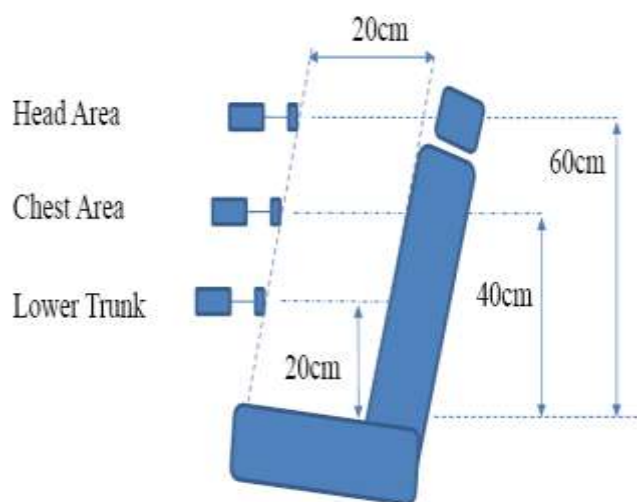
Test positions for Passenger Back and Front

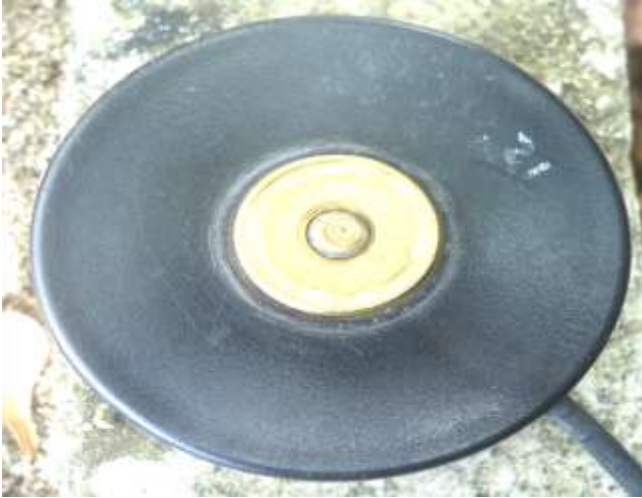
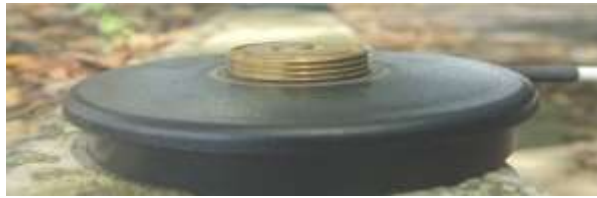
Magnetic mount base (top and side view)
