## 8 Appendix 3: Test configuration illustration

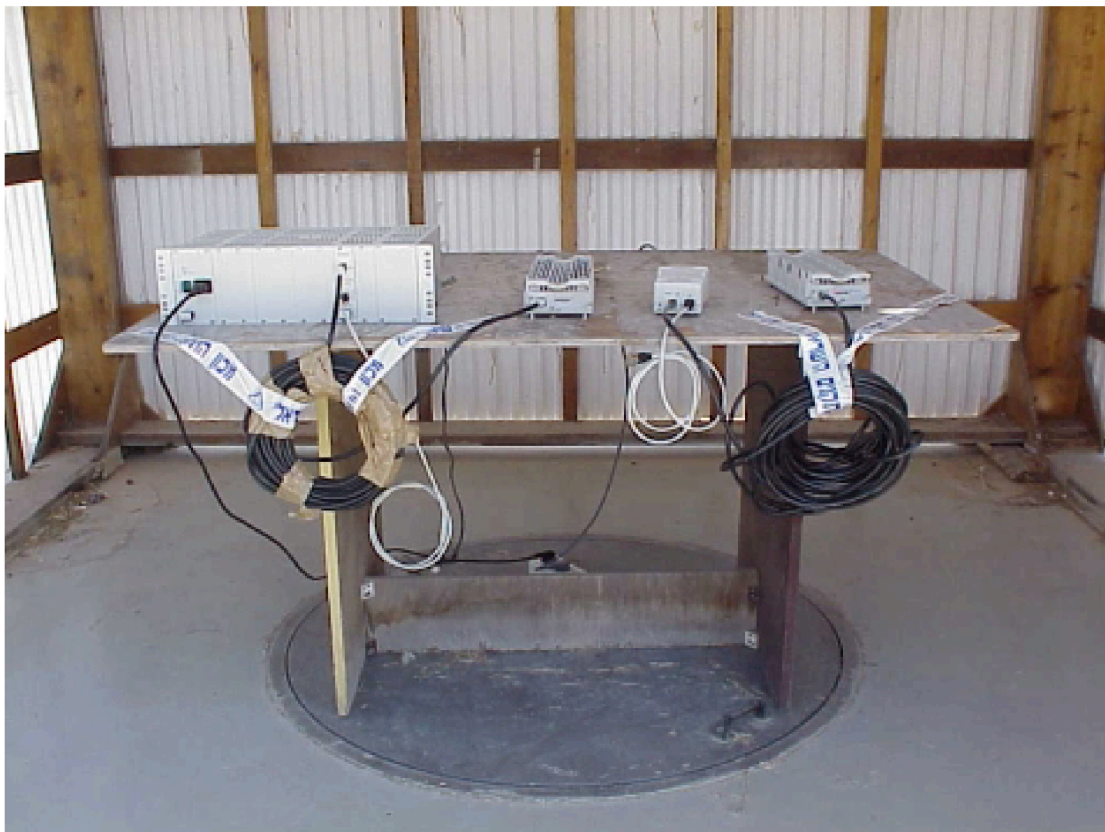
**Photo #3.**  
**Base Station + Subscriber Unit**  
**Radiated emission test on open site**

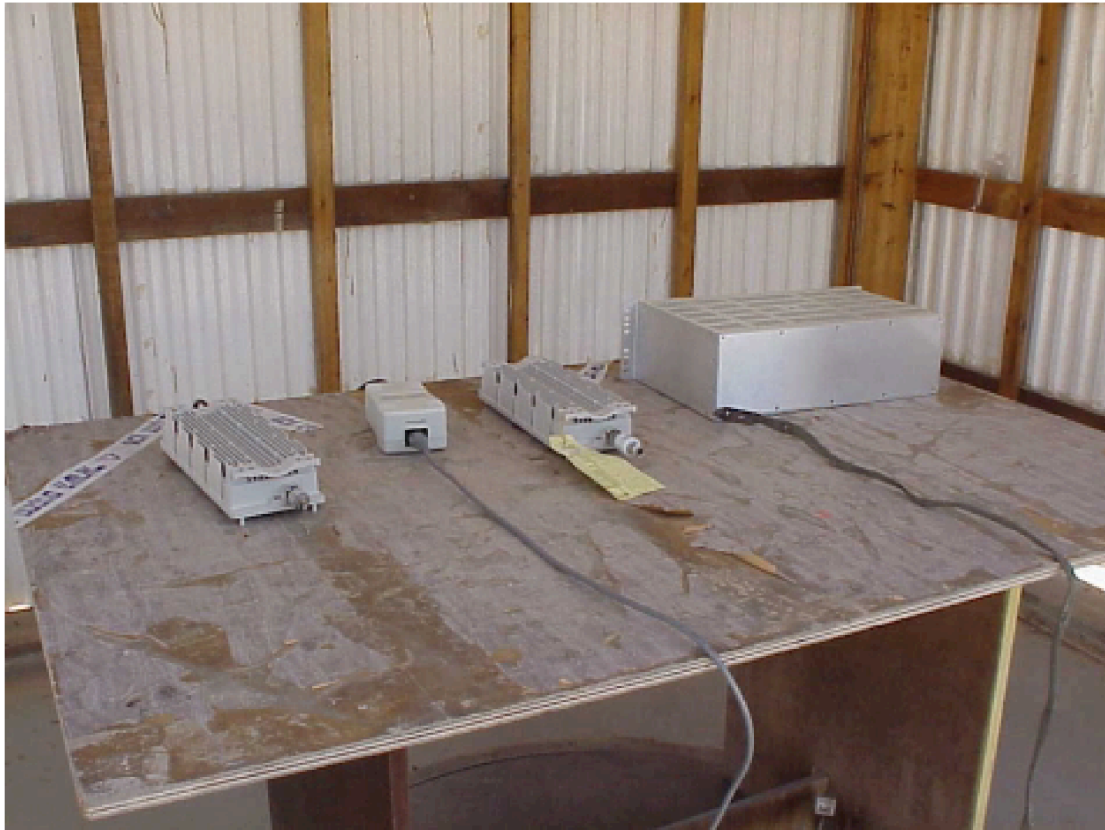
**Photo #4.**  
**Base Station + Subscriber Unit**  
**Radiated emission test on open site**

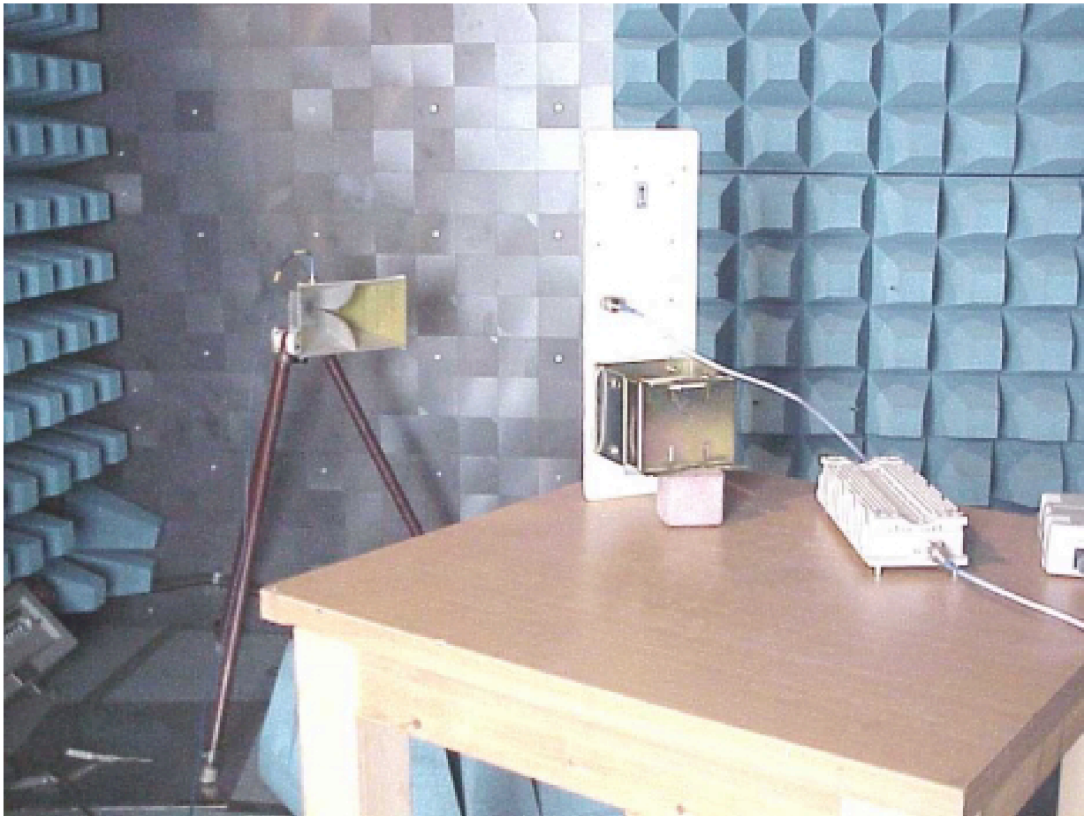
**Photo #5**  
**Radio unit with MTI sector antenna P/N MT-484025/NV.**  
**Spurious emission test**

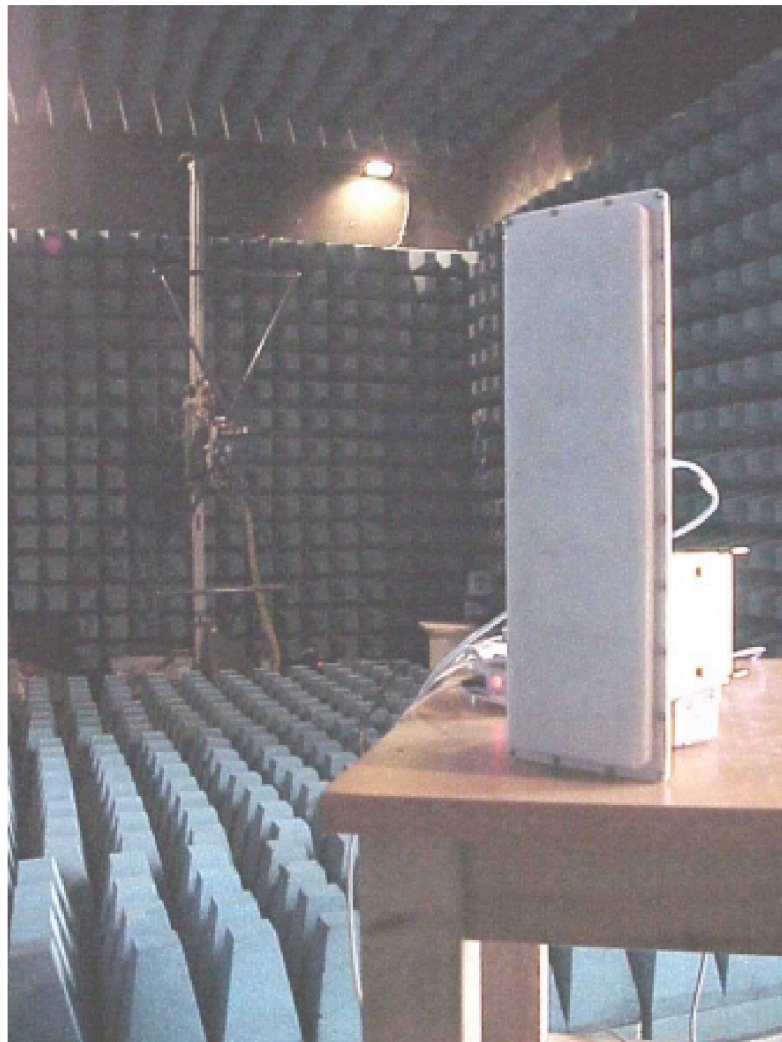
**Photo #6.**  
**Radio unit with MTI sector antenna P/N MT-484025/NV.**  
**Spurious emission test**
