## Setup photos for HAC RF Emissions and T-Coil Test Report

| <b>Test report no.:</b> | HAC_Photo_RM-1105_03 | <b>Date of report:</b> | 2015-09-24 |
| <b>Tested devices:</b> | RM-1105 | | |

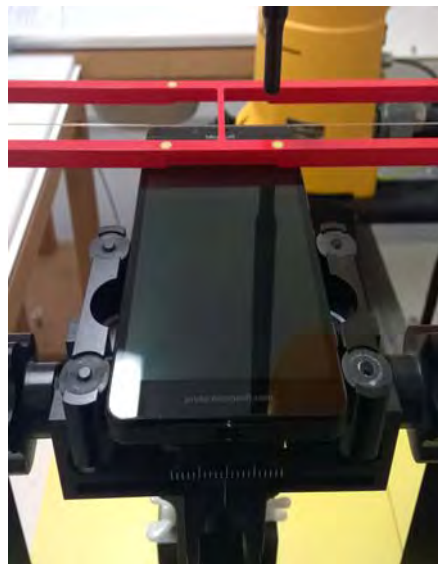
The device was positioned such that Device Reference plane was touching the bottom of the Test Arch. The scan is centered at the acoustic output by aligning the acoustic output with the intersection of the Test Arch's middle bar and dielectric wire.

Photo of the device positioned under Test Arch
