Radiated Emission Measurement

Site : 966A Chamber  
Condition : FCC\_part 15E RE\_Above 1GHz\_PK  
EUT : W6M22409-23739  
M/N:  
Test Mode : TX 802.11ax20 CH1  
Note :

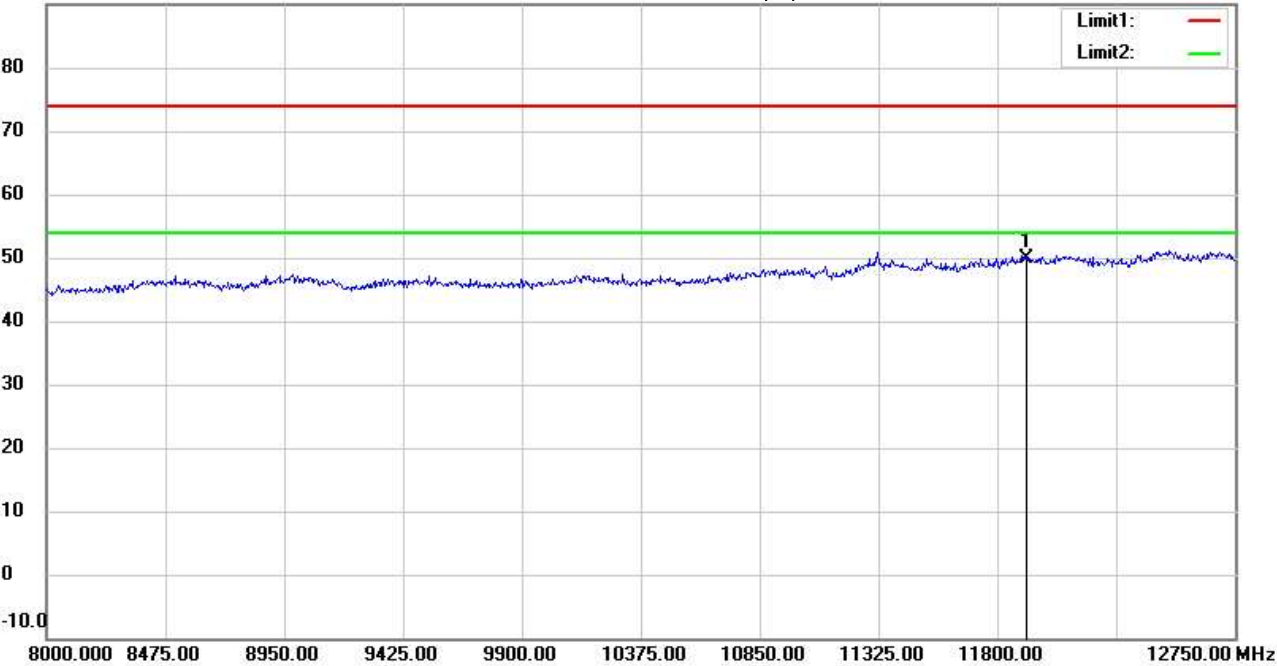
Data :#3

Polarization: **Horizontal**  
Power : 120 V.a.c.  
Distance: 3m

| Mk. | Frequency (MHz) | Reading (dBuV) | Detector | Corr. factor (dB/m) | Result (dBuV/m) | Limit (dBuV/m) | Ant.Pos (cm) | Tab.Pos (deg.) | Margin (dB) | Comment |
|---|---|---|---|---|---|---|---|---|---|---|
| * | 11910.000 | 33.89 | peak | 16.09 | 49.98 | 74.00 | 150 | 129 | -24.02 | |

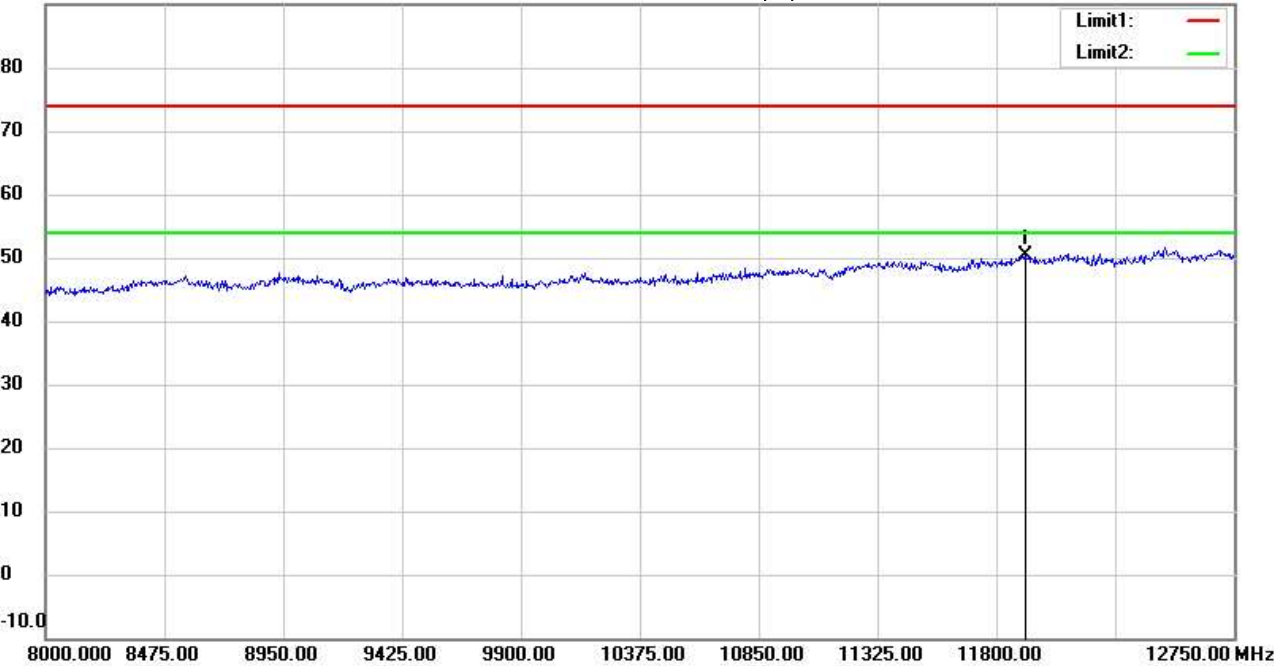
Data :#9

Site : 966A Chamber  
Condition : FCC\_part 15E RE\_Above 1GHz\_PK  
EUT : W6M22409-23739  
M/N:  
Test Mode : TX 802.11ax20 CH1  
Note :

Polarization: Vertical  
Power : 120 Va.c.  
Distance: 3m

| Mk. | Frequency (MHz) | Reading (dBuV) | Detector | Corr. factor (dB/m) | Result (dBuV/m) | Limit (dBuV/m) | Ant.Pos (cm) | Tab.Pos (deg.) | Margin (dB) | Comment |
|---|---|---|---|---|---|---|---|---|---|---|
| * | 11910.000 | 34.29 | peak | 16.09 | 50.38 | 74.00 | 150 | 82 | -23.62 | |

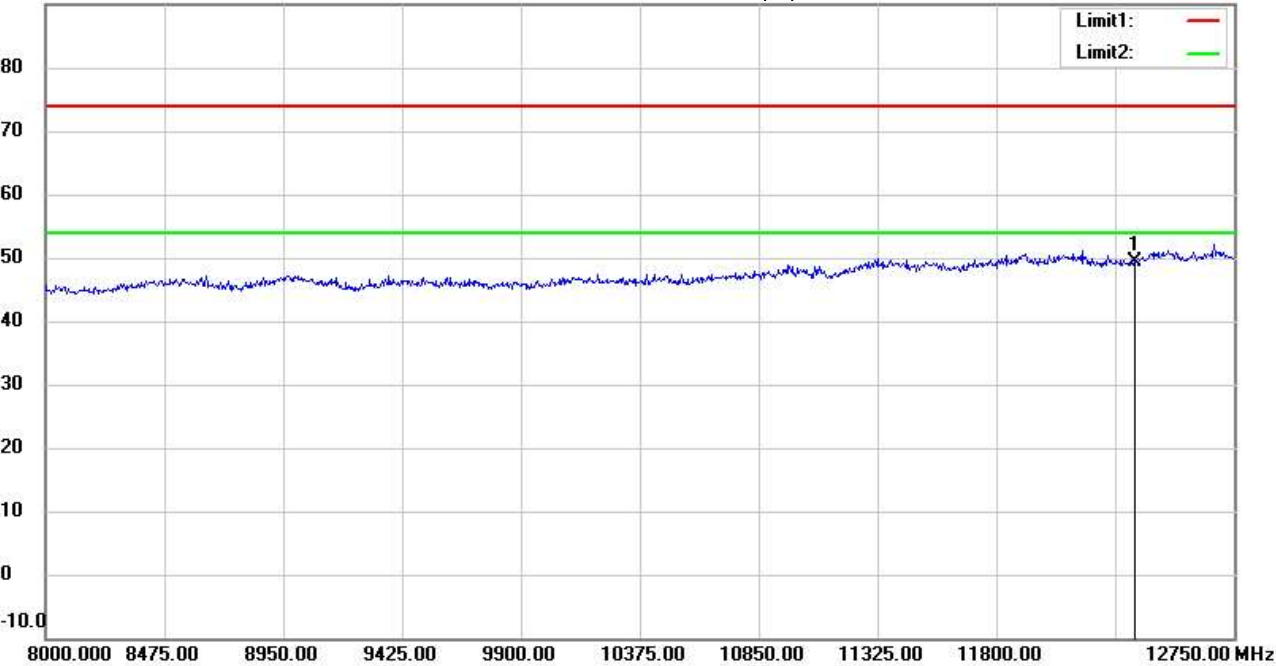
Data :#3

Site : 966A Chamber  
Condition : FCC\_part 15E RE\_Above 1GHz\_PK  
EUT : W6M22409-23739  
M/N:  
Test Mode : TX 802.11ax20 CH45  
Note :

Polarization: Horizontal  
Power : 120 Va.c.  
Distance: 3m

| Mk. | Frequency (MHz) | Reading (dBuV) | Detector | Corr. factor (dB/m) | Result (dBuV/m) | Limit (dBuV/m) | Ant.Pos (cm) | Tab.Pos (deg.) | Margin (dB) | Comment |
|---|---|---|---|---|---|---|---|---|---|---|
| * | 12350.000 | 33.07 | peak | 16.43 | 49.50 | 74.00 | 150 | 275 | -24.50 | |

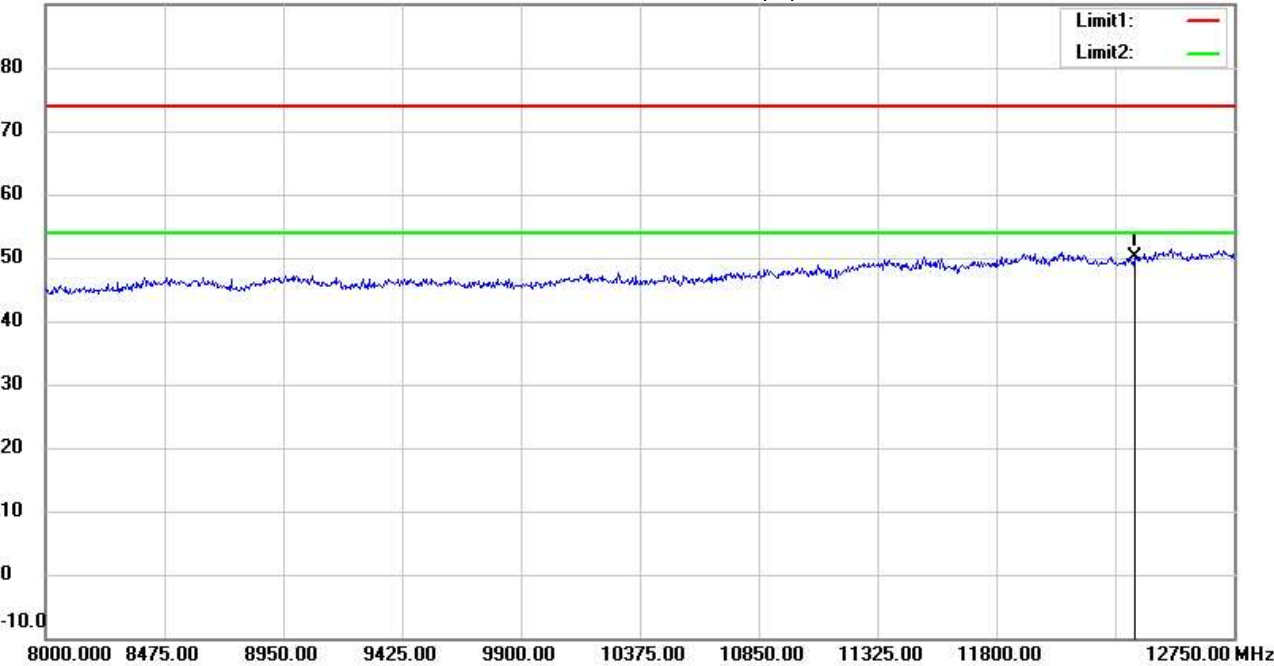
Data :#9

Site : 966A Chamber  
Condition : FCC\_part 15E RE\_Above 1GHz\_PK  
EUT : W6M22409-23739  
M/N:  
Test Mode : TX 802.11ax20 CH45  
Note :

Polarization: Vertical  
Power : 120 V.a.c.  
Distance: 3m

| Mk. | Frequency (MHz) | Reading (dBuV) | Detector | Corr. factor (dB/m) | Result (dBuV/m) | Limit (dBuV/m) | Ant.Pos (cm) | Tab.Pos (deg.) | Margin (dB) | Comment |
|---|---|---|---|---|---|---|---|---|---|---|
| * | 12350.000 | 33.66 | peak | 16.43 | 50.09 | 74.00 | 150 | 62 | -23.91 | |

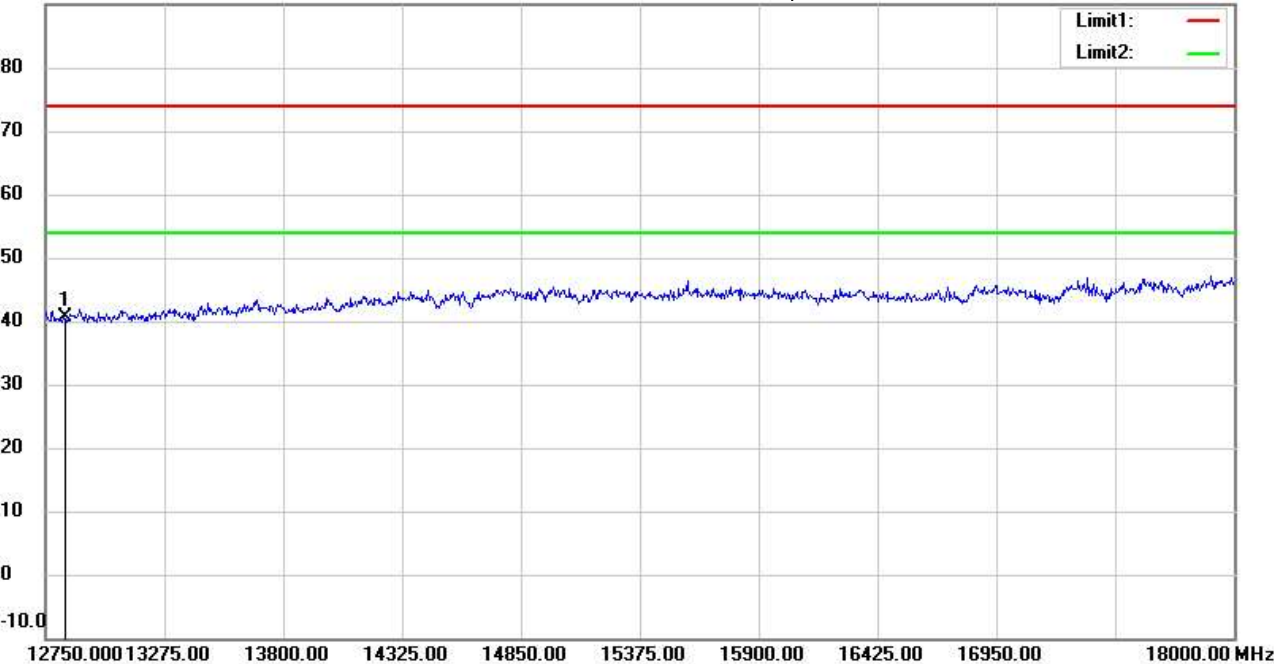
Data :#4

Test Mode : TX 802.11ax20 CH93

Polarization: **Horizontal**

| Mk. | Frequency (MHz) | Reading (dBuV) | Detector | Corr. factor (dB/m) | Result (dBuV/m) | Limit (dBuV/m) | Ant.Pos (cm) | Tab.Pos (deg.) | Margin (dB) | Comment |
|---|---|---|---|---|---|---|---|---|---|---|
| * | 12830.000 | 23.49 | peak | 17.09 | 40.58 | 74.00 | 150 | 68 | -33.42 | |
