## 7.5Band Edge

## 7.6 Conducted RF Spurious Emission

## Appendix B: photographs of test setup

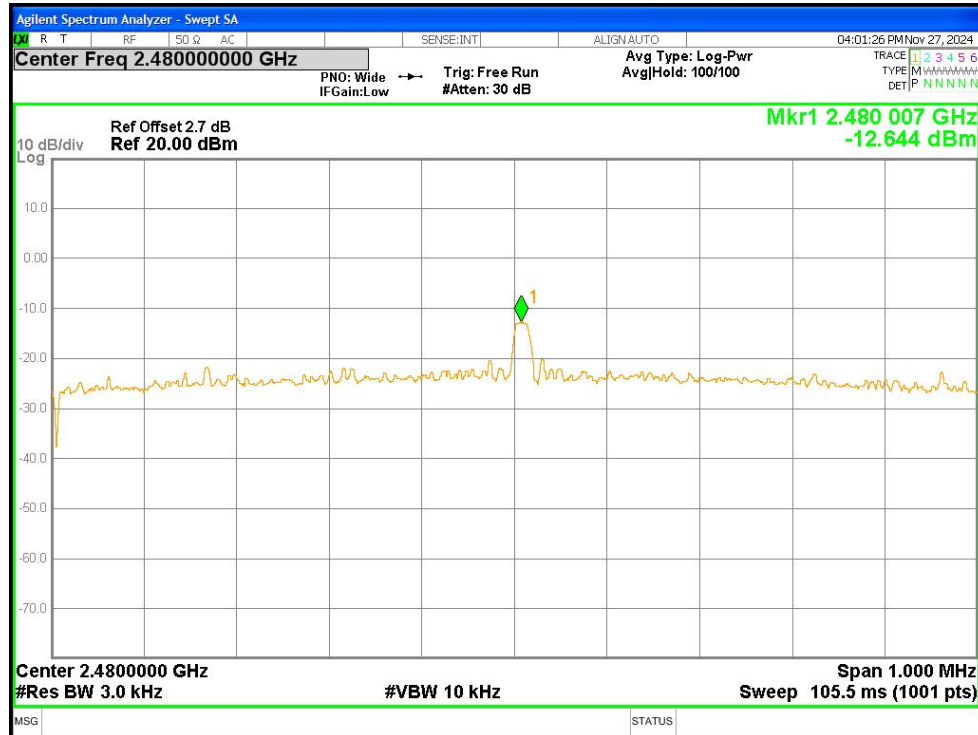
PSD NVNT BLE 2M 2480MHz Ant1

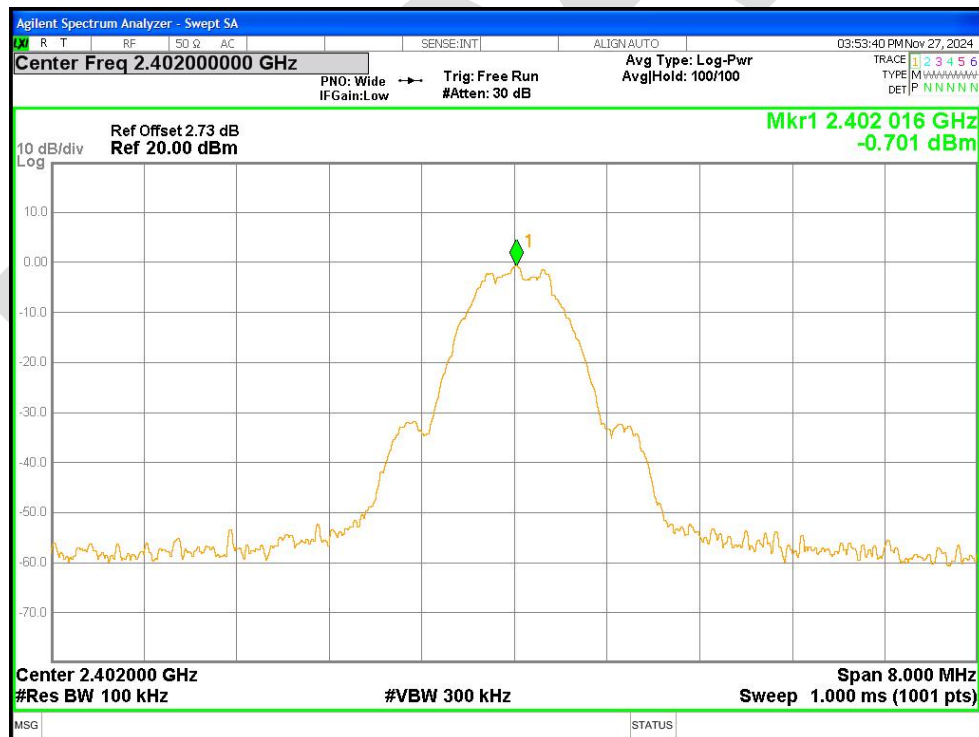
Band Edge NVNT BLE 1M 2402MHz Ant1 Ref

| Condition | Mode | Frequency (MHz) | Antenna | Max Value (dBc) | Limit (dBc) | Verdict |
|---|---|---|---|---|---|---|
| NVNT | BLE 1M | 2402 | Ant1 | -54.17 | -20 | Pass |

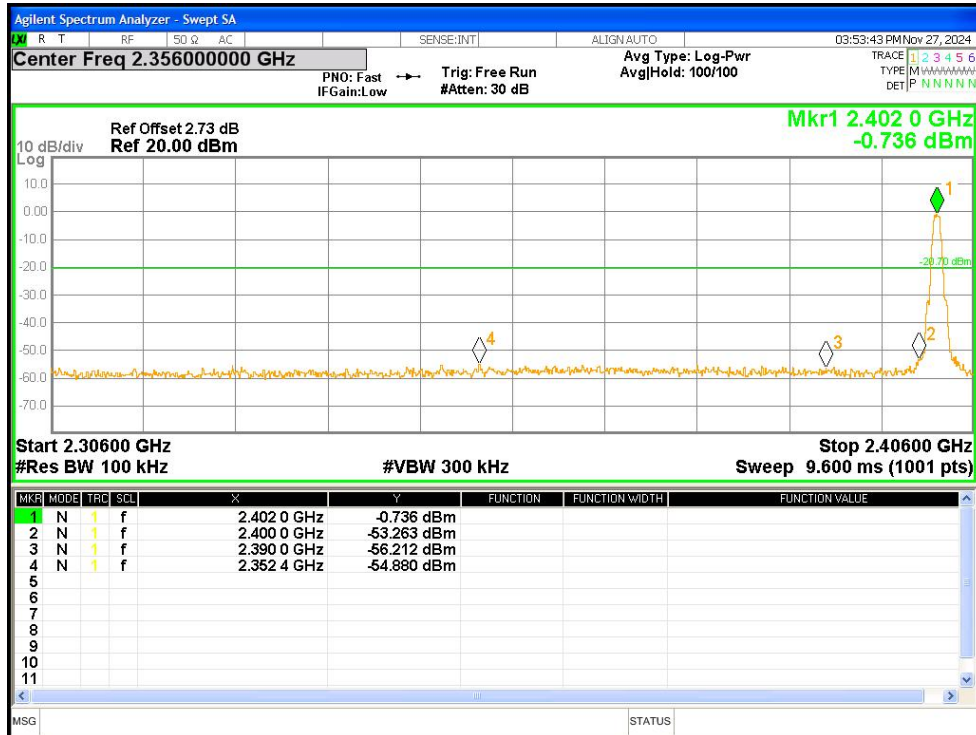
## Band Edge NVNT BLE 1M 2402MHz Ant1 Emission

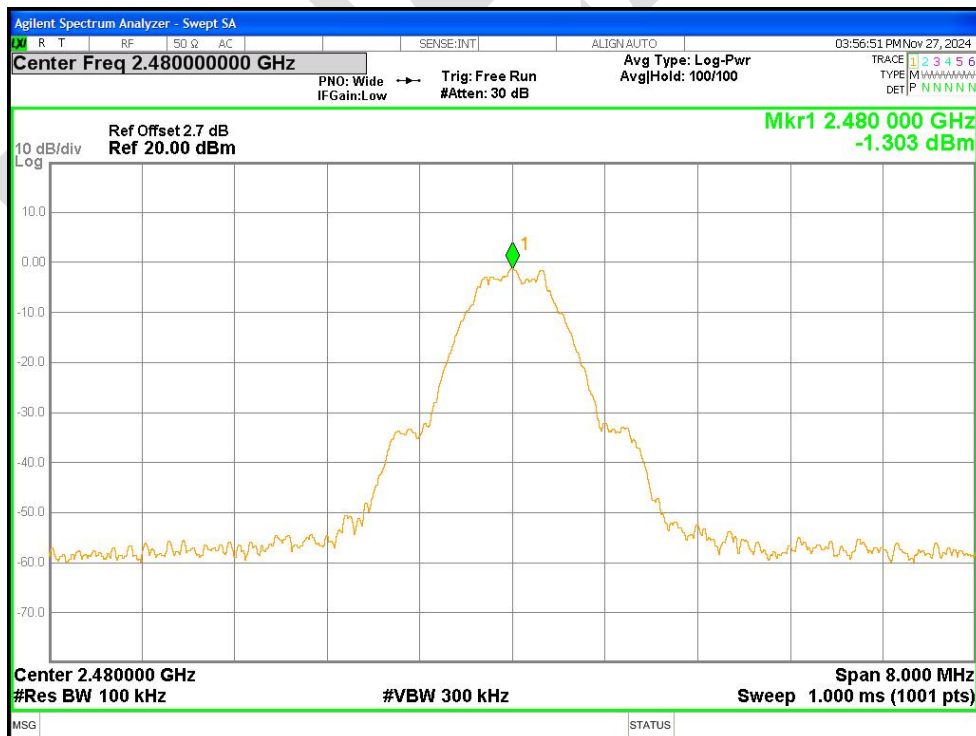
## Band Edge NVNT BLE 1M 2480MHz Ant1 Ref

| Condition | Mode | Frequency (MHz) | Antenna | Max Value (dBc) | Limit (dBc) | Verdict |
|---|---|---|---|---|---|---|
| NVNT | BLE 1M | 2480 | Ant1 | -53.68 | -20 | Pass |

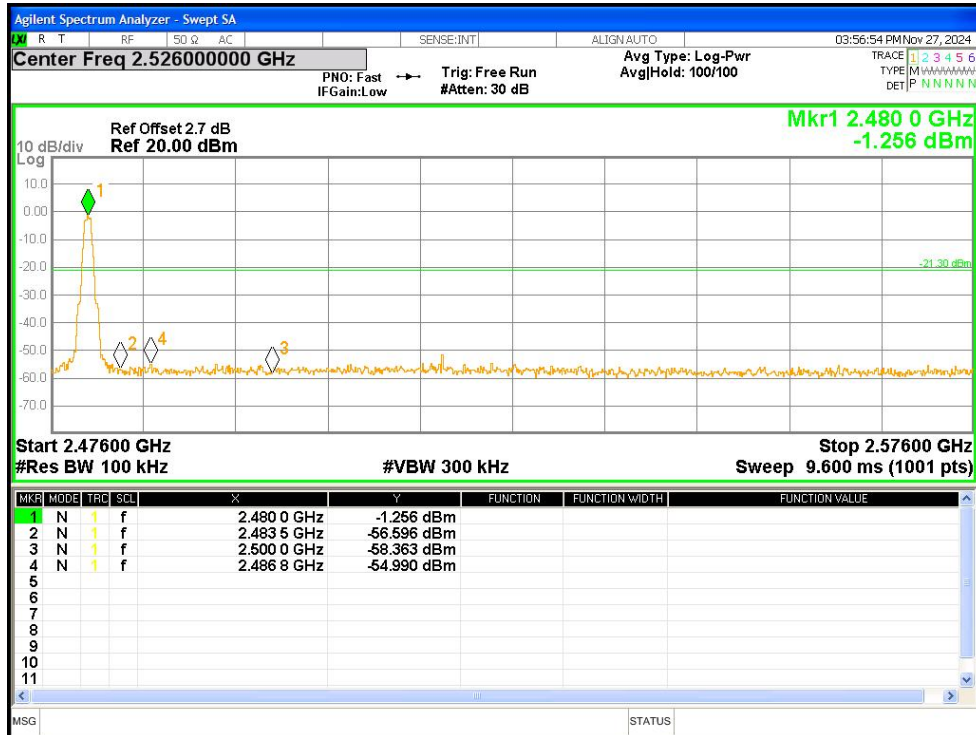
## Band Edge NVNT BLE 1M 2480MHz Ant1 Emission

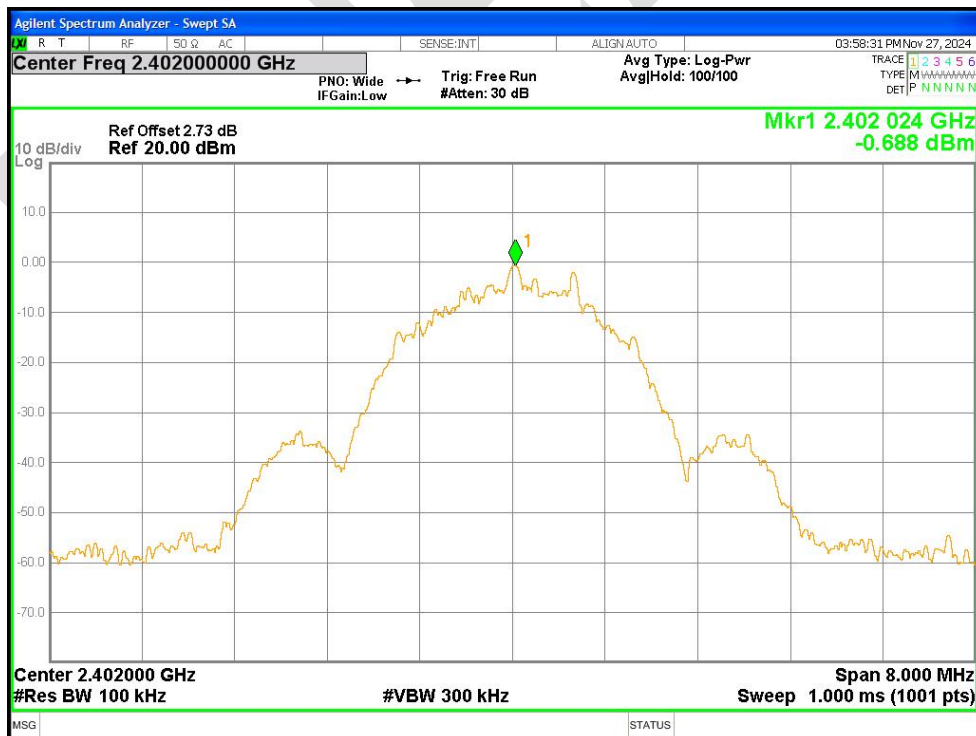
## Band Edge NVNT BLE 2M 2402MHz Ant1 Ref

| Condition | Mode | Frequency (MHz) | Antenna | Max Value (dBc) | Limit (dBc) | Verdict |
|---|---|---|---|---|---|---|
| NVNT | BLE 2M | 2402 | Ant1 | -54.2 | -20 | Pass |

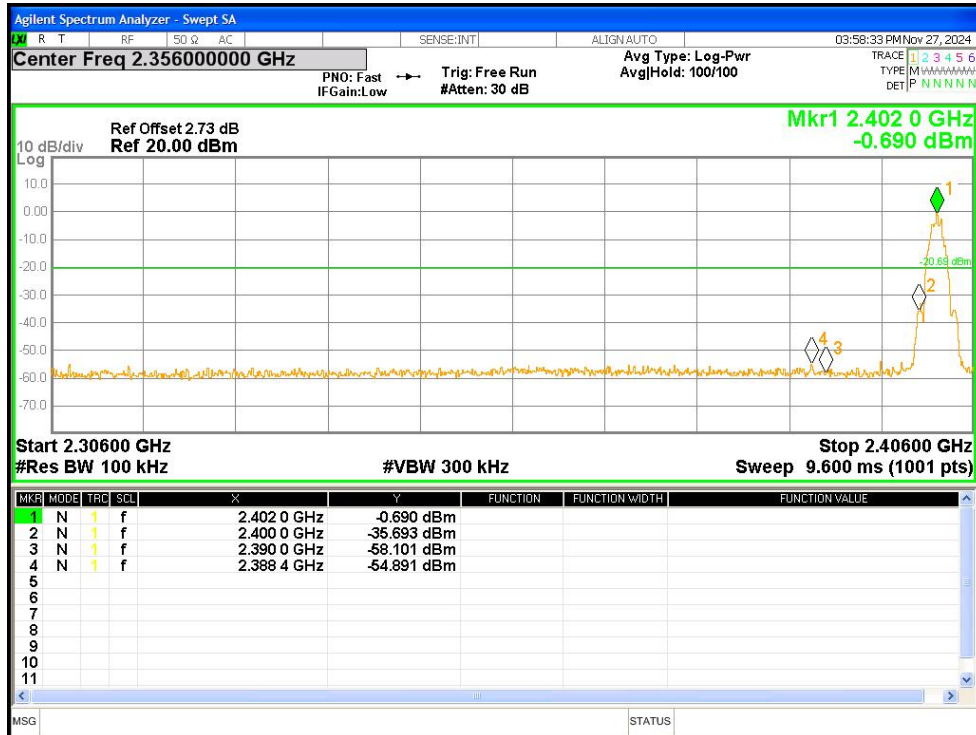
Band Edge NVNT BLE 2M 2402MHz Ant1 Emission

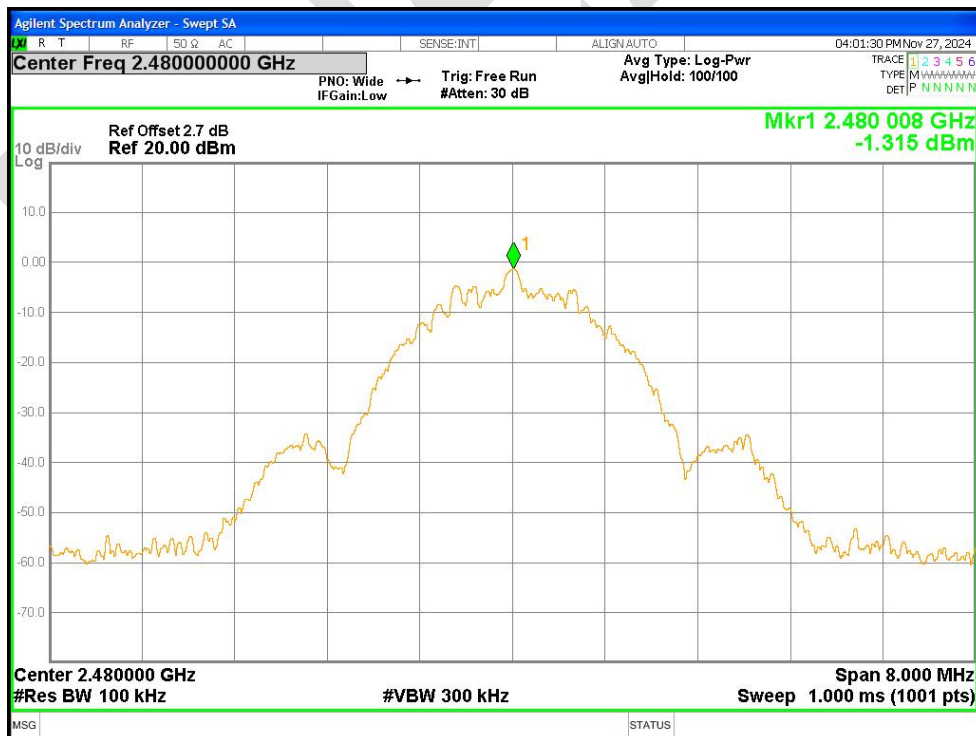
Band Edge NVNT BLE 2M 2480MHz Ant1 Ref

| Condition | Mode | Frequency (MHz) | Antenna | Max Value (dBc) | Limit (dBc) | Verdict |
|---|---|---|---|---|---|---|
| NVNT | BLE 2M | 2480 | Ant1 | -49.25 | -20 | Pass |

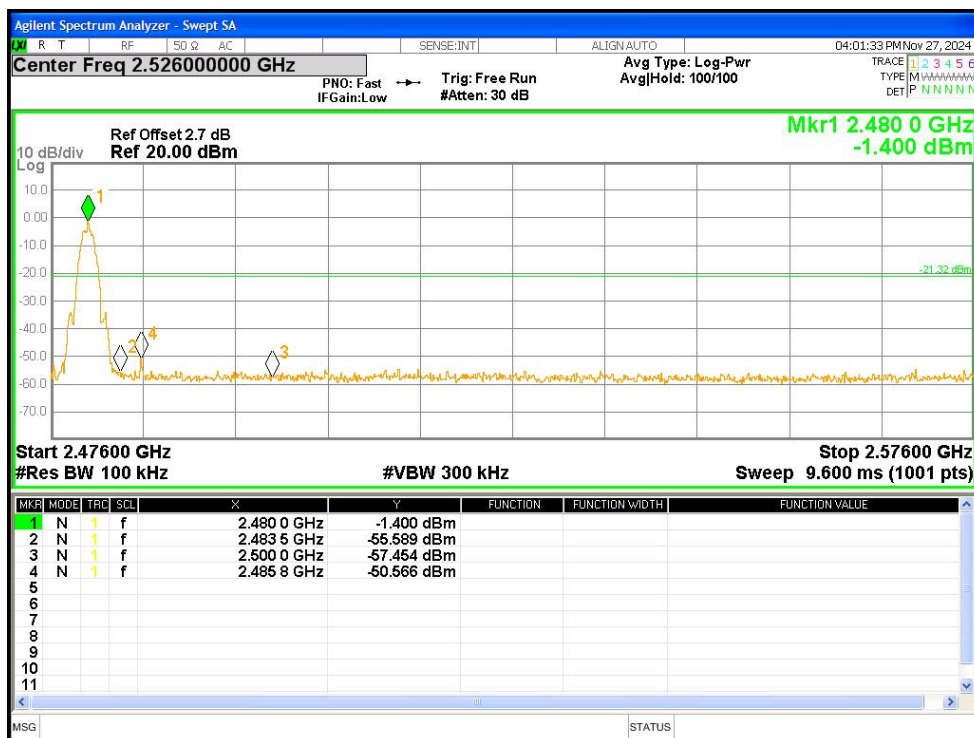
Band Edge NVNT BLE 2M 2480MHz Ant1 Emission

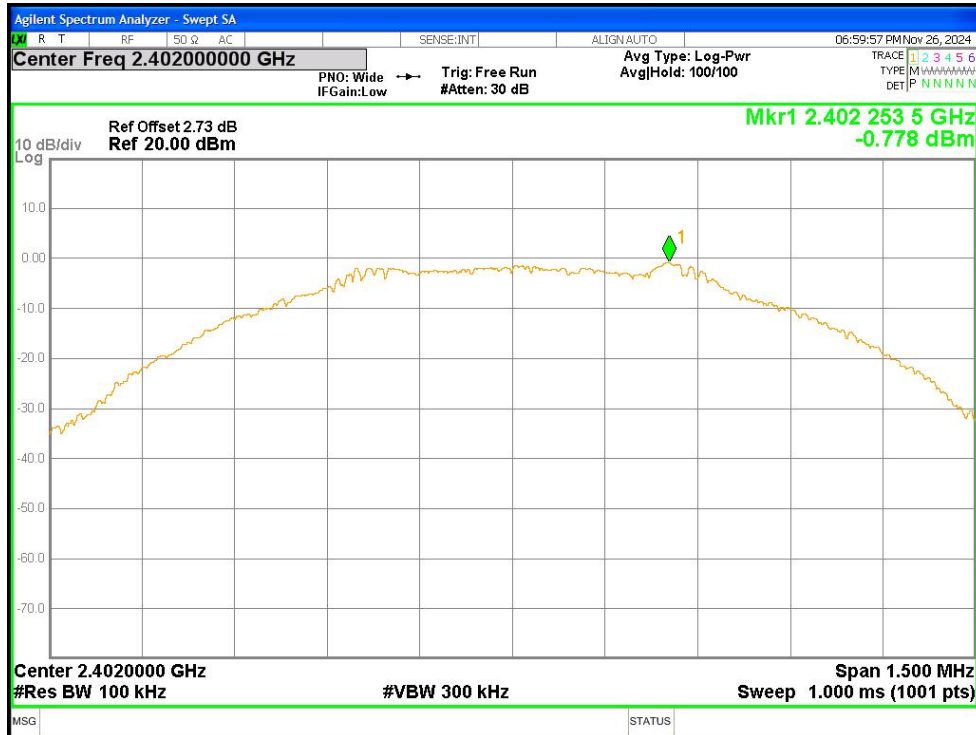
Tx. Spurious NVNT BLE 1M 2402MHz Ant1 Ref

| Condition | Mode | Frequency (MHz) | Antenna | Max Value (dBc) | Limit (dBc) | Verdict |
|---|---|---|---|---|---|---|
| NVNT | BLE 1M | 2402 | Ant1 | -43.96 | -20 | Pass |

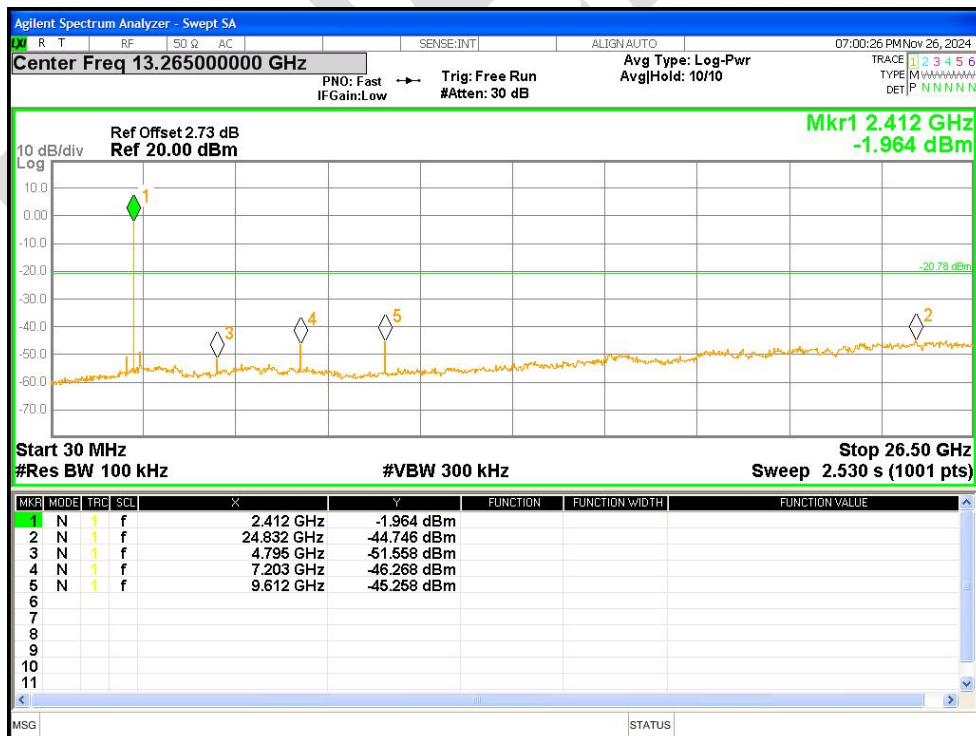
Tx. Spurious NVNT BLE 1M 2402MHz Ant1 Emission

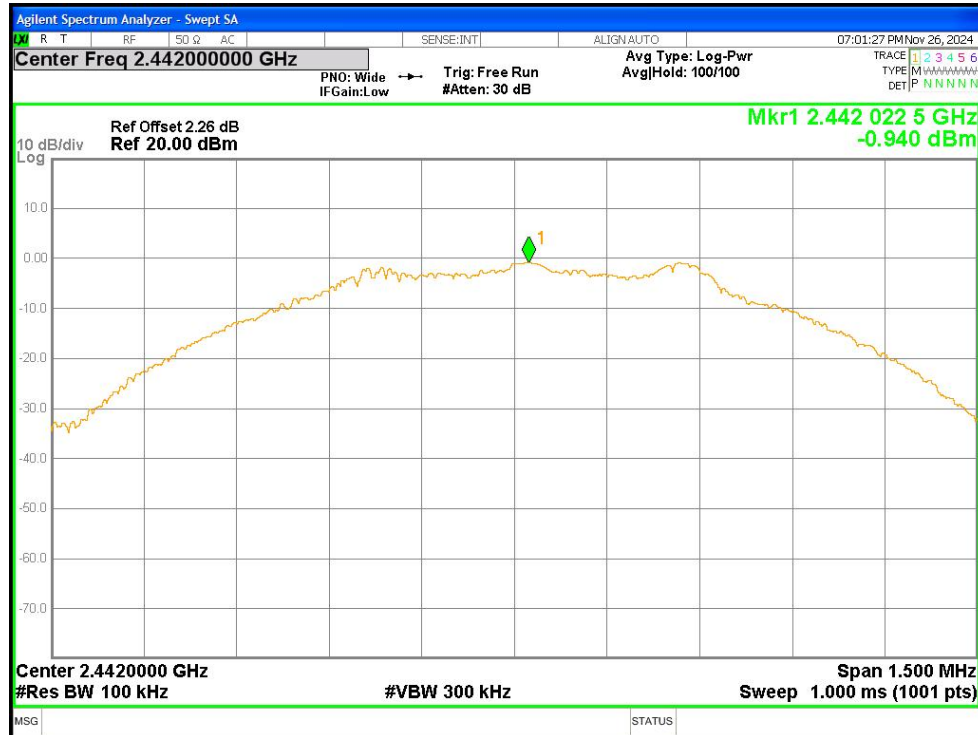
Tx. Spurious NVNT BLE 1M 2442MHz Ant1 Ref

| Condition | Mode | Frequency (MHz) | Antenna | Max Value (dBc) | Limit (dBc) | Verdict |
|---|---|---|---|---|---|---|
| NVNT | BLE 1M | 2442 | Ant1 | -44.72 | -20 | Pass |

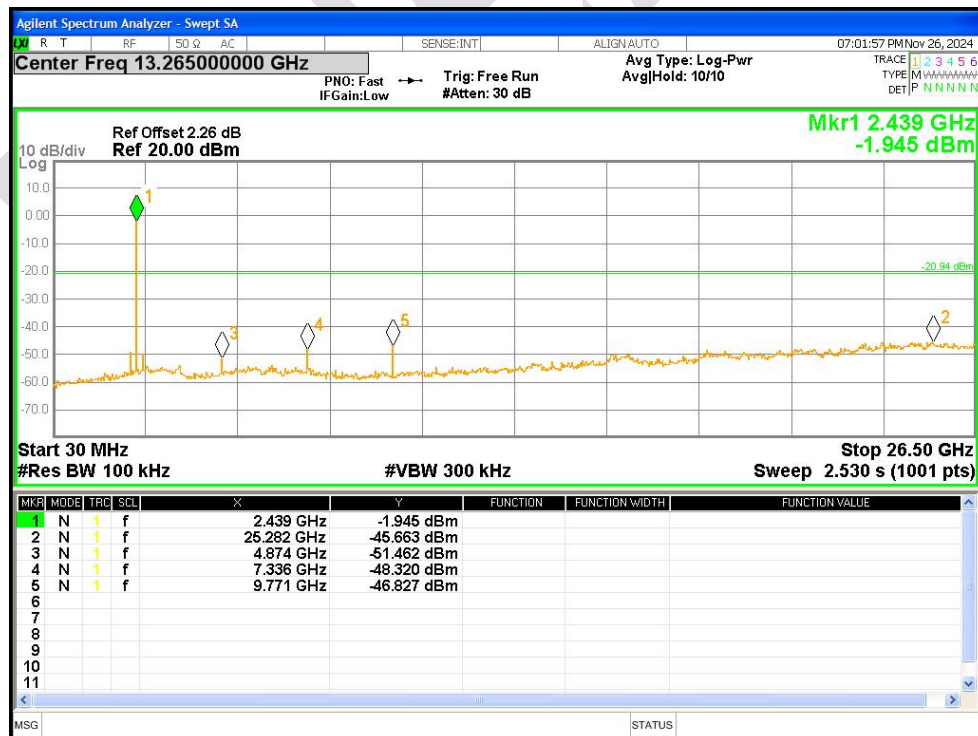
Tx. Spurious NVNT BLE 1M 2442MHz Ant1 Emission

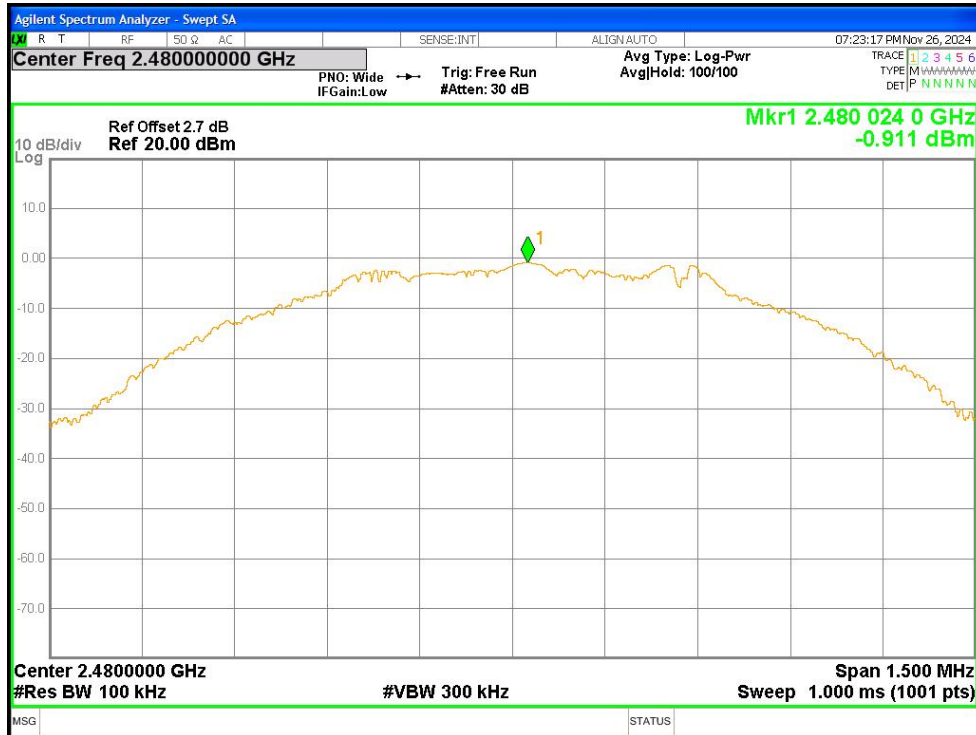
Tx. Spurious NVNT BLE 1M 2480MHz Ant1 Ref

| Condition | Mode | Frequency (MHz) | Antenna | Max Value (dBc) | Limit (dBc) | Verdict |
|---|---|---|---|---|---|---|
| NVNT | BLE 1M | 2480 | Ant1 | -43.36 | -20 | Pass |

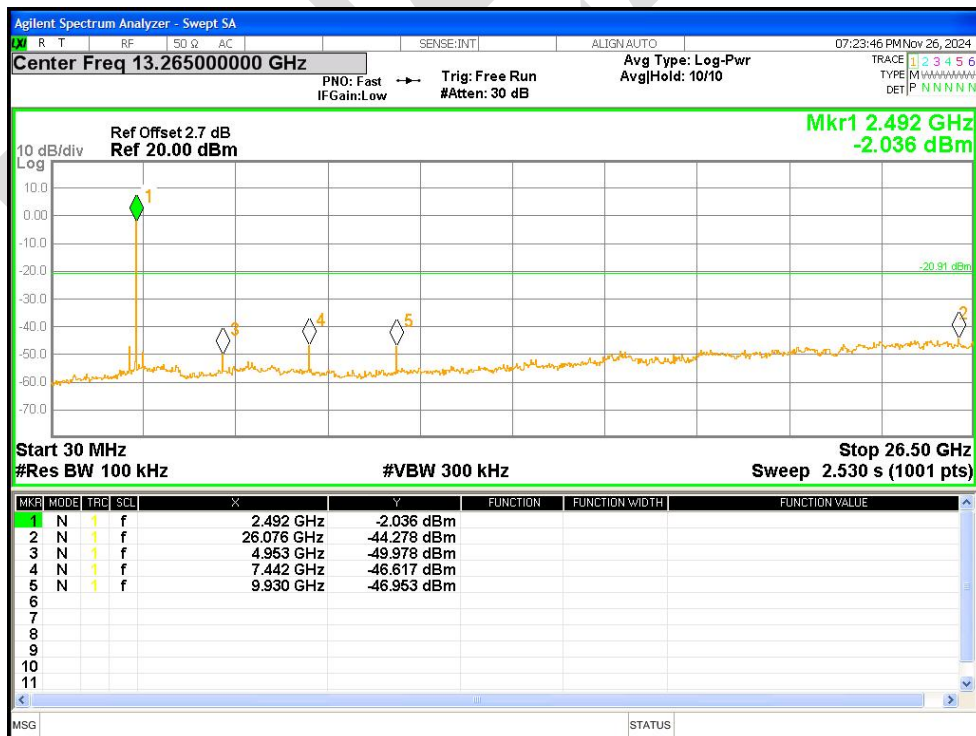
Tx. Spurious NVNT BLE 1M 2480MHz Ant1 Emission

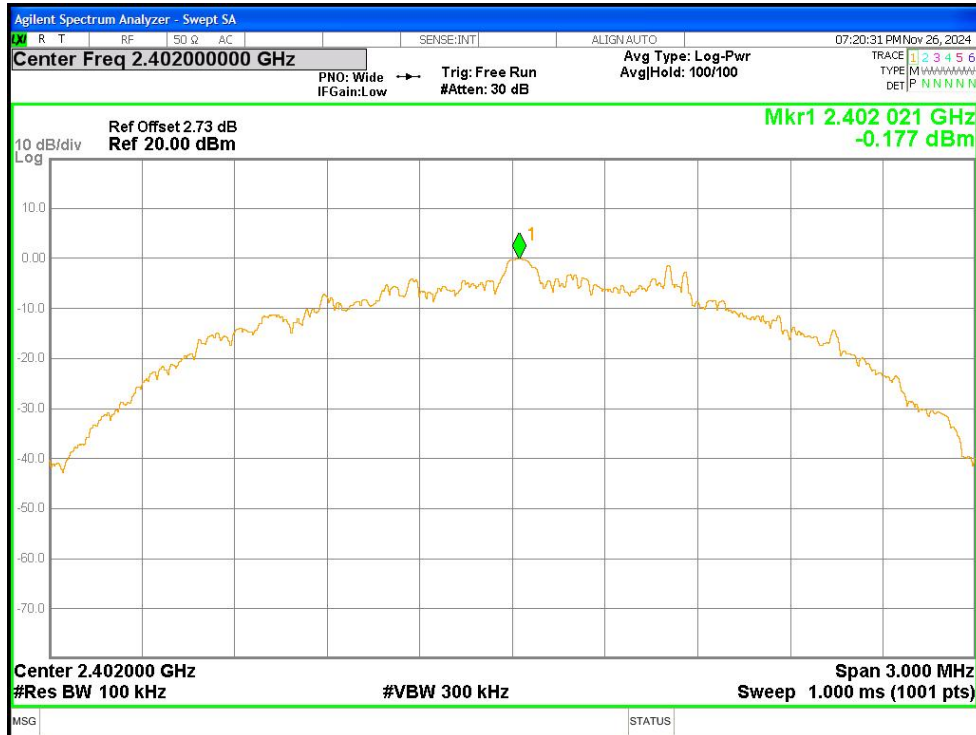
Tx. Spurious NVNT BLE 2M 2402MHz Ant1 Ref

| Condition | Mode | Frequency (MHz) | Antenna | Max Value (dBc) | Limit (dBc) | Verdict |
|---|---|---|---|---|---|---|
| NVNT | BLE 2M | 2402 | Ant1 | -44.09 | -20 | Pass |

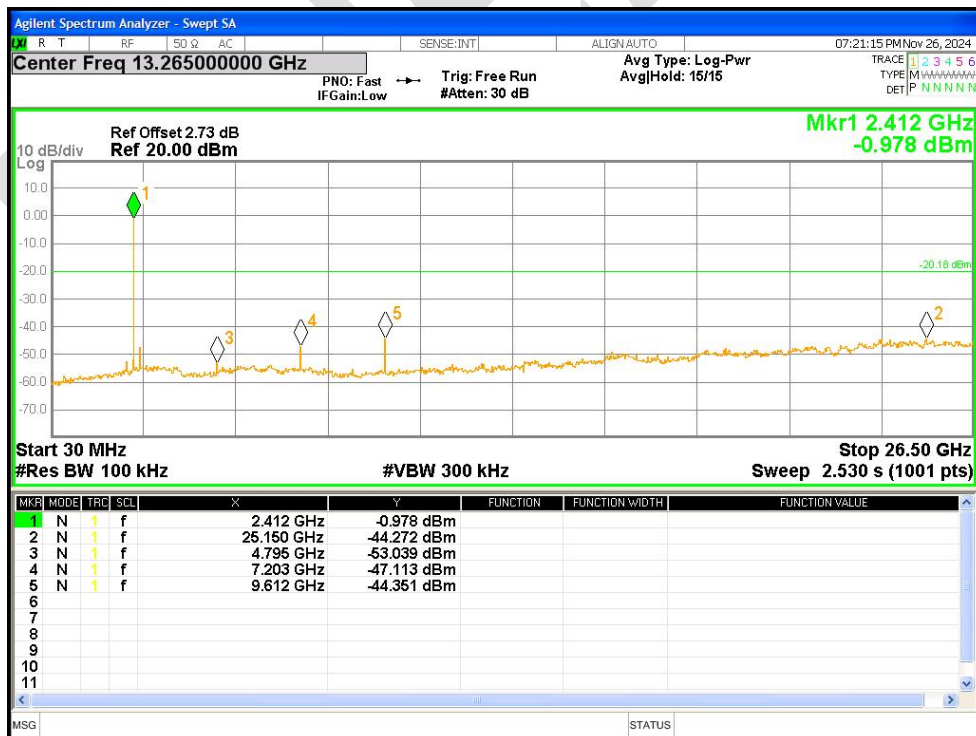
Tx. Spurious NVNT BLE 2M 2402MHz Ant1 Emission

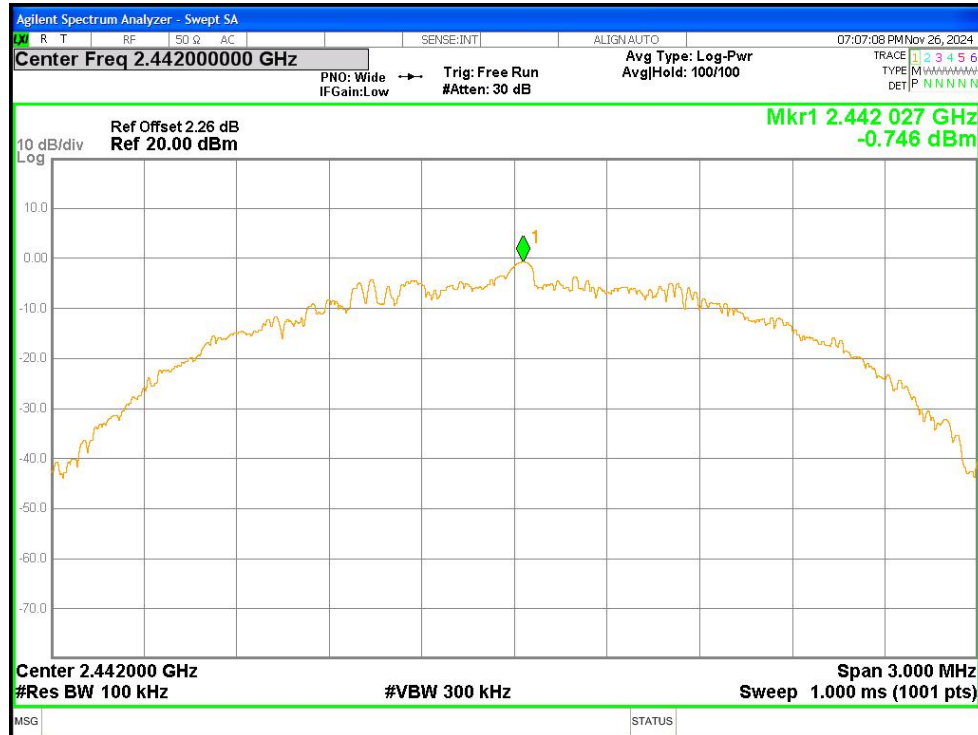
Tx. Spurious NVNT BLE 2M 2442MHz Ant1 Ref

| Condition | Mode | Frequency (MHz) | Antenna | Max Value (dBc) | Limit (dBc) | Verdict |
|---|---|---|---|---|---|---|
| NVNT | BLE 2M | 2442 | Ant1 | -44.4 | -20 | Pass |

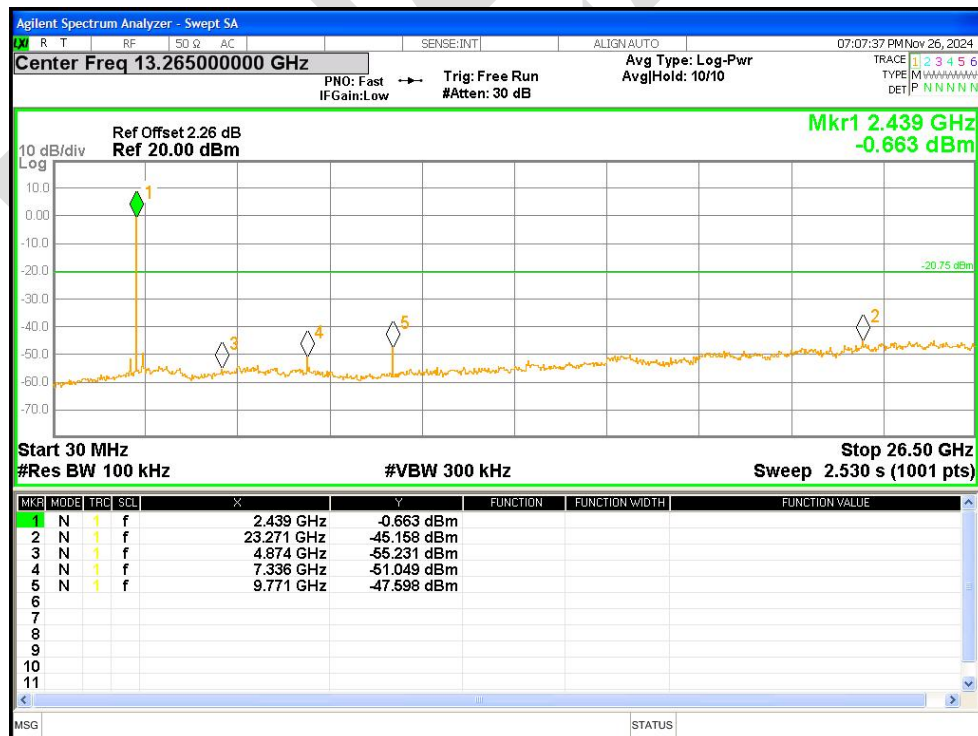
Tx. Spurious NVNT BLE 2M 2442MHz Ant1 Emission

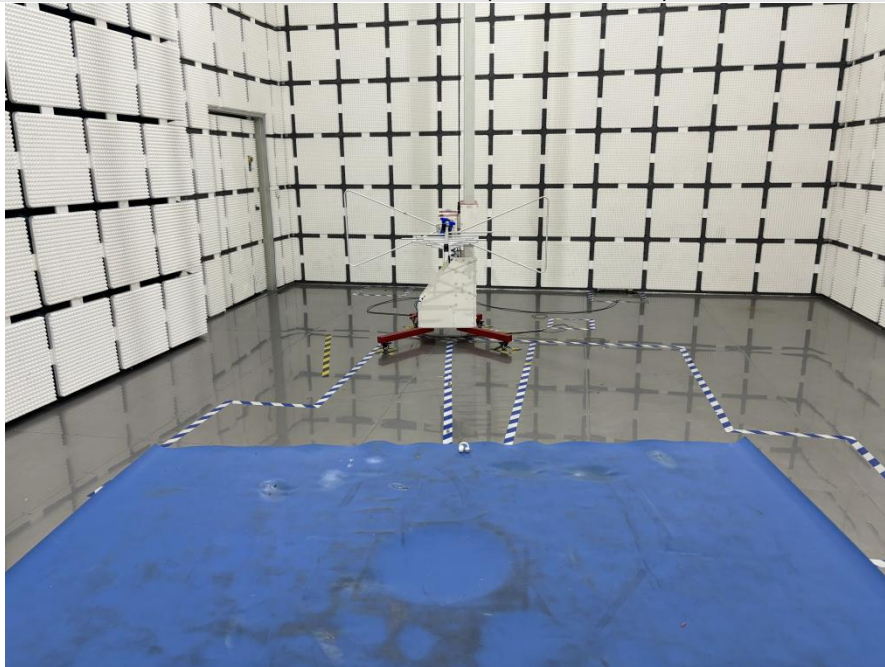
Radiated Emissions (30MHz-1GHz)

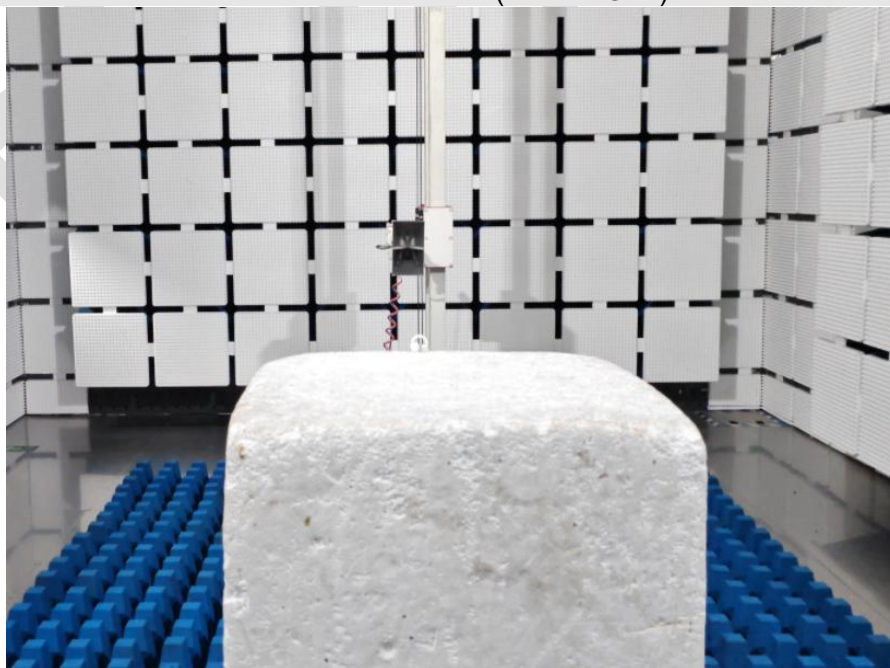
Radiated Emissions (above 1GHz)
