**5.7 100 kHz Bandwidth of Frequency Band Edge:**

**5.8 Duty Cycle:**

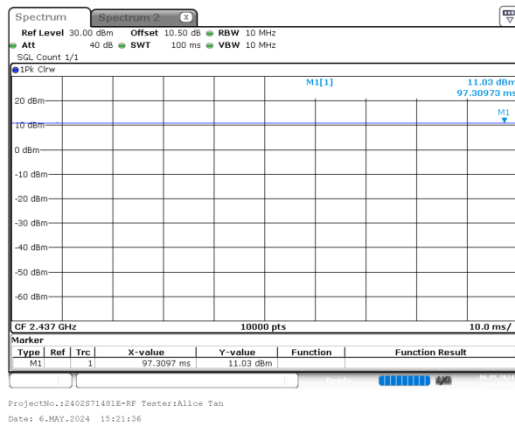
b\_2437MHz\_Chain 0

| Mode | Ton (ms) | Ton+Toff (ms) | Duty Cycle (%) | Duty Cycle Factor (dB) | 1/Ton (Hz) | VBW Setting (kHz) |
|---|---|---|---|---|---|---|
| b_2437MHz_Chain 0 | 100 | 100 | 100 | 0 | / | 0.01 |

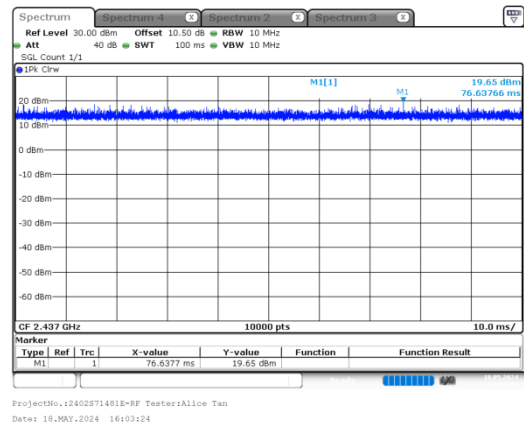
g\_2437MHz\_Chain 0

| Mode | Ton (ms) | Ton+Toff (ms) | Duty Cycle (%) | Duty Cycle Factor (dB) | 1/Ton (Hz) | VBW Setting (kHz) |
|---|---|---|---|---|---|---|
| g_2437MHz_Chain 0 | 100 | 100 | 100 | 0 | / | 0.01 |

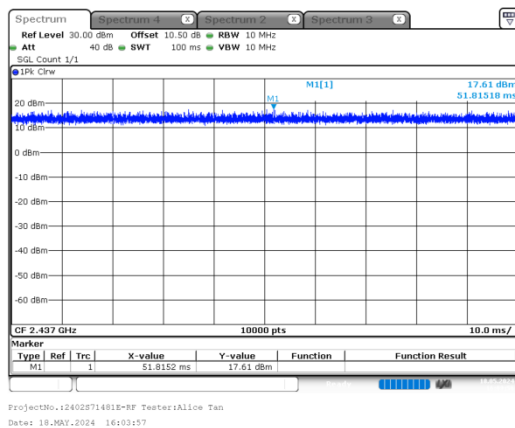
n20\_2437MHz\_Chain 0

| Mode | Ton (ms) | Ton+Toff (ms) | Duty Cycle (%) | Duty Cycle Factor (dB) | 1/Ton (Hz) | VBW Setting (kHz) |
|---|---|---|---|---|---|---|
| n20_2437MHz_Chain 0 | 100 | 100 | 100 | 0 | / | 0.01 |

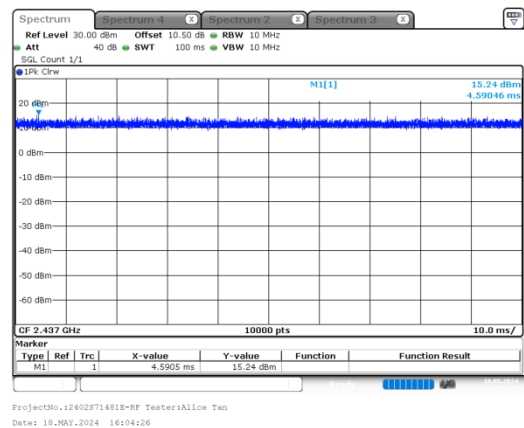
n40\_2437MHz\_Chain 0

| Mode | Ton (ms) | Ton+Toff (ms) | Duty Cycle (%) | Duty Cycle Factor (dB) | 1/Ton (Hz) | VBW Setting (kHz) |
|---|---|---|---|---|---|---|
| n40_2437MHz_Chain 0 | 100 | 100 | 100 | 0 | / | 0.01 |

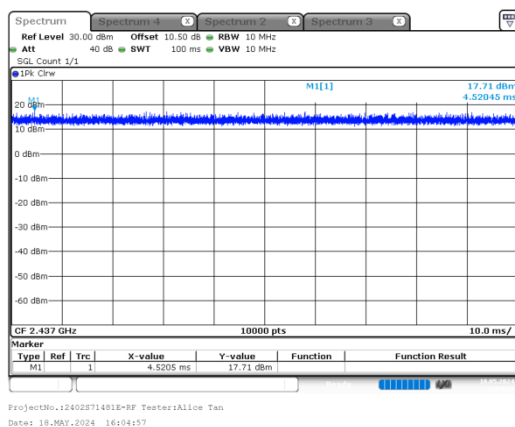
ax20\_2437MHz\_RU\_Full\_Chain 0

| Mode | Ton (ms) | Ton+Toff (ms) | Duty Cycle (%) | Duty Cycle Factor (dB) | 1/Ton (Hz) | VBW Setting (kHz) |
|---|---|---|---|---|---|---|
| ax20_2437MHz_RU_Full_Chain 0 | 100 | 100 | 100 | 0 | / | 0.01 |

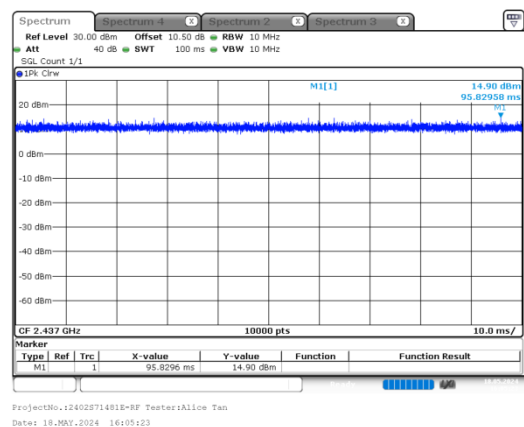
ax40\_2437MHz\_RU\_Full\_Chain 0

| Mode | Ton (ms) | Ton+Toff (ms) | Duty Cycle (%) | Duty Cycle Factor (dB) | 1/Ton (Hz) | VBW Setting (kHz) |
|---|---|---|---|---|---|---|
| ax40_2437MHz_RU_Full_Chain 0 | 100 | 100 | 100 | 0 | / | 0.01 |
