Radiated Emission Measurement

Condition : FCC\_part 15E RE\_Above 1GHz\_PK

EUT : W6M22409-23739

Test Mode : TX 802.11ax20 CH97

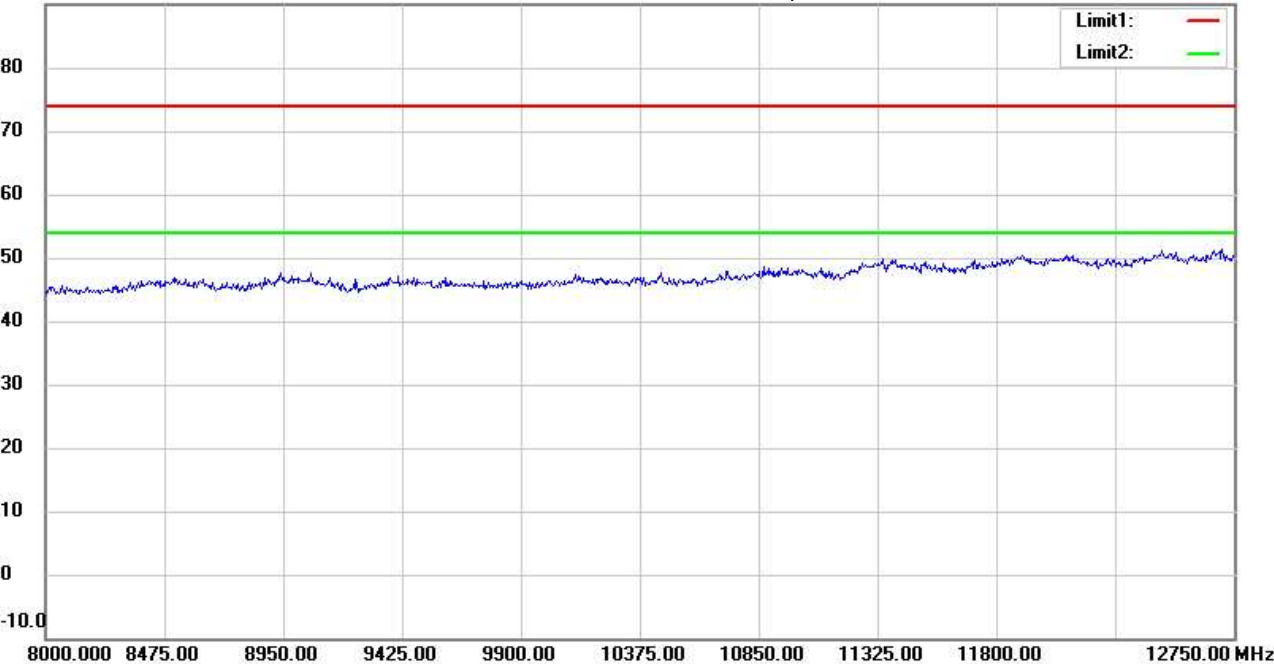
Site : 966A Chamber

Polarization: *Horizontal*

Distance: 3m

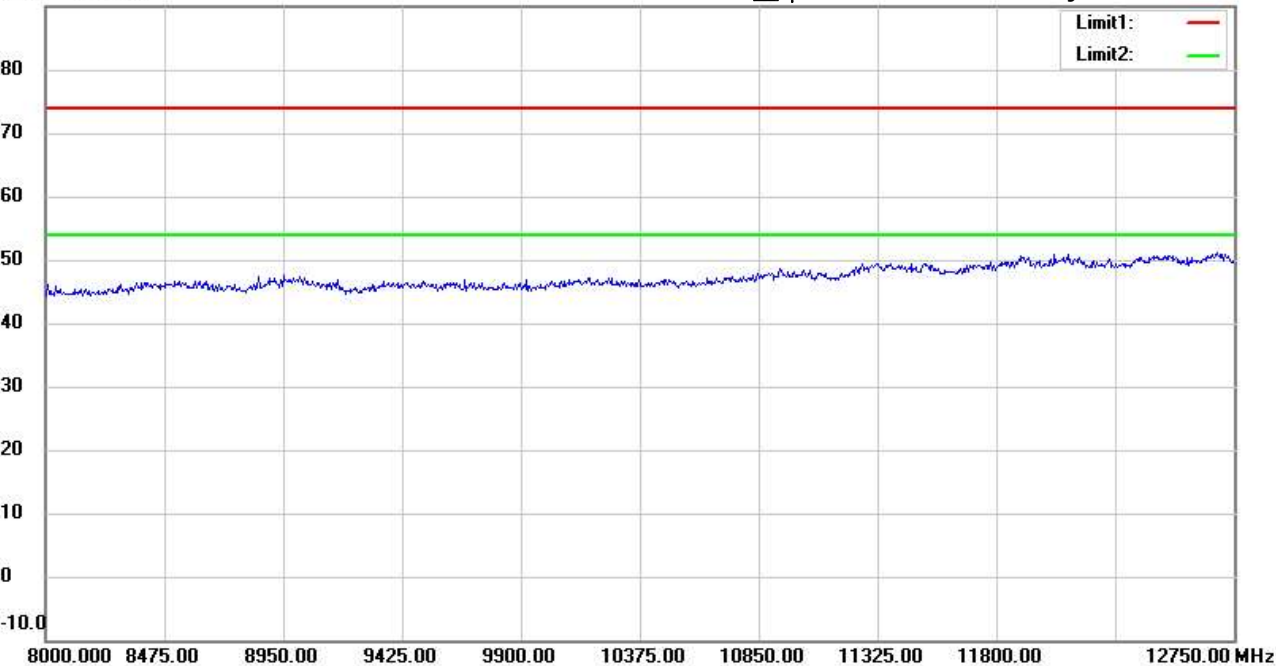
Site : 966A Chamber

Condition : FCC\_part 15E RE\_Above 1GHz\_PK

Test Mode : TX 802.11ax20 CH97

Polarization: Vertical

Distance: 3m

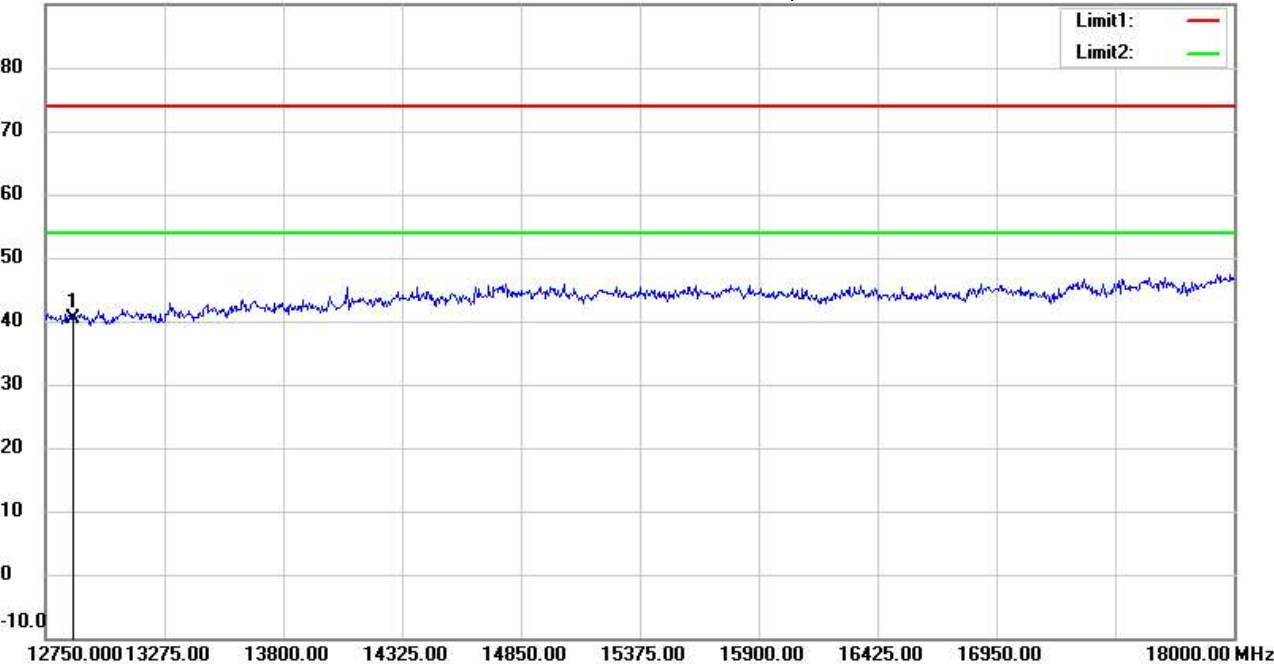
Data :#4

Test Mode : TX 802.11ax20 CH97

Polarization: **Horizontal**

| Mk. | Frequency (MHz) | Reading (dBuV) | Detector | Corr. factor (dB/m) | Result (dBuV/m) | Limit (dBuV/m) | Ant.Pos (cm) | Tab.Pos (deg.) | Margin (dB) | Comment |
|---|---|---|---|---|---|---|---|---|---|---|
| * | 12870.000 | 22.92 | peak | 17.37 | 40.29 | 74.00 | 150 | 357 | -33.71 | |

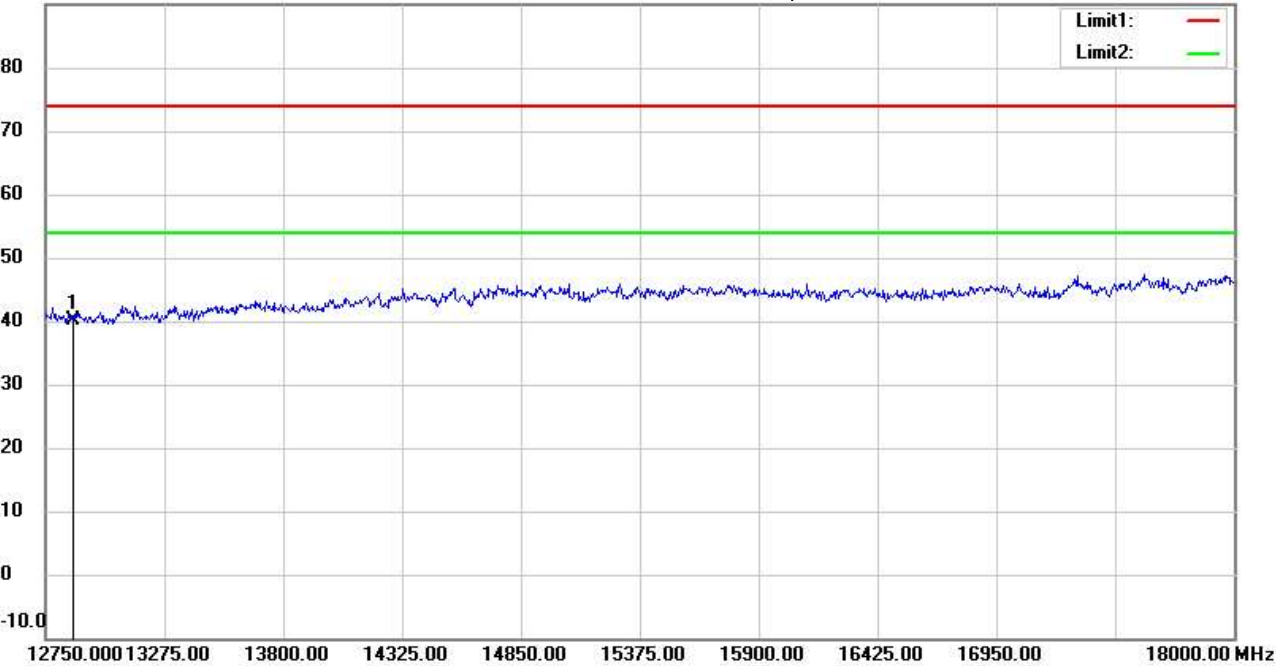
Data :#10

Test Mode : TX 802.11ax20 CH97

Polarization: Vertical

| Mk. | Frequency (MHz) | Reading (dBuV) | Detector | Corr. factor (dB/m) | Result (dBuV/m) | Limit (dBuV/m) | Ant.Pos (cm) | Tab.Pos (deg.) | Margin (dB) | Comment |
|---|---|---|---|---|---|---|---|---|---|---|
| * | 12870.000 | 22.76 | peak | 17.37 | 40.13 | 74.00 | 150 | 359 | -33.87 | |

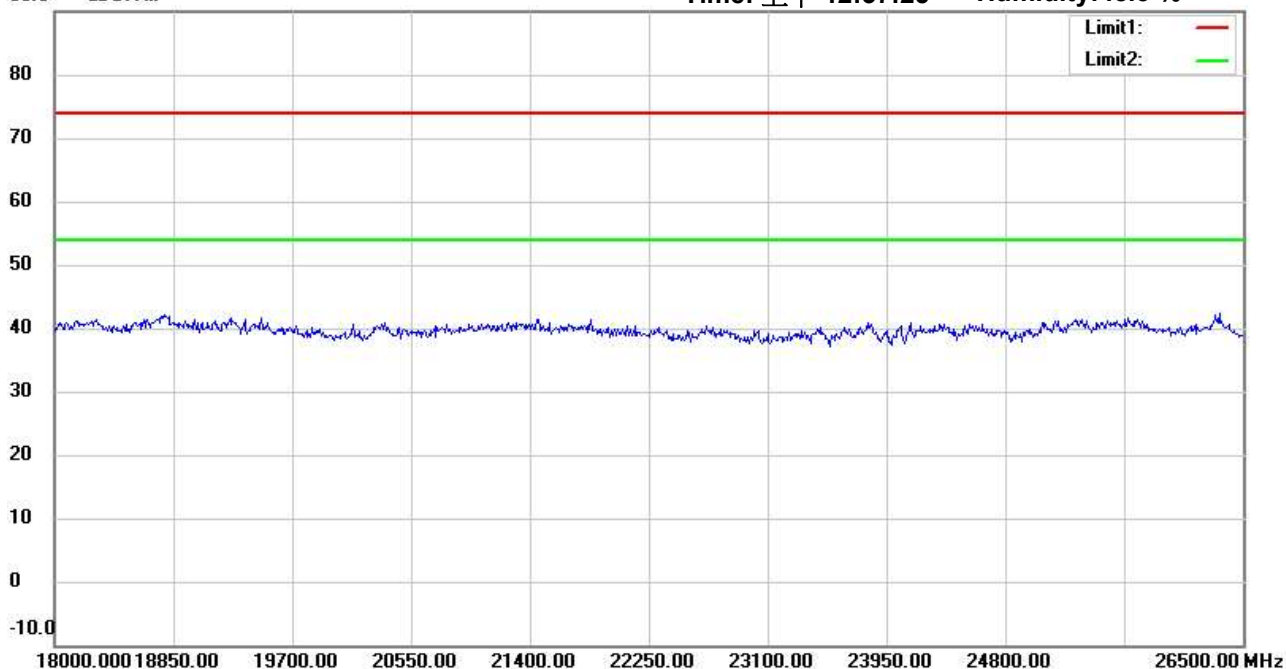
Site : 966A Chamber

Condition : FCC\_part 15E RE\_Above 1GHz\_PK

Test Mode : TX 802.11ax20 CH97

Polarization: **Horizontal**

Distance: 3m

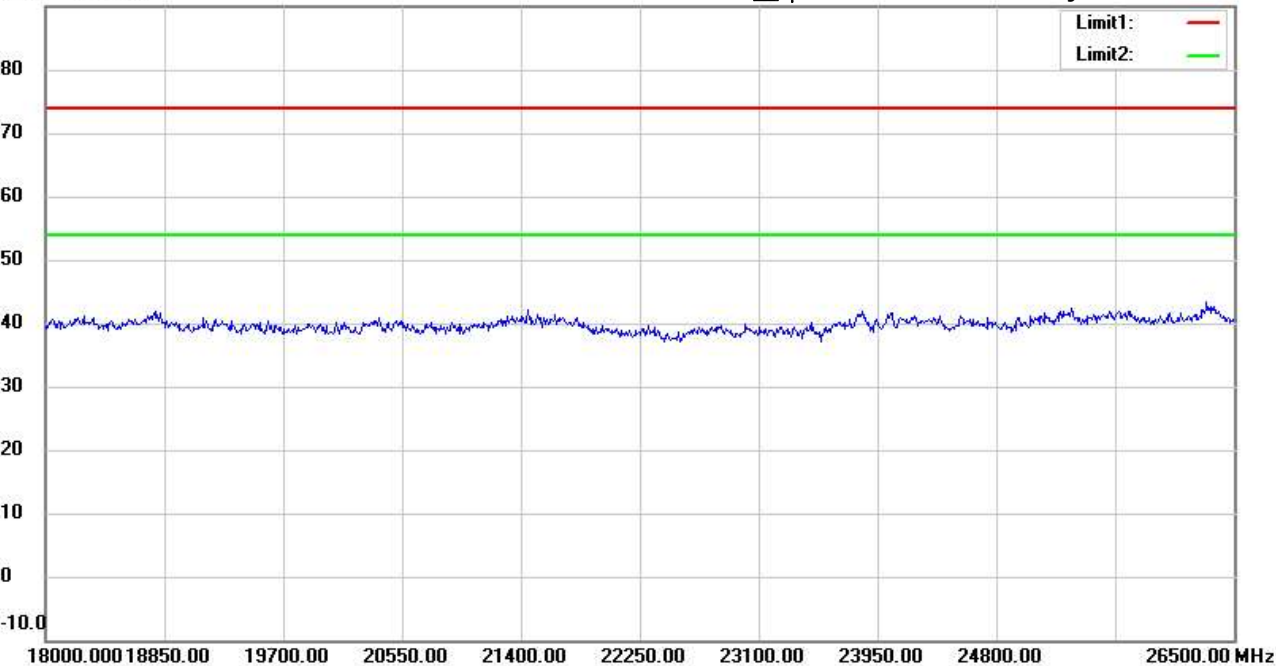
Site : 966A Chamber

Condition : FCC\_part 15E RE\_Above 1GHz\_PK

Test Mode : TX 802.11ax20 CH97

Polarization: Vertical

Distance: 3m

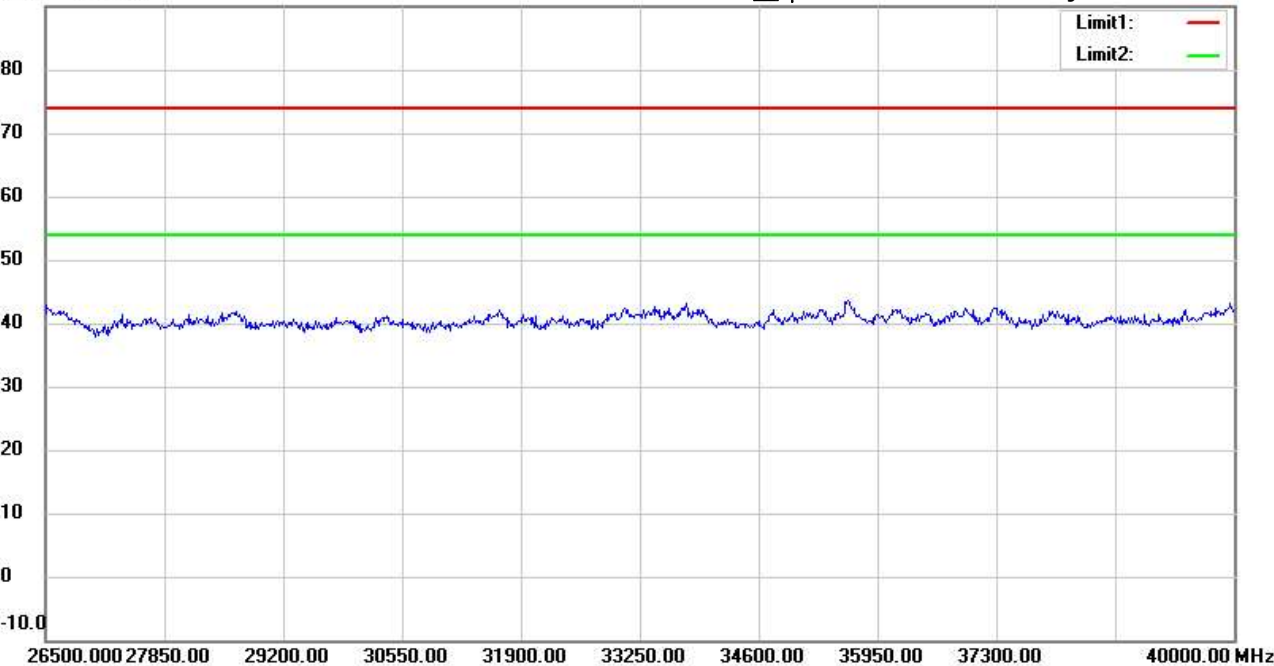
Site : 966A Chamber

Condition : FCC\_part 15E RE\_Above 1GHz\_PK

Test Mode : TX 802.11ax20 CH97

Polarization: **Horizontal**

Distance: 3m

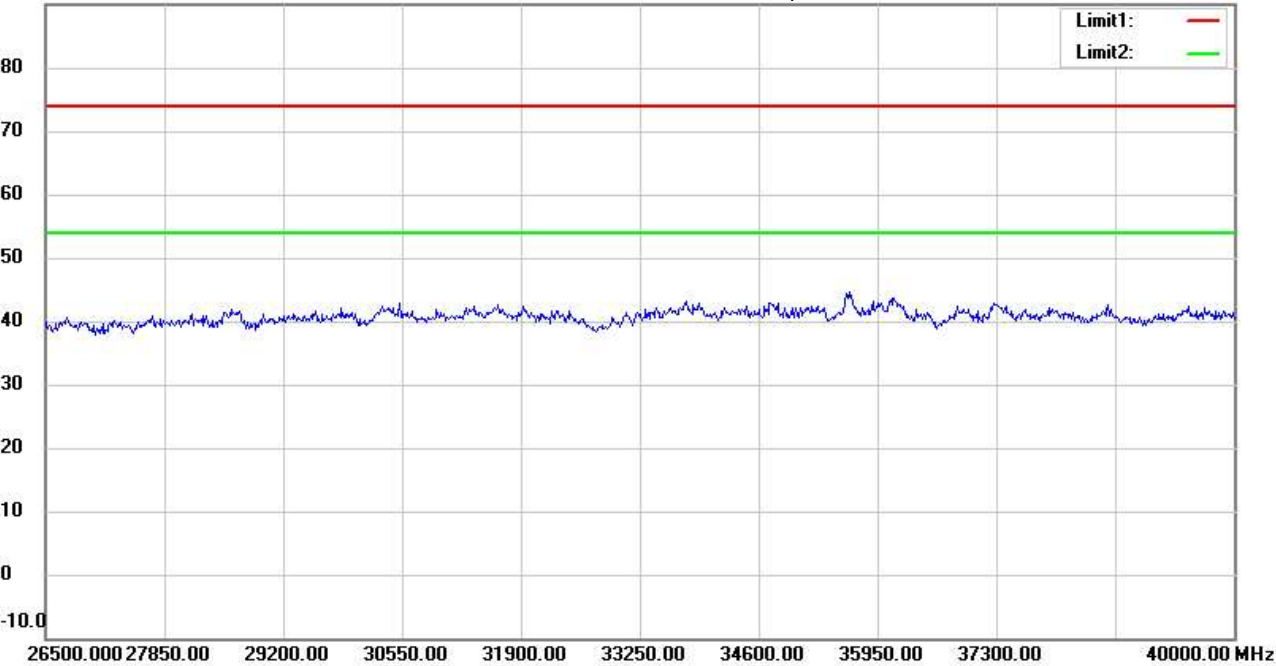
Site : 966A Chamber

Condition : FCC\_part 15E RE\_Above 1GHz\_PK

Test Mode : TX 802.11ax20 CH97

Polarization: Vertical

Distance: 3m

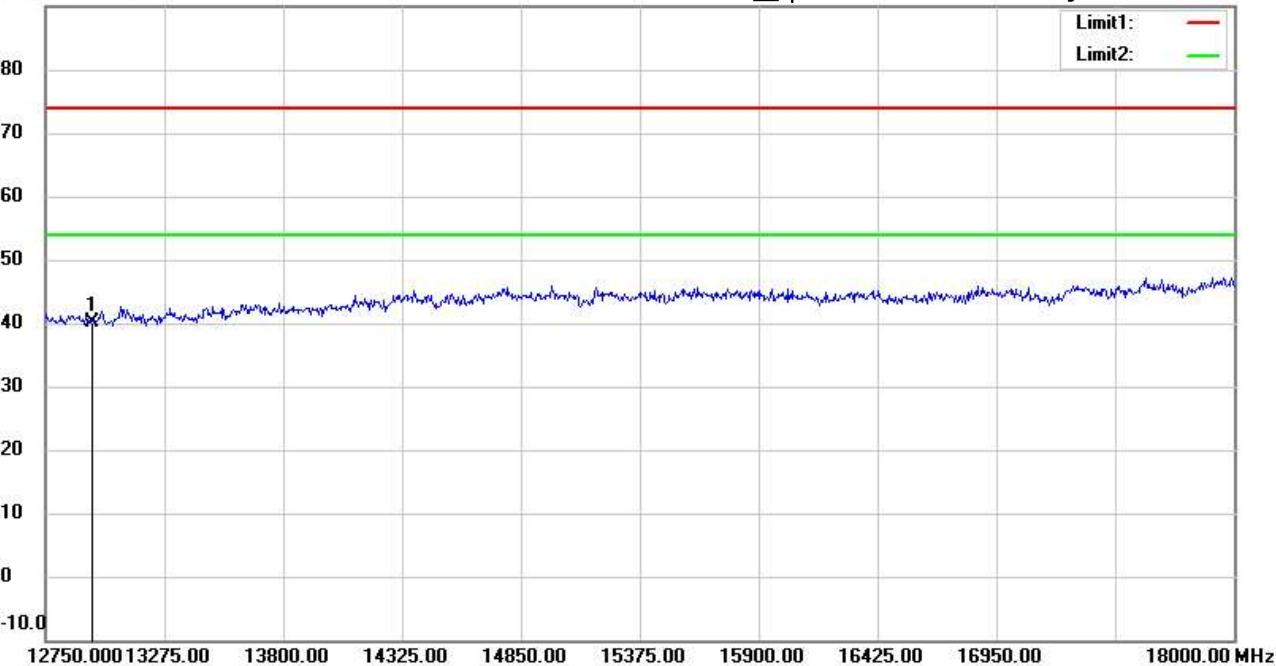
Data :#4

Test Mode : TX 802.11ax20 CH105

Polarization: *Horizontal*

| Mk. | Frequency (MHz) | Reading (dBuV) | Detector | Corr. factor (dB/m) | Result (dBuV/m) | Limit (dBuV/m) | Ant.Pos (cm) | Tab.Pos (deg.) | Margin (dB) | Comment |
|---|---|---|---|---|---|---|---|---|---|---|
| * | 12950.000 | 22.95 | peak | 17.30 | 40.25 | 74.00 | 150 | 279 | -33.75 | |

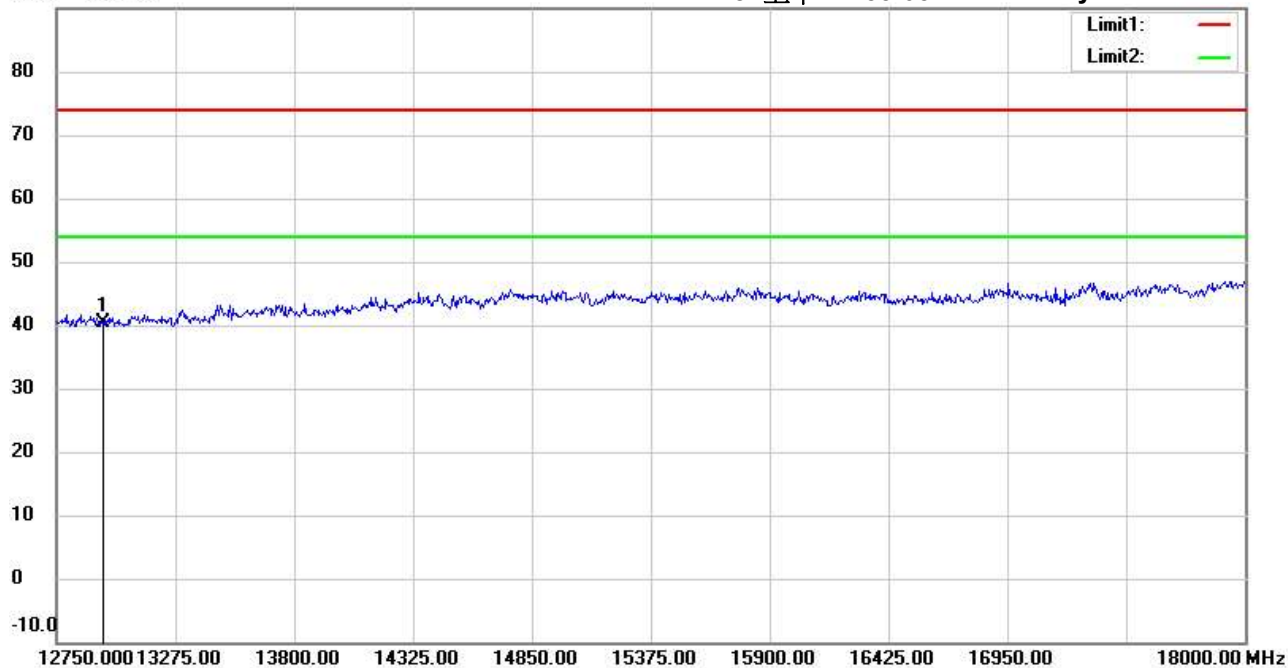
Data : #10

Test Mode : TX 802.11ax20 CH105

Polarization: Vertical

| Mk. | Frequency (MHz) | Reading (dBuV) | Detector | Corr. factor (dB/m) | Result (dBuV/m) | Limit (dBuV/m) | Ant.Pos (cm) | Tab.Pos (deg.) | Margin (dB) | Comment |
|---|---|---|---|---|---|---|---|---|---|---|
| * | 12950.000 | 23.06 | peak | 17.30 | 40.36 | 74.00 | 150 | 359 | -33.64 | |

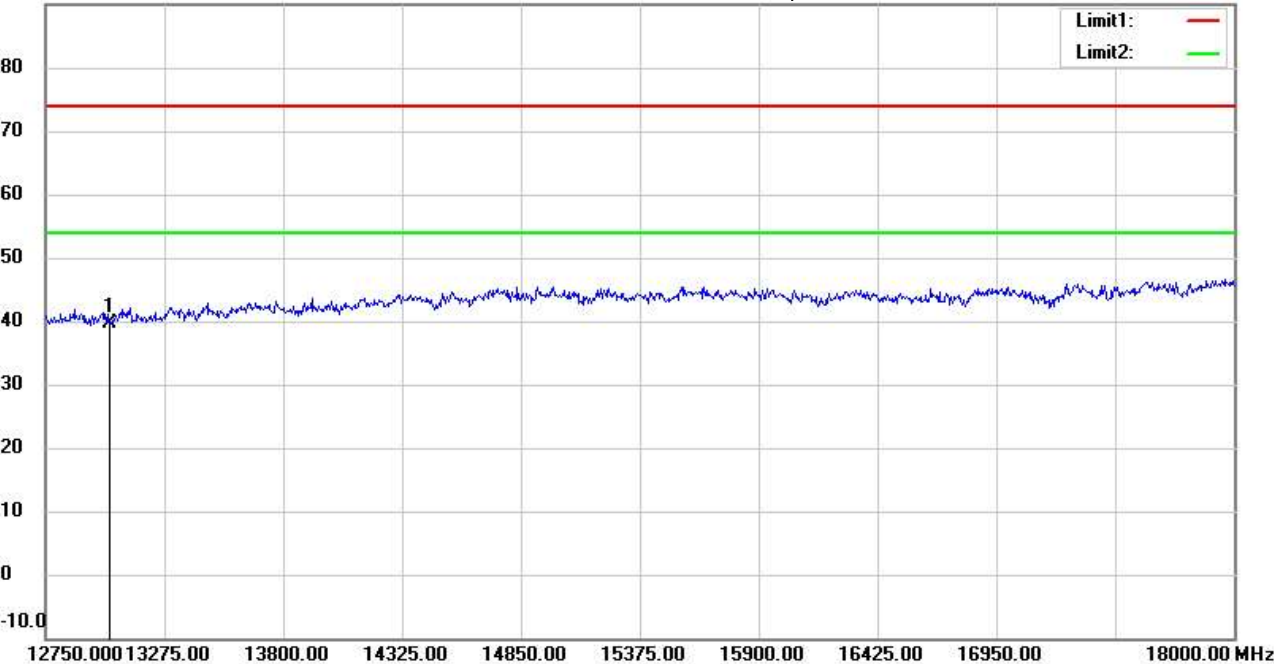
Data :#4

Test Mode : TX 802.11ax20 CH113

Polarization: **Horizontal**

| Mk. | Frequency (MHz) | Reading (dBuV) | Detector | Corr. factor (dB/m) | Result (dBuV/m) | Limit (dBuV/m) | Ant.Pos (cm) | Tab.Pos (deg.) | Margin (dB) | Comment |
|---|---|---|---|---|---|---|---|---|---|---|
| * | 13030.000 | 22.48 | peak | 17.10 | 39.58 | 74.00 | 150 | 359 | -34.42 | |
