# Photo Report on Test Setups

**Report Reference:** MDE\_PEIKER\_1801\_FCC03/04\_Photo\_Setups

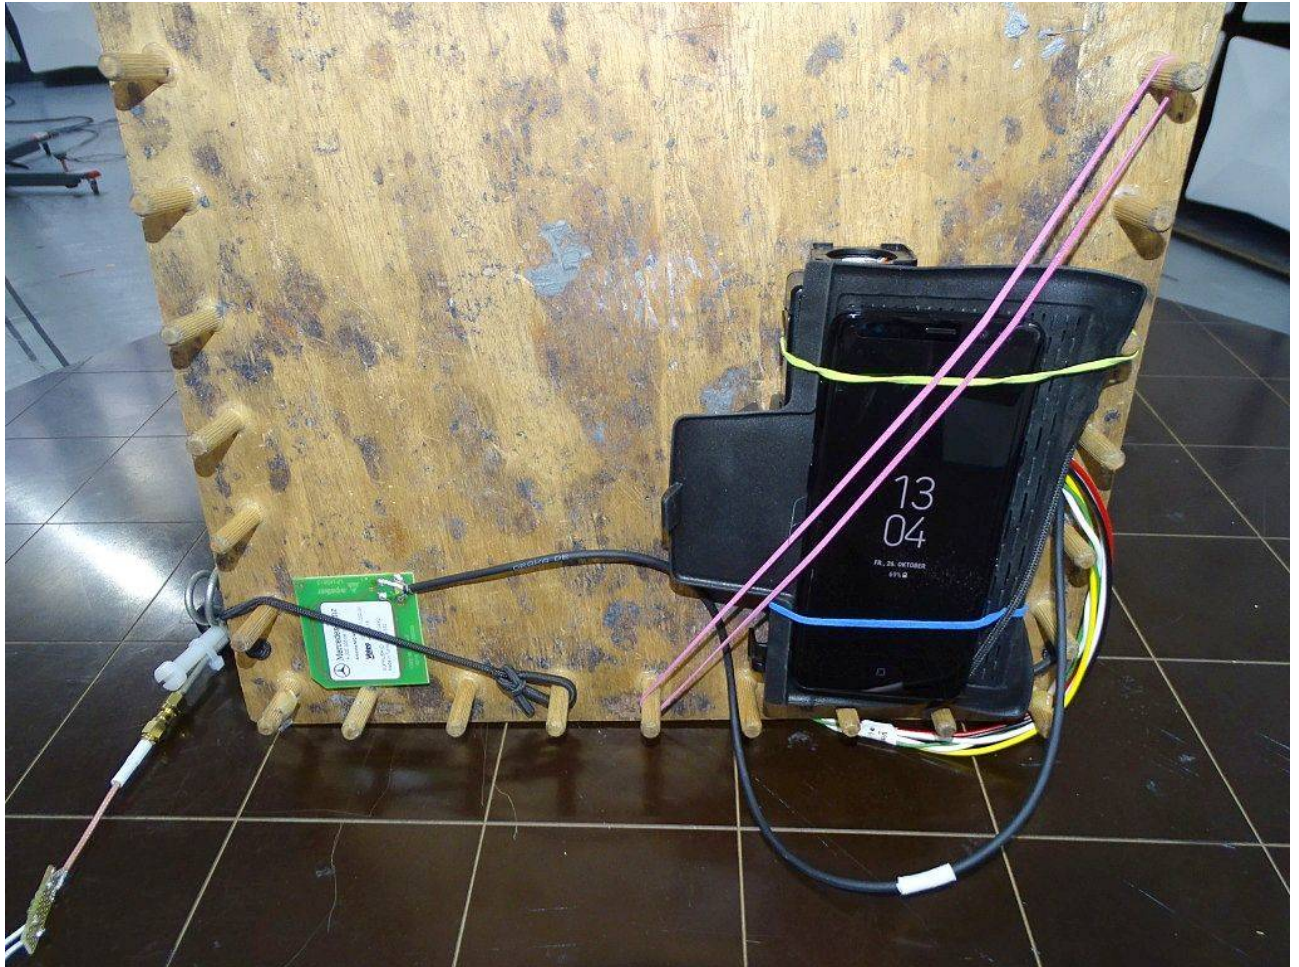
**Photo 6:** Test setup for radiated measurements (Enclosure, semi-anechoic chamber, NFC integral antenna, detail)
