### **APPENDIX 3: Photographs of test setup**

#### **Radiated Emission**

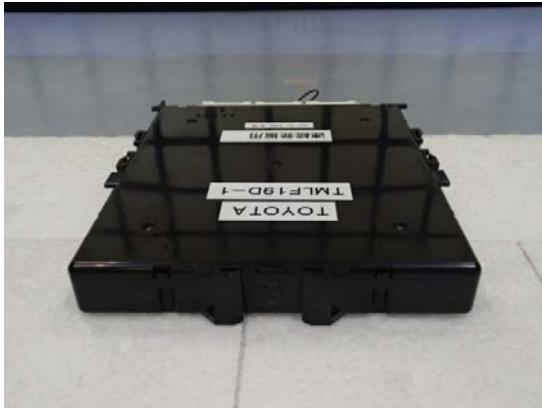
**X-axis**

ECU  
Below 30 MHz: X-axis  
Above 30 MHz (Horizontal: X / Vertical: X)
