### **APPENDIX 3: Photographs of test setup**

#### **Radiated Spurious Emission**

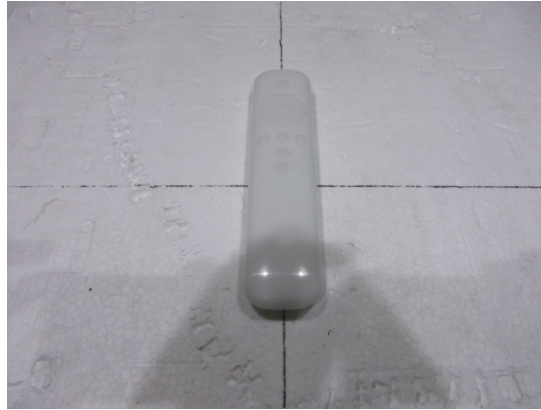
**X-axis**

### **Worst Case Position**

(Below 1 GHz: Horizontal: X-axis/ Vertical: X-axis)  
(Above 1 GHz: Horizontal: X-axis/ Vertical: Y-axis)
