Spurious Emissions at antenna terminal

Band Edges Compliance
Test result

Frequency Stability

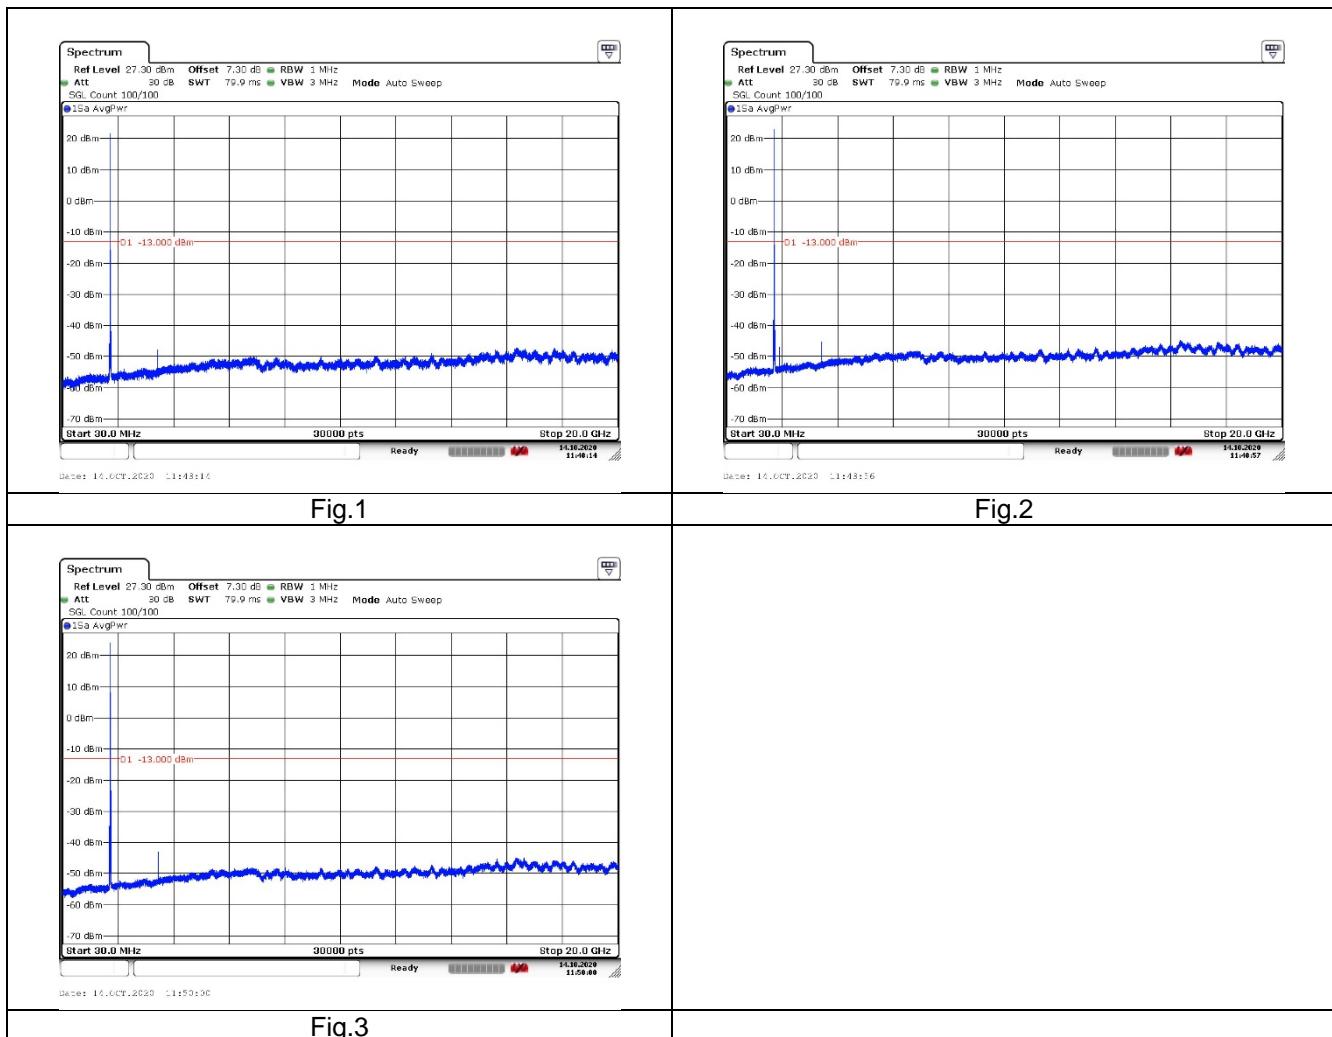
Band	Carrier frequency (MHz)	Channel	BW	RB Size	RB Offset	Conducted Spurious Plot
						QPSK
4	1720	20050	20	1	99	Fig.1
	1732.5	20175	20	1	99	Fig.2
	1745	20300	20	1	99	Fig.3

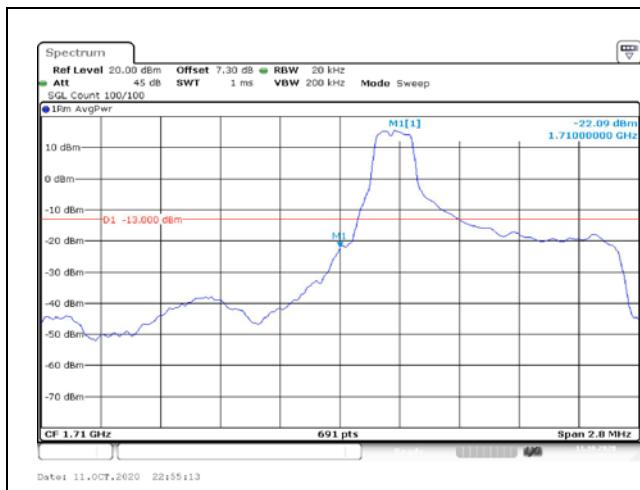
Band	Carrier frequency (MHz)	Channel	BW	RB Size	RB Offset	Band Edges Plot	
						QPSK	
4	1710.7	19957	1.4	1	0	Fig.1	
				6	0	Fig.2	
	1754.3	20393		1	5	Fig.3	
				6	0	Fig.4	
	1711.5	19965	3	1	0	Fig.5	
				15	0	Fig.6	
	1753.5	20385		1	14	Fig.7	
				15	0	Fig.8	
	1712.5	19975	5	1	0	Fig.9	
				25	0	Fig.10	
	1752.5	20375		1	24	Fig.11	
				25	0	Fig.12	
	1715	20000	10	1	0	Fig.13	
				50	0	Fig.14	
	1750	20350		1	49	Fig.15	
				50	0	Fig.16	
	1717.5	20025	15	1	0	Fig.17	
				75	0	Fig.18	
	1747.5	20325		1	74	Fig.19	
				75	0	Fig.20	
	1720	20050	20	1	0	Fig.21	
				100	0	Fig.22	
	1745	20300		1	99	Fig.23	
				100	0	Fig.24
