## Test Graphs

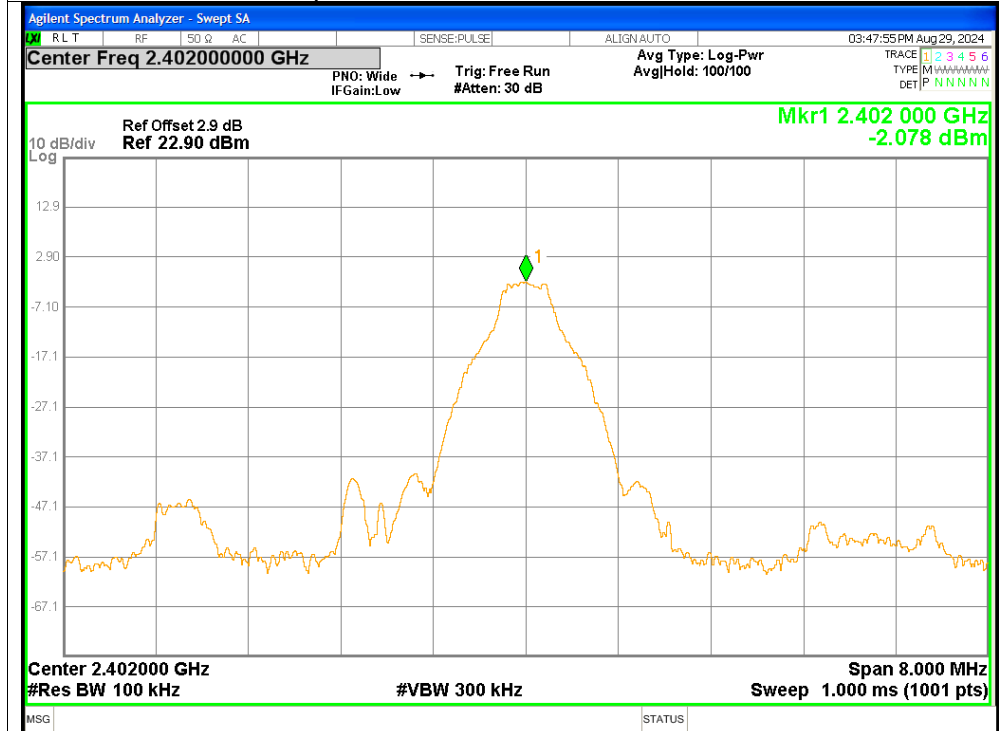
## Tx. Spurious NVNT 1-DH5 2402MHz Ref

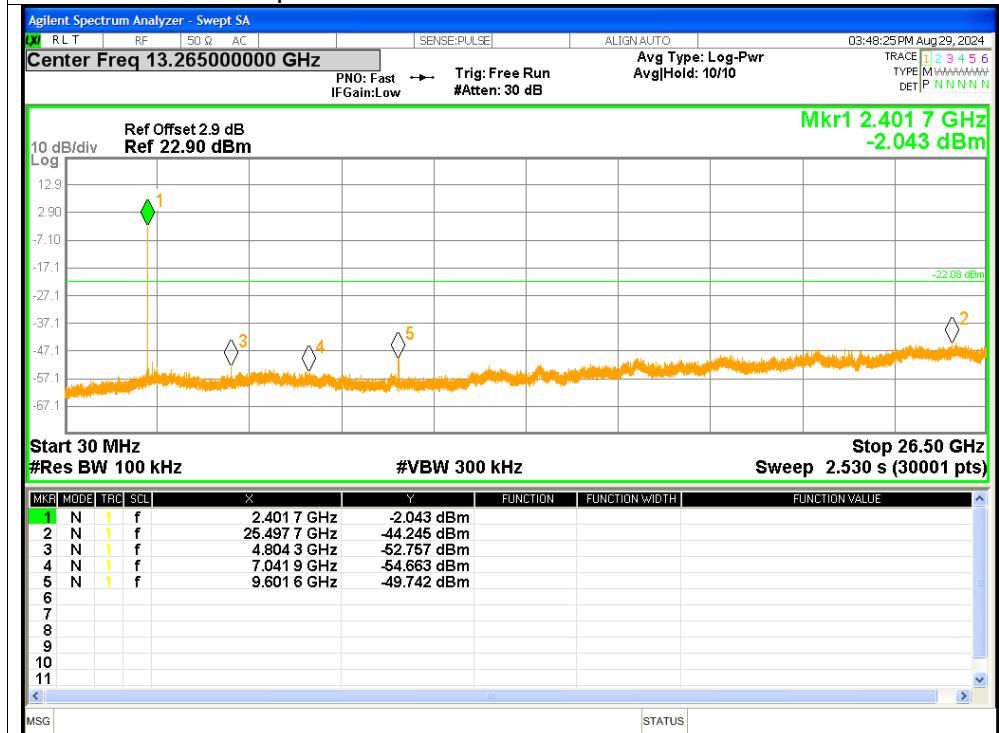
## Tx. Spurious NVNT 1-DH5 2402MHz Emission

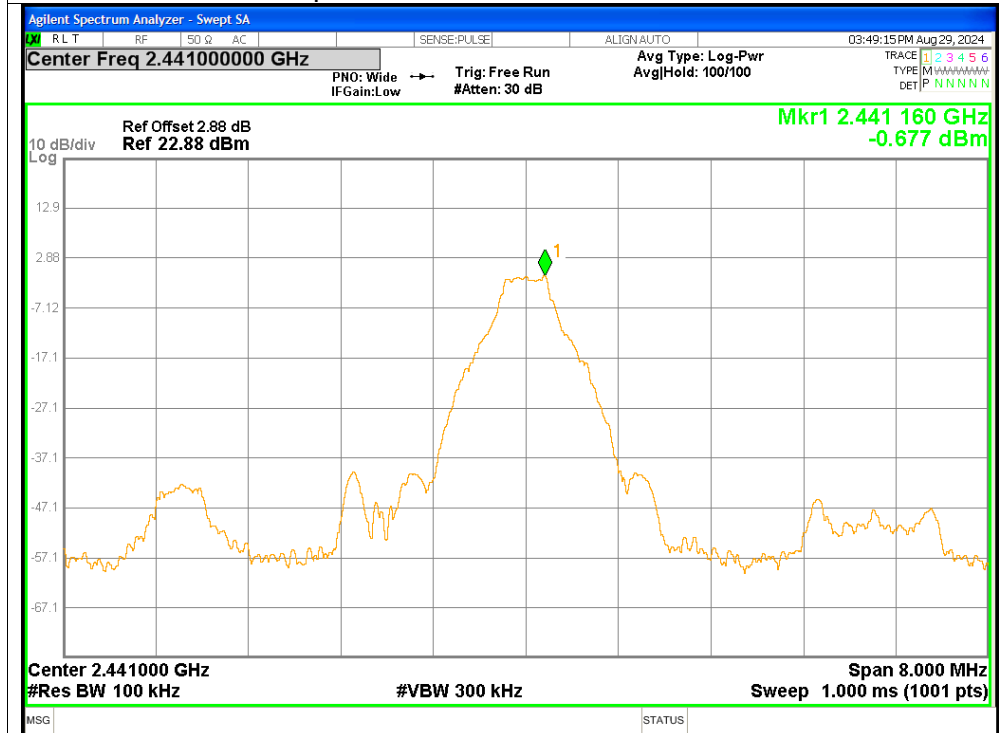
## Tx. Spurious NVNT 1-DH5 2441MHz Ref

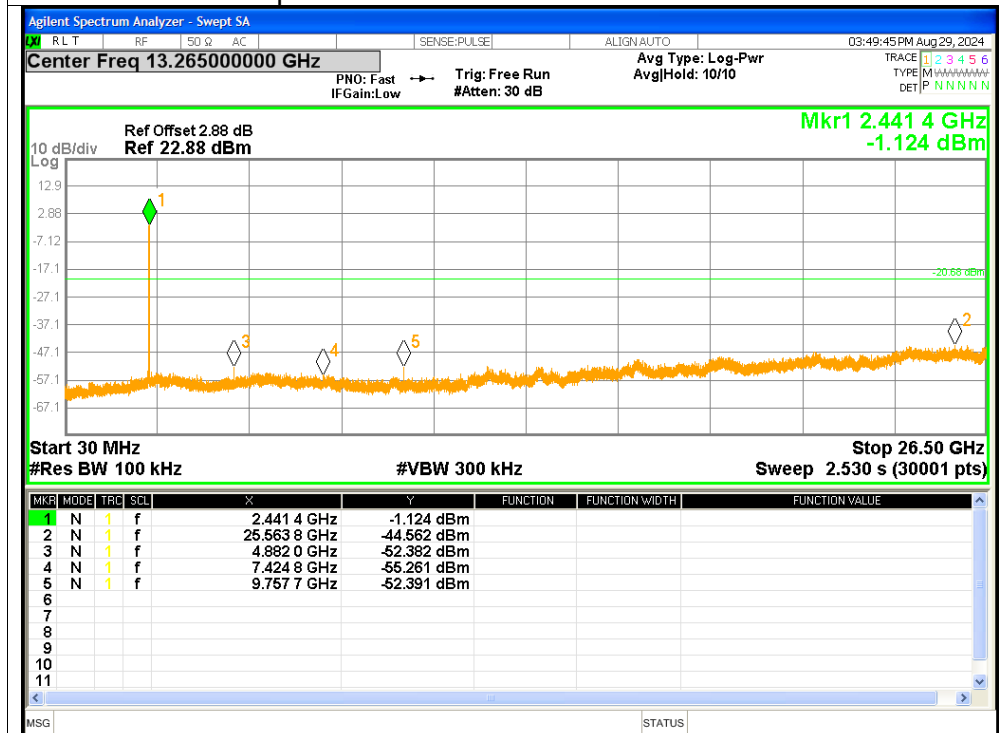
## Tx. Spurious NVNT 1-DH5 2441MHz Emission

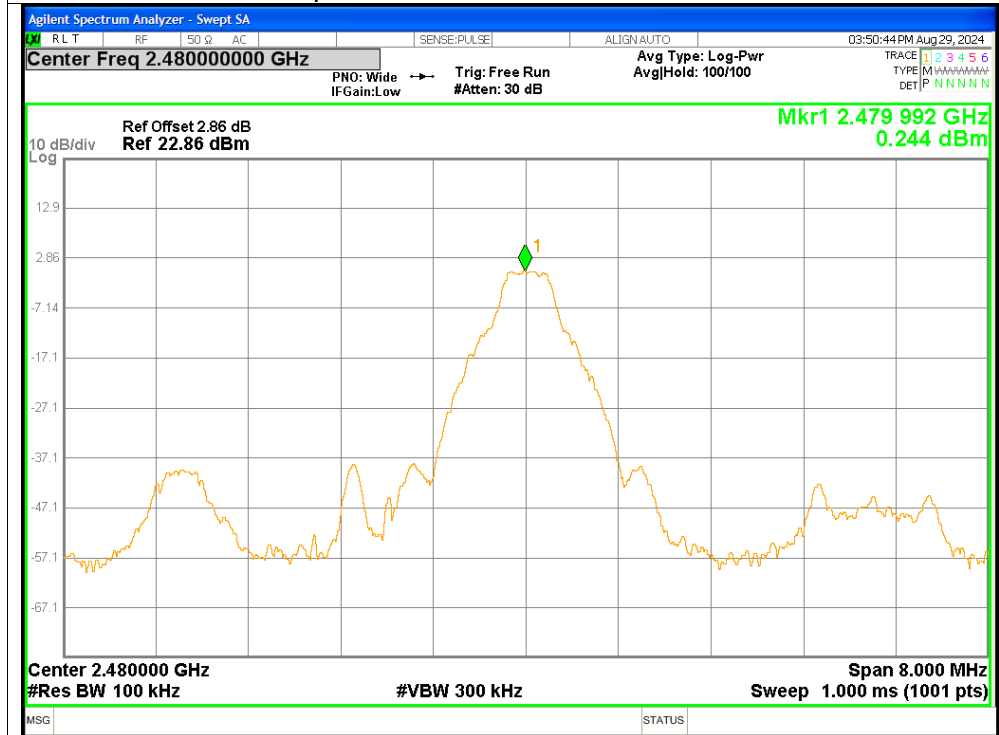
## Tx. Spurious NVNT 1-DH5 2480MHz Ref

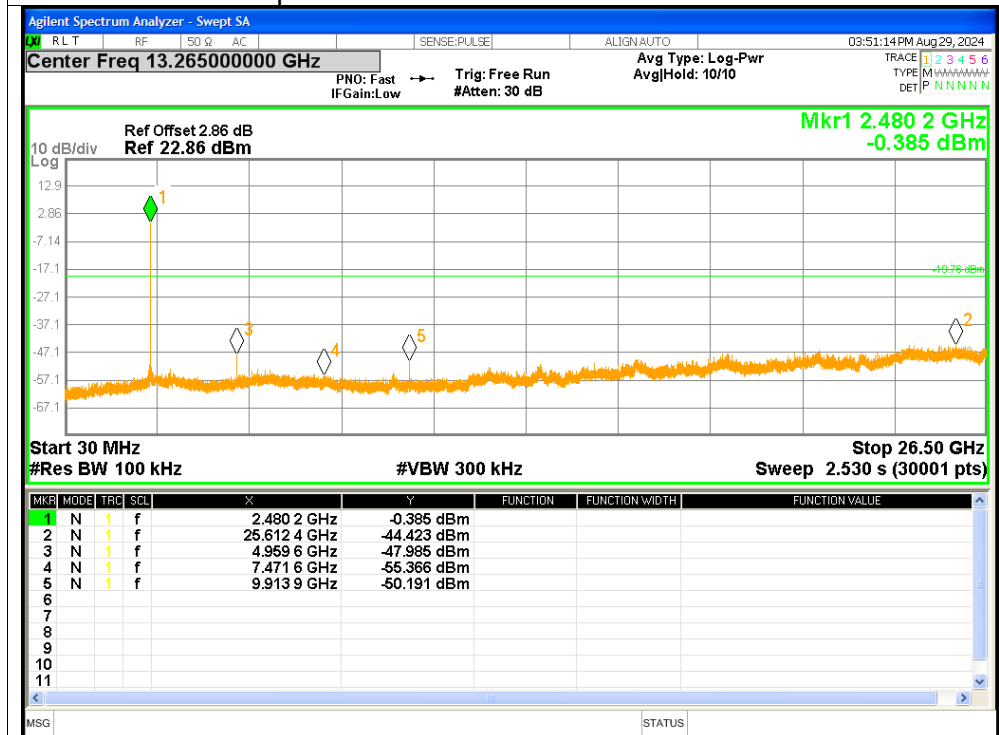
## Tx. Spurious NVNT 1-DH5 2480MHz Emission

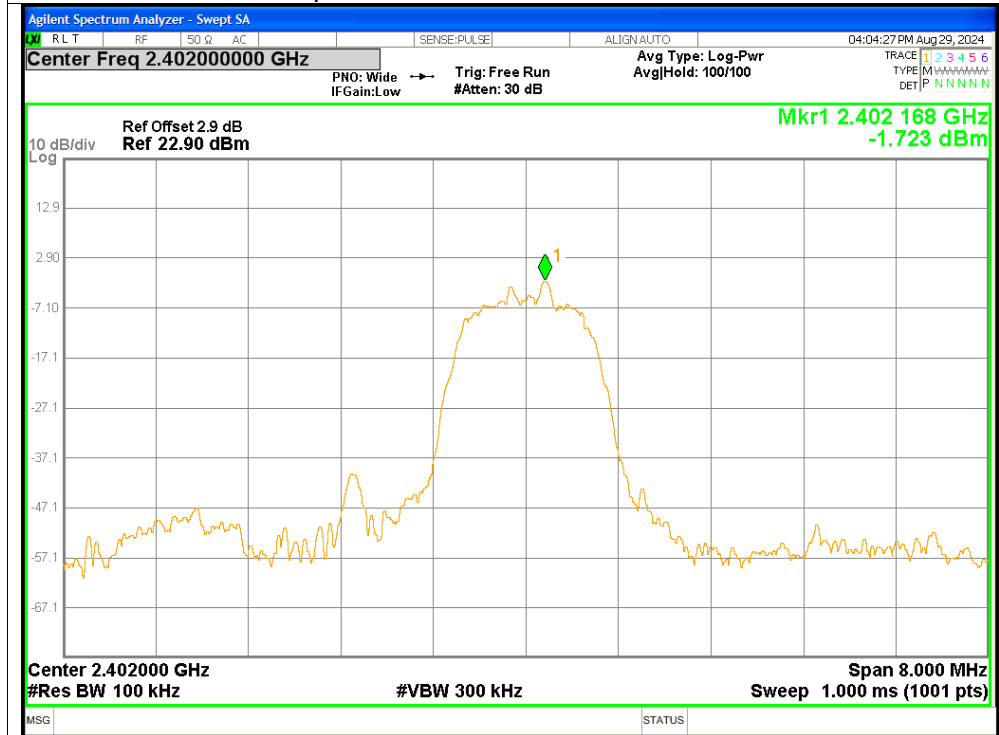
## Tx. Spurious NVNT 2-DH5 2402MHz Ref

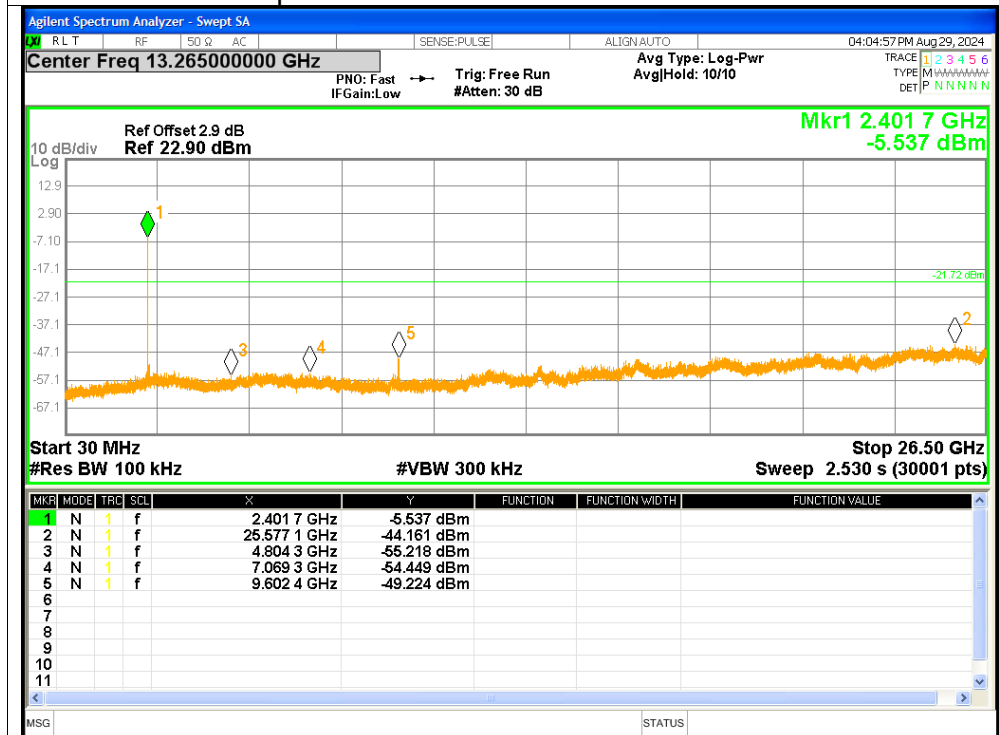
## Tx. Spurious NVNT 2-DH5 2402MHz Emission

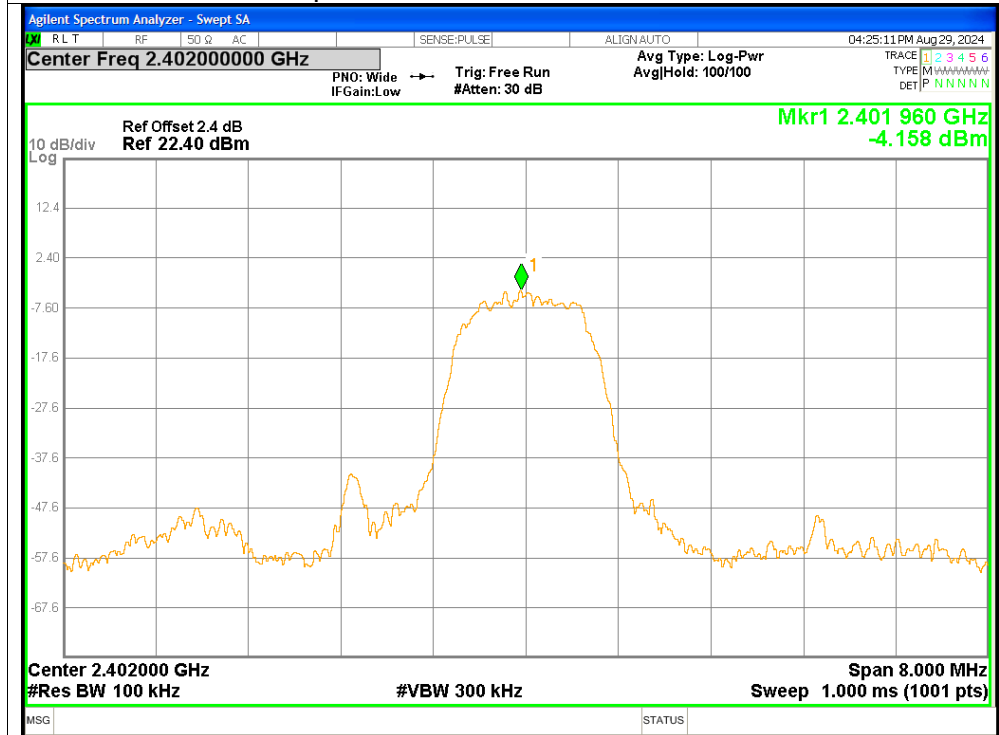
## Tx. Spurious NVNT 3-DH5 2402MHz Ref

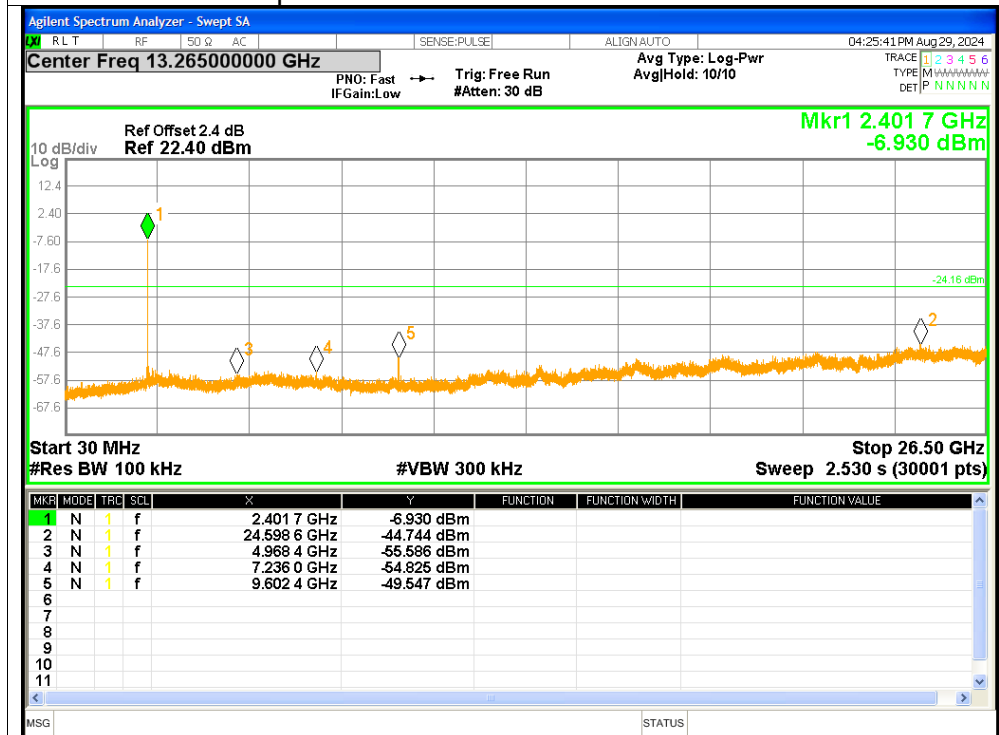
## Tx. Spurious NVNT 3-DH5 2402MHz Emission

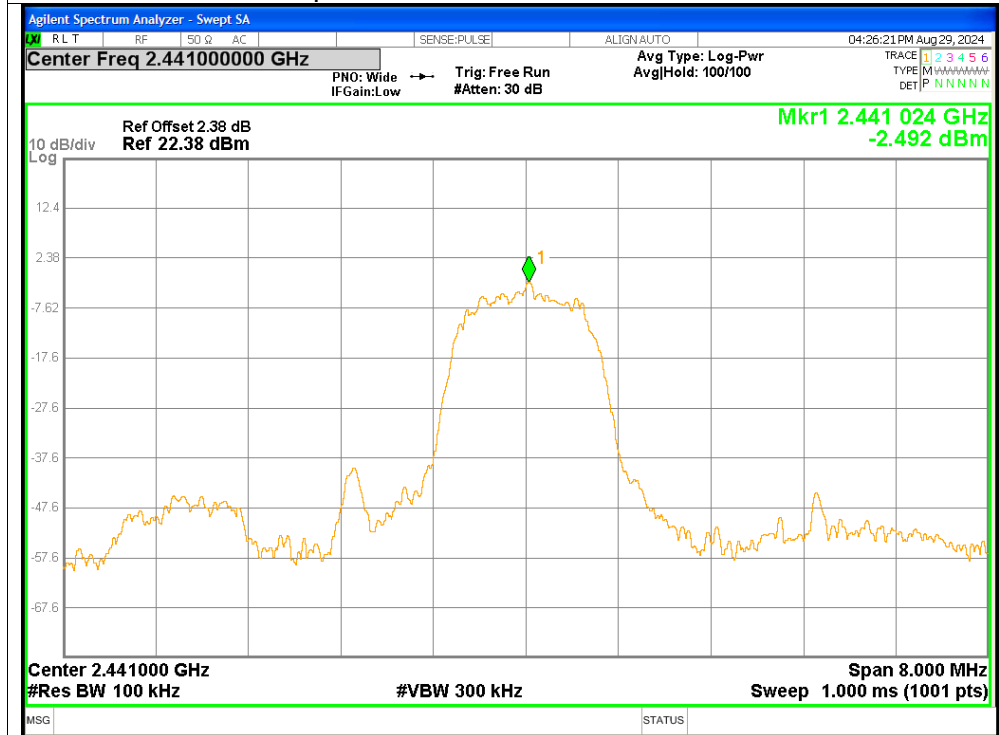
## Tx. Spurious NVNT 3-DH5 2441MHz Ref

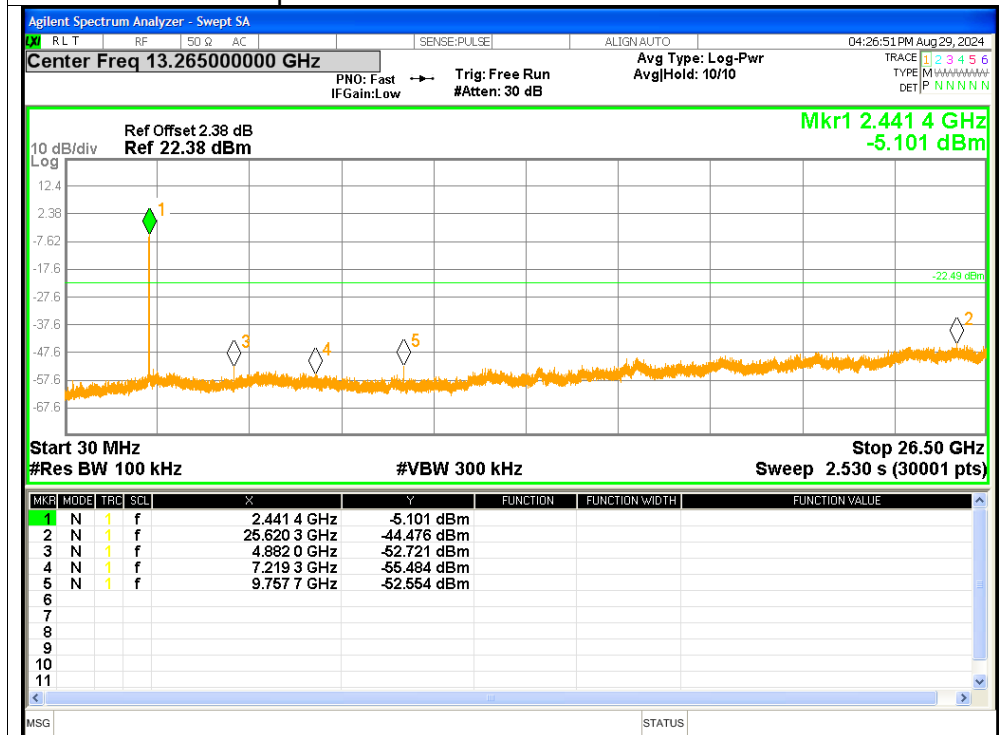
## Tx. Spurious NVNT 3-DH5 2441MHz Emission

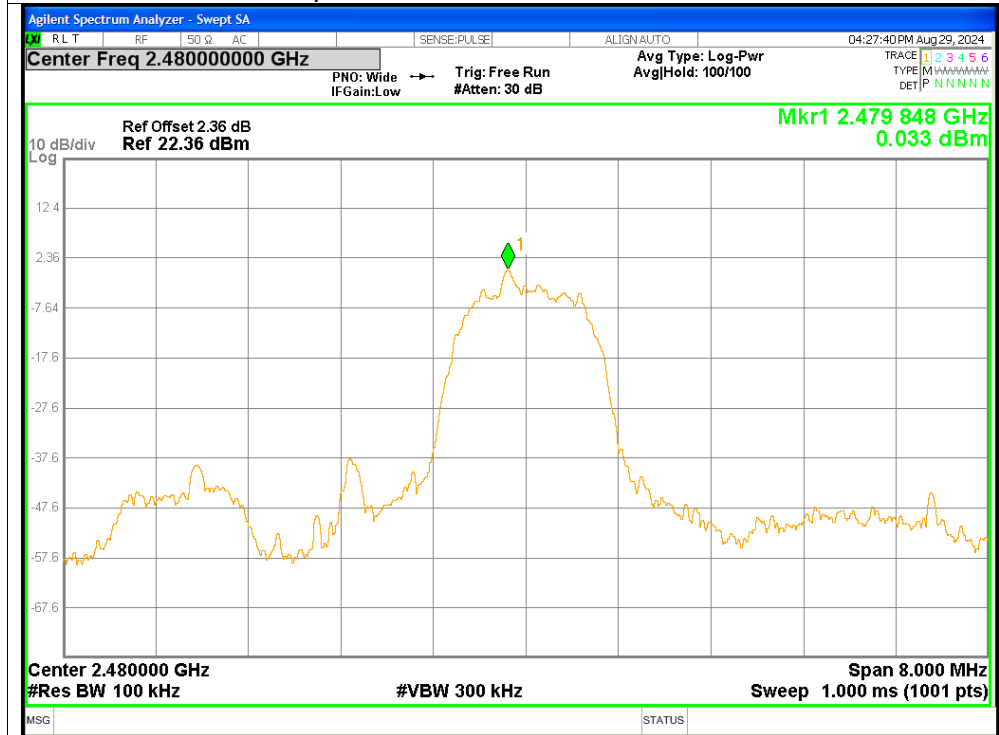
## Tx. Spurious NVNT 3-DH5 2480MHz Ref

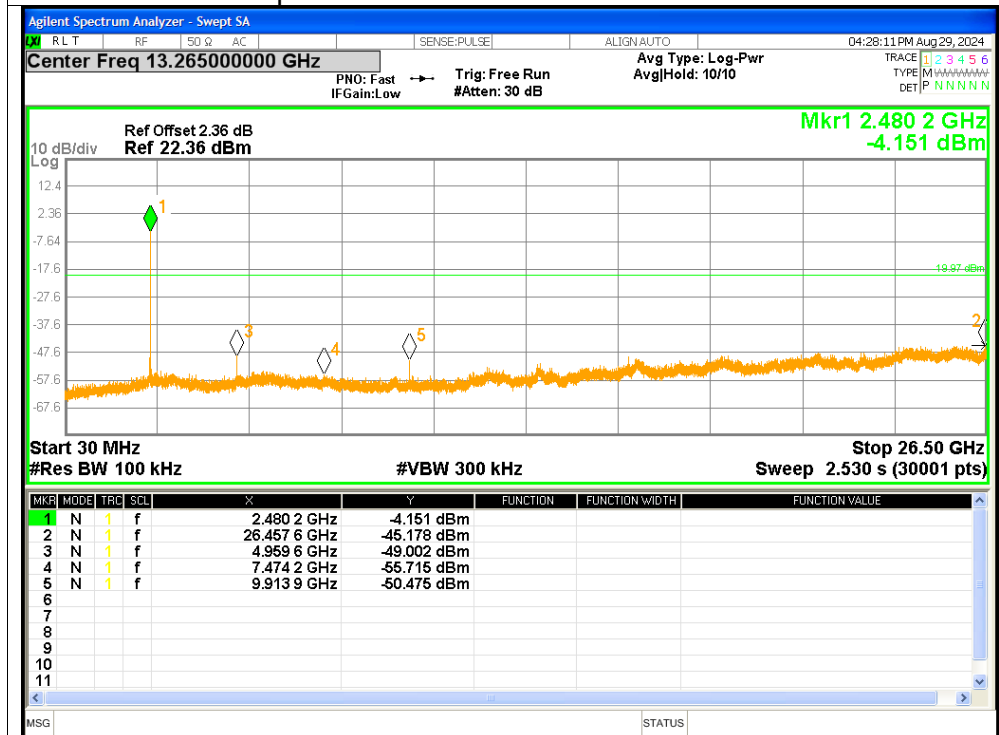
## Tx. Spurious NVNT 3-DH5 2480MHz Emission
