# Radiated Emission Measurement

Condition : ETSI EN300\_422-RX\_Spurious

EUT : W6M22405-23507

Test Mode : Rx 607MHz

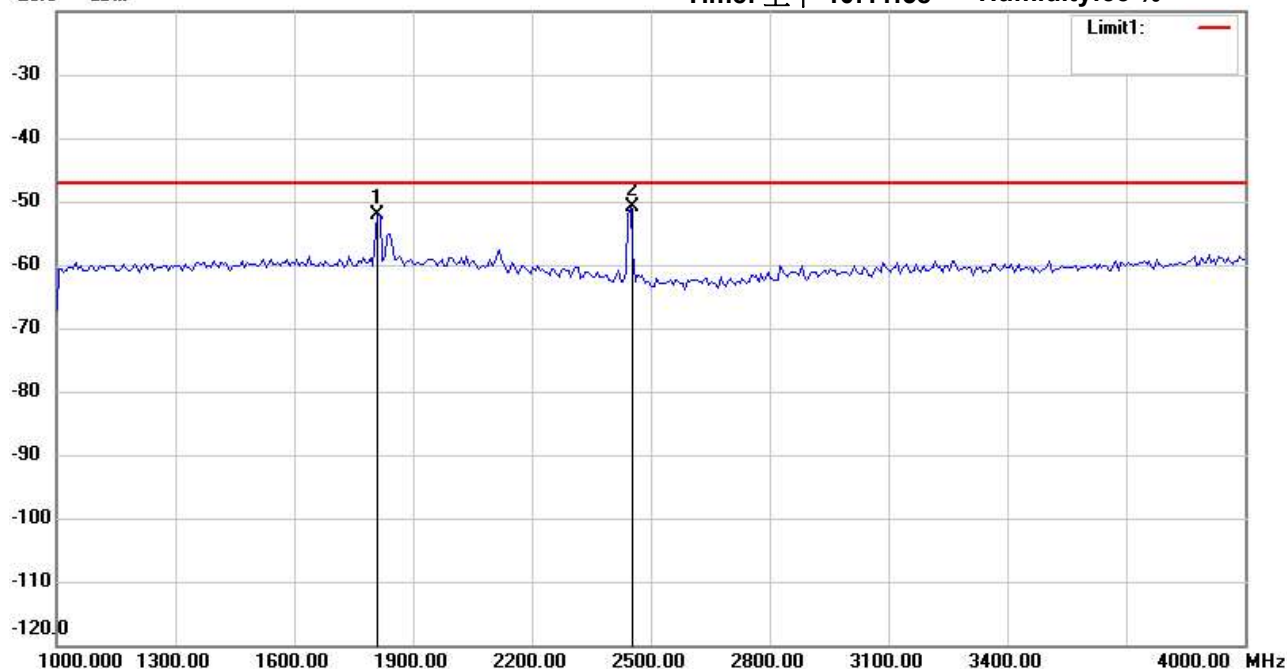
Data : #1

Site : 966A Chamber

Polarization: **Horizontal**

Distance: 3m

| Mk. | Frequency (MHz) | Reading (dBm) | Detector | Corr. factor (dB) | Result (dBm) | Limit (dBm) | Ant.Pos (cm) | Tab.Pos (deg.) | Margin (dB) | Comment |
|---|---|---|---|---|---|---|---|---|---|---|
| | 1811.623 | -55.74 | peak | 3.72 | -52.02 | -47.00 | 150 | 155 | -5.02 | |
| * | 2448.898 | -52.04 | peak | 1.25 | -50.79 | -47.00 | 150 | 105 | -3.79 | |

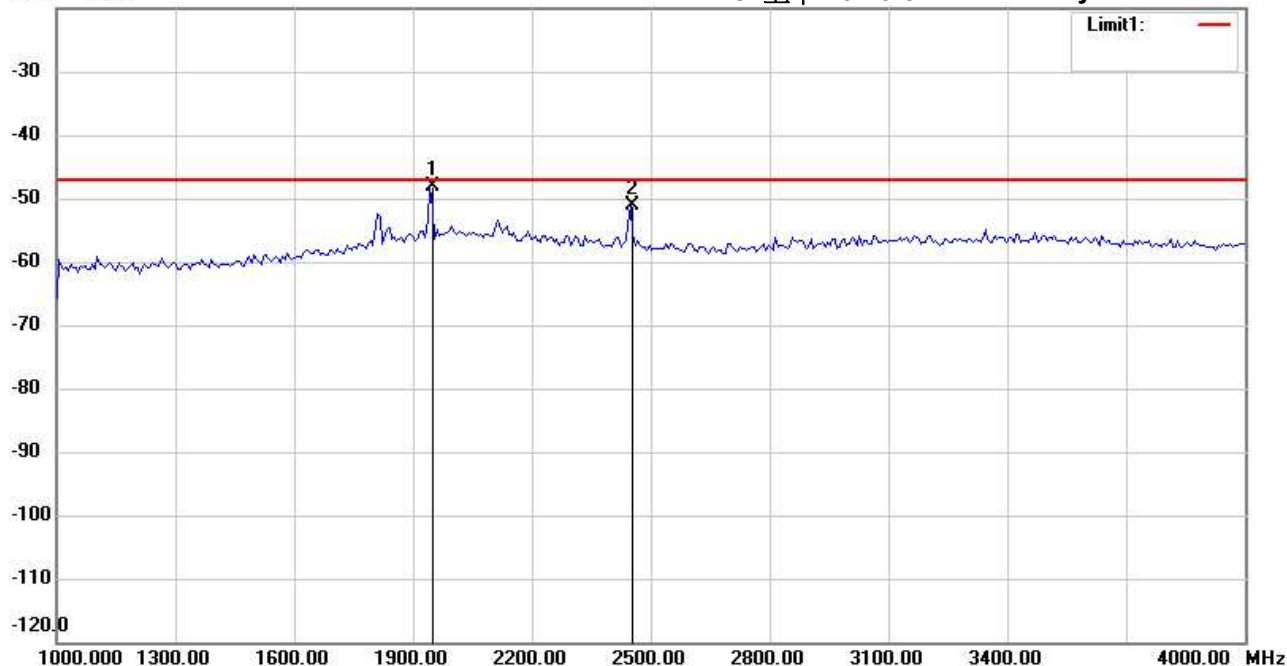
Data : #2

Site : 966A Chamber

Condition : ETSI EN300\_422-RX\_Spurious

Test Mode : Rx 607MHz

Polarization: Vertical

Distance: 3m

| Mk. | Frequency (MHz) | Reading (dBm) | Detector | Corr. factor (dB) | Result (dBm) | Limit (dBm) | Ant.Pos (cm) | Tab.Pos (deg.) | Margin (dB) | Comment |
|---|---|---|---|---|---|---|---|---|---|---|
| * | 1943.888 | -55.79 | peak | 7.75 | -48.04 | -47.00 | 150 | 245 | -1.04 | |
| | 2448.898 | -57.38 | peak | 6.38 | -51.00 | -47.00 | 150 | 305 | -4.00 | |
