### **APPENDIX 3: Photographs of Test Setup**

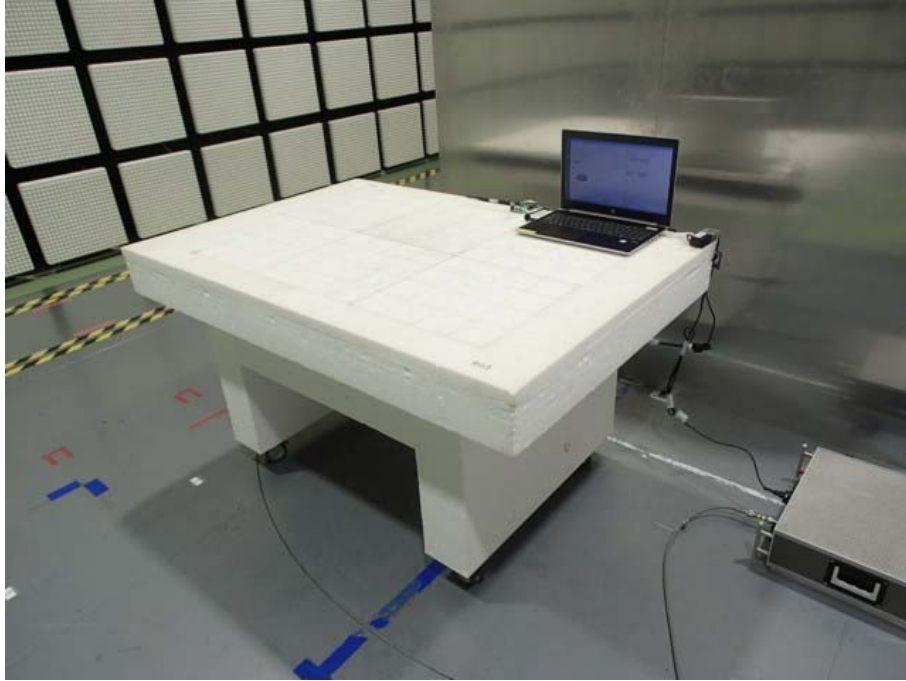
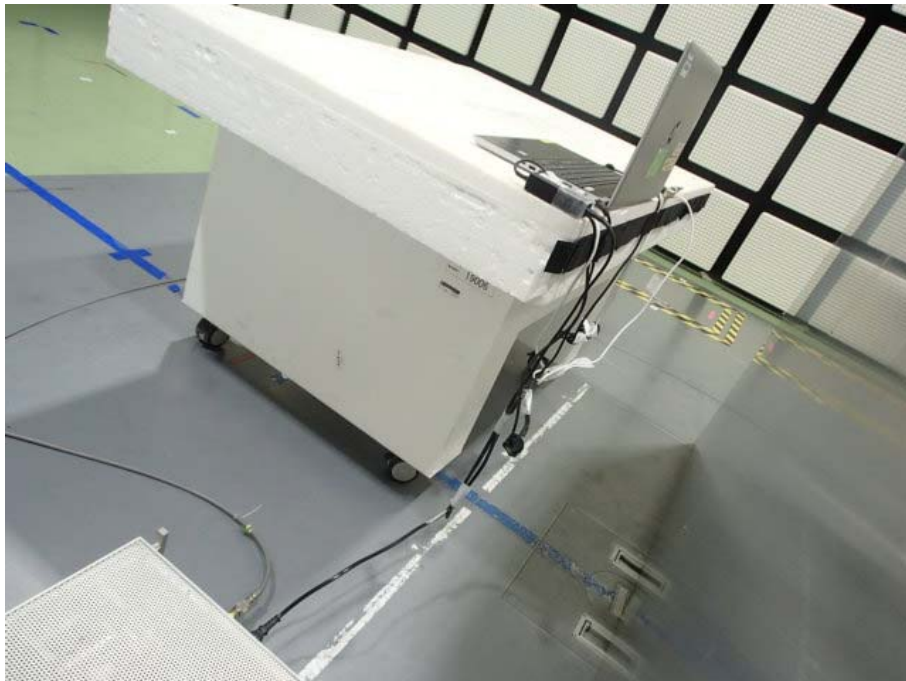
#### **Conducted Emission**

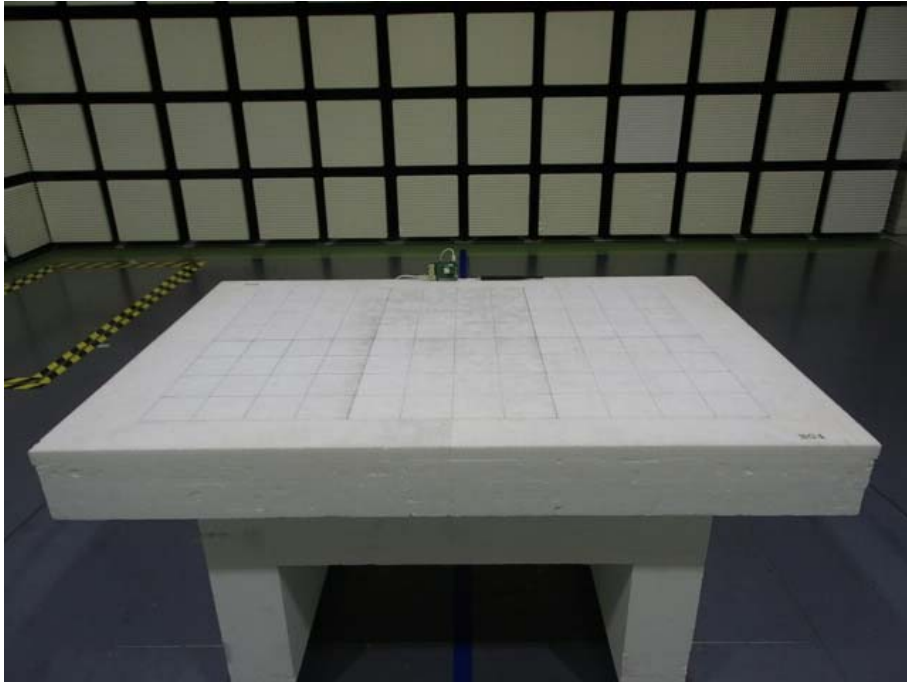
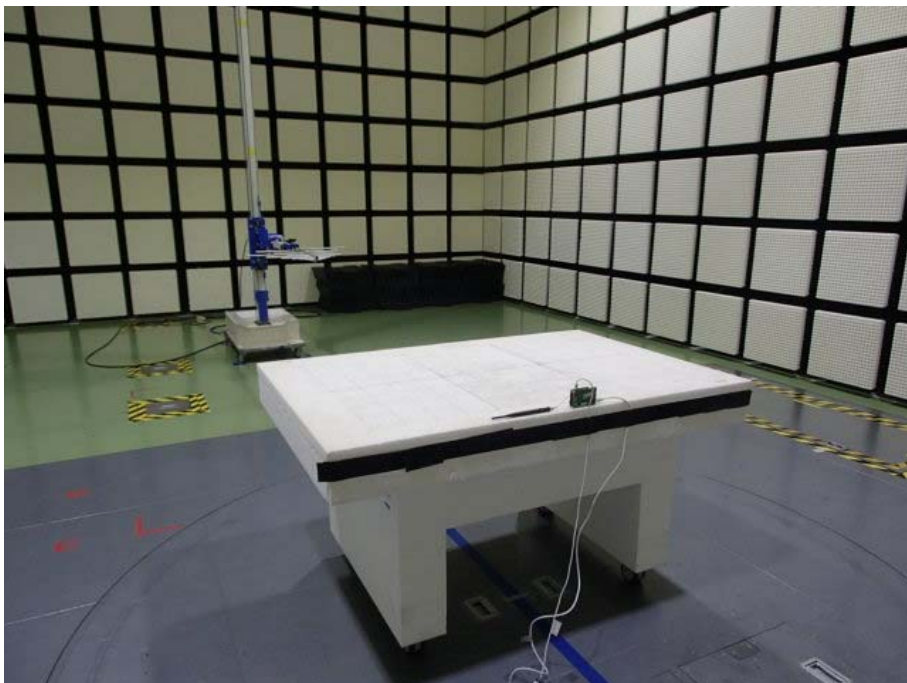
**Radiated Spurious Emission**  
(Below 1 GHz)

#### **(Below 1 GHz)**

(Module: Horizontal: Y-axis / Vertical: Y-axis)  
(Antenna: Horizontal: Z0-axis / Vertical: Y0-axis)

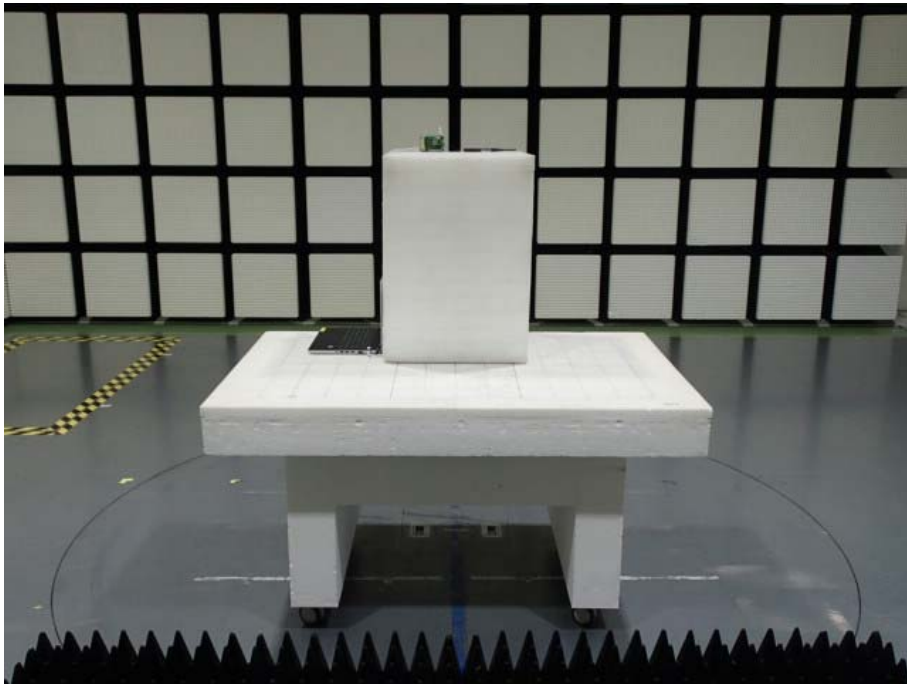
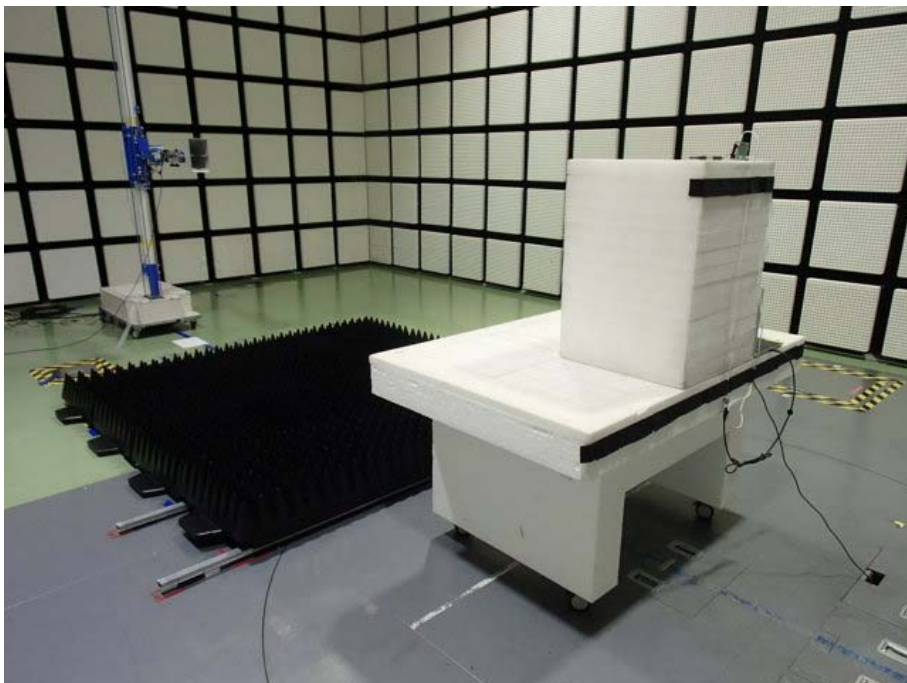
**Radiated Spurious Emission**  
(Above 1 GHz)

#### **(Above 1 GHz)**

(Module: Horizontal: Y-axis / Vertical: Y-axis)  
(Antenna: Horizontal: Z0-axis / Vertical: Y0-axis)

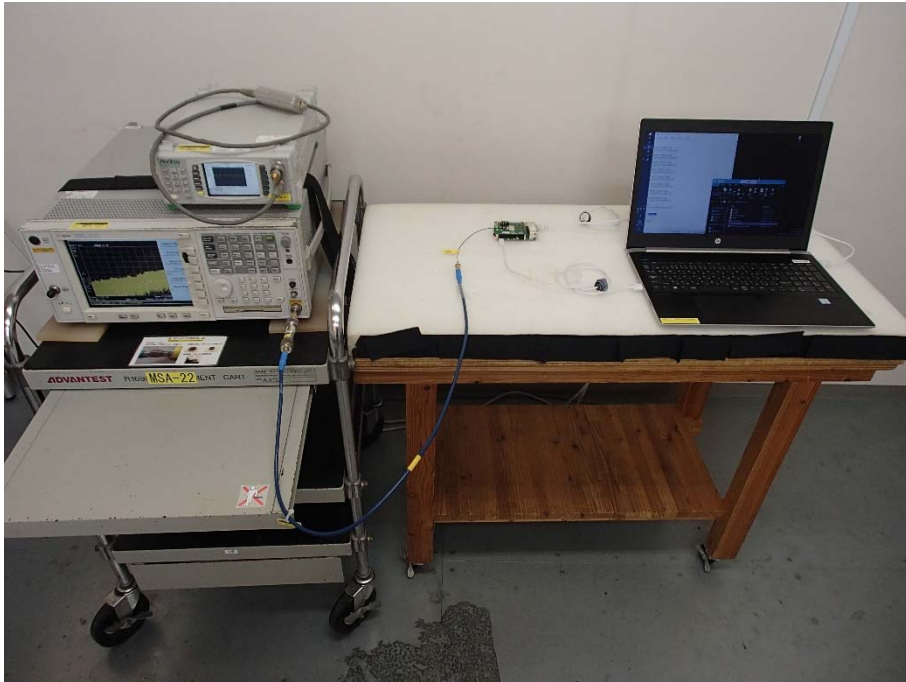
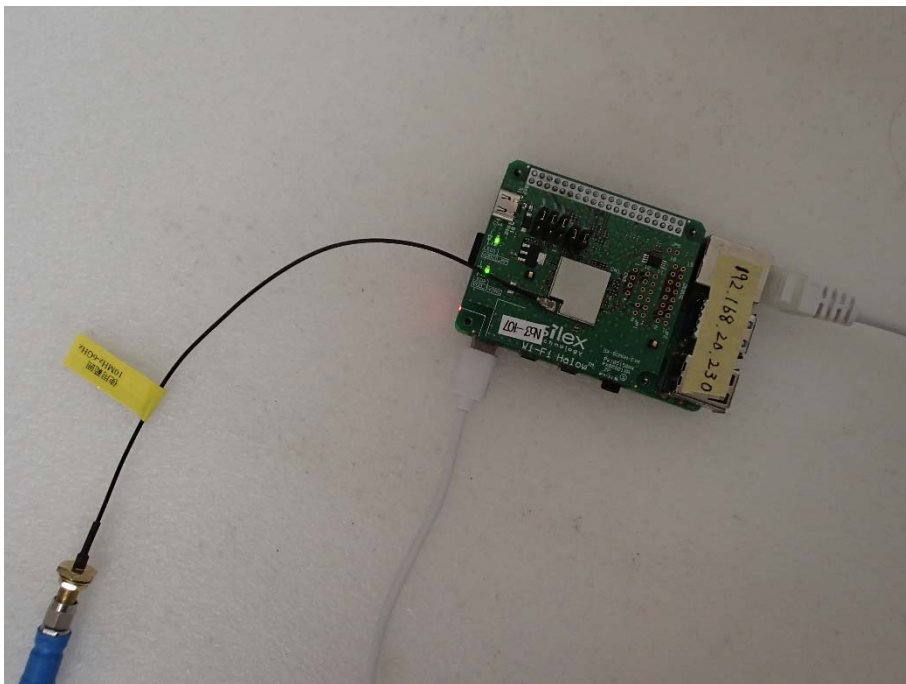
### Antenna Terminal Conducted Tests
