**FCC PART 15 SUBPART B TEST REPORT**

**Notebook Computer**

**Model No.: RS13**

**Report No.: W6M21904-18981-P-15B**

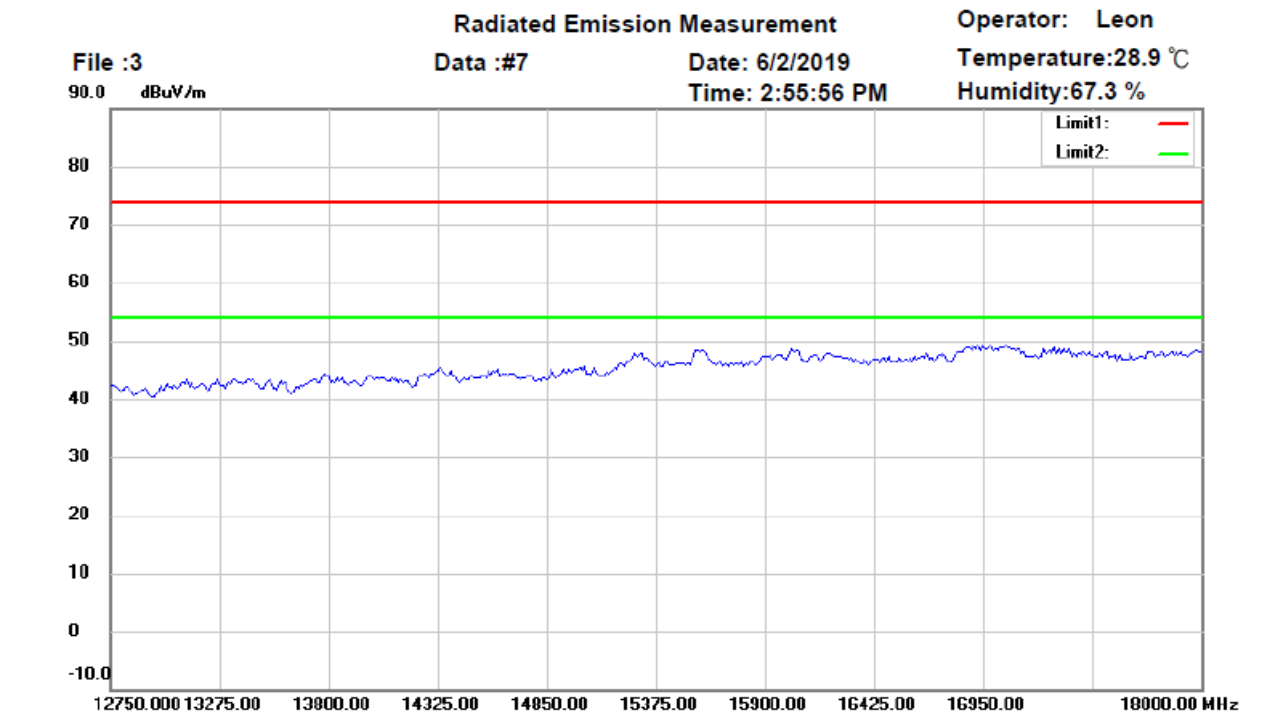
Site : 966 Chamber

Condition : FCC\_part 15 RE-Class B\_Above 1GHz\_PK

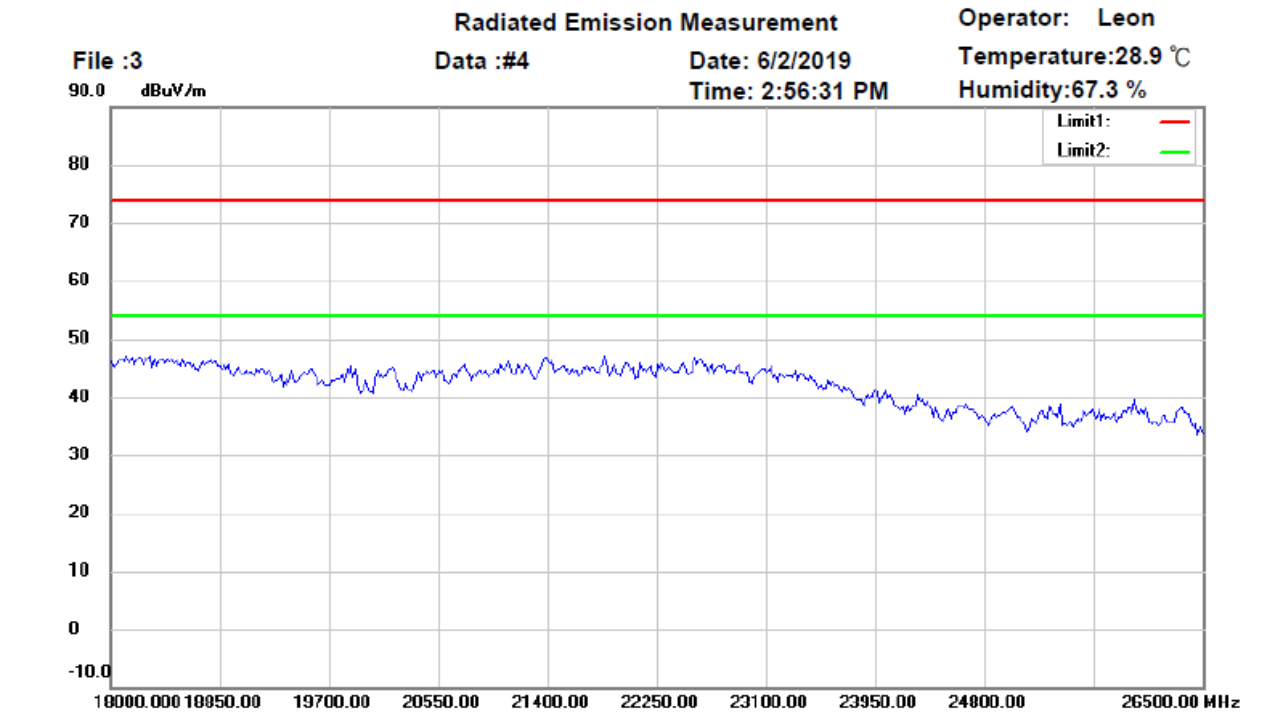
Site : 966 Chamber

Condition : FCC\_part 15 RE-Class B\_Above 1GHz\_PK

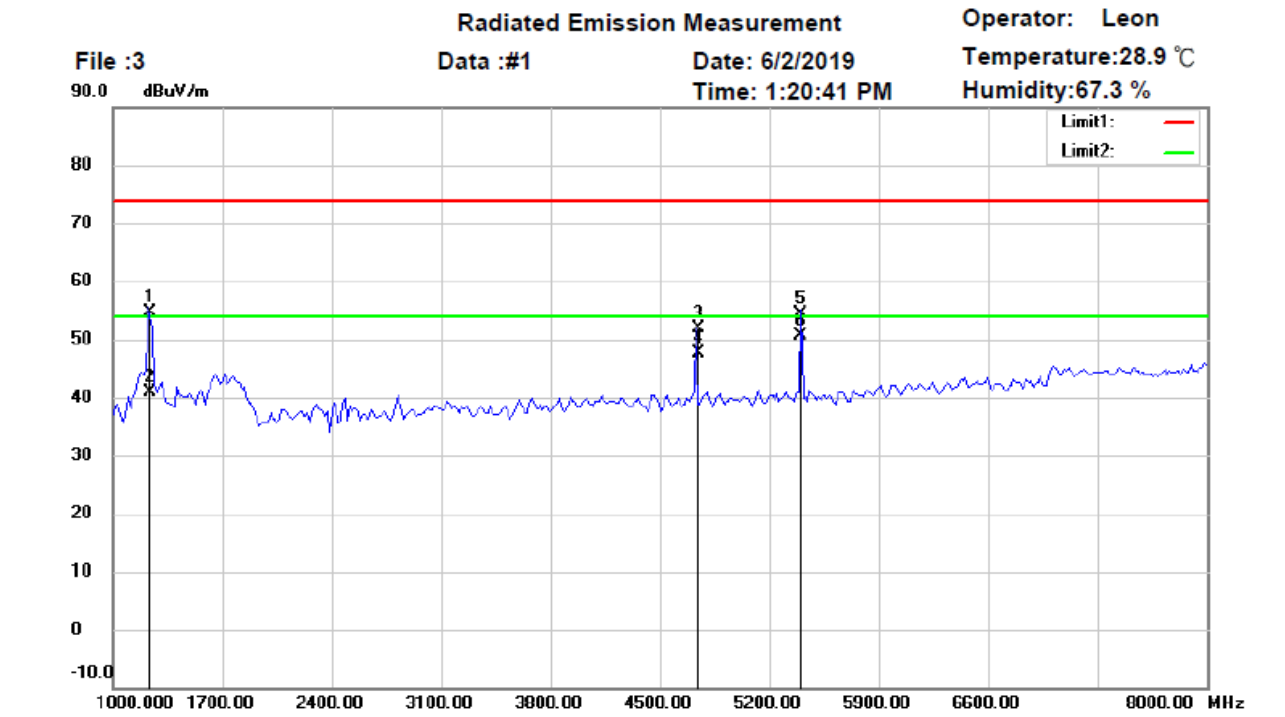
Site : 966 Chamber

Condition : FCC\_part 15 RE-Class B\_Above 1GHz\_PK

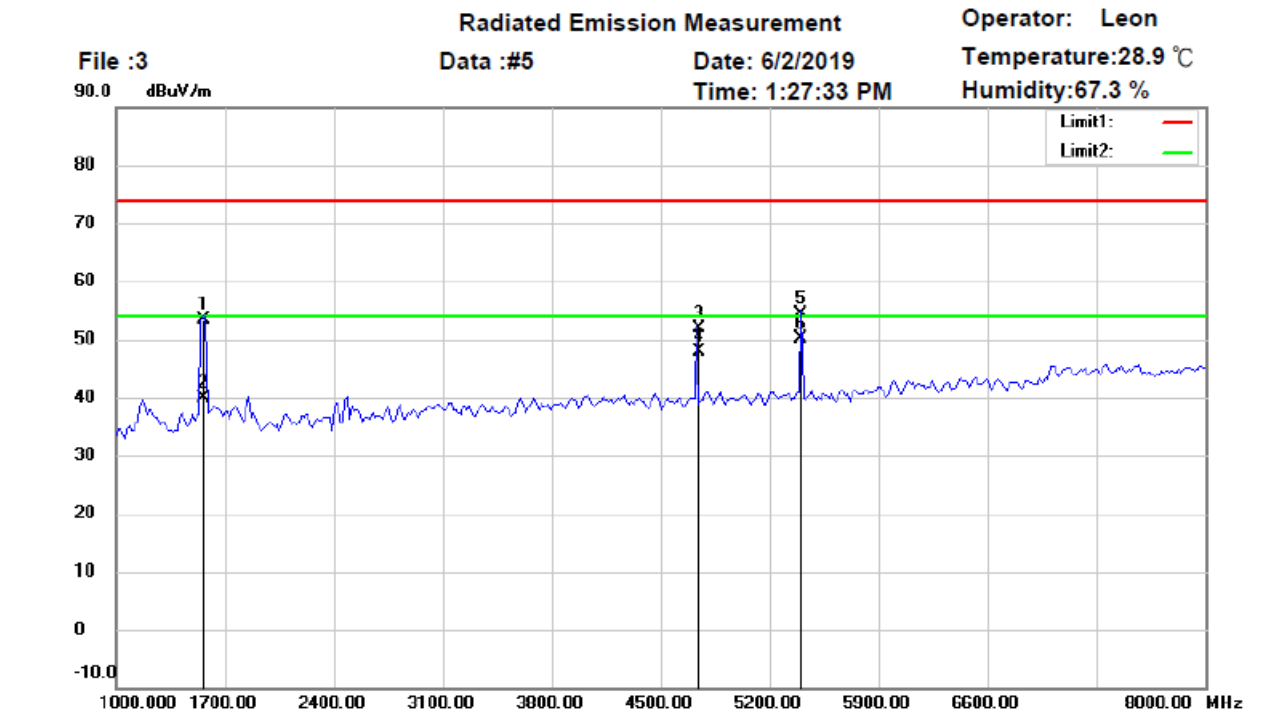
Site : 966 Chamber

Condition : FCC\_part 15 RE-Class B\_Above 1GHz\_PK

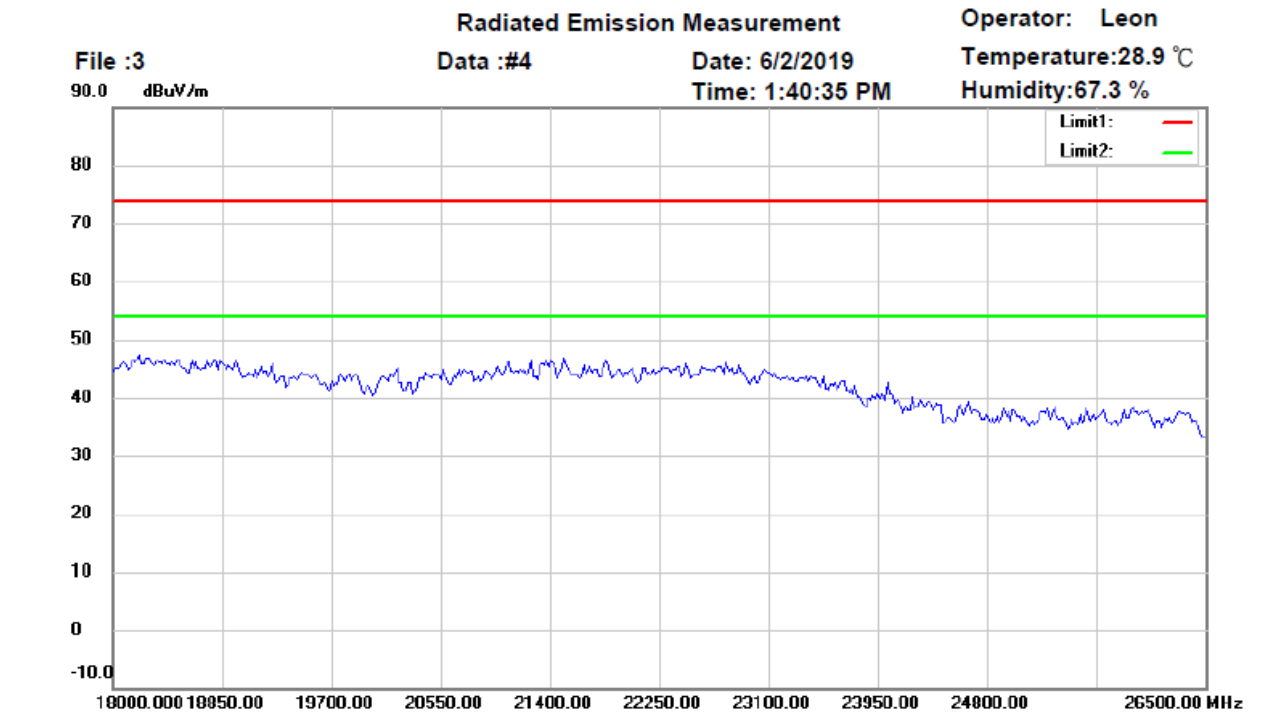
Site : 966 Chamber

Condition : FCC\_part 15 RE-Class B\_Above 1GHz\_PK

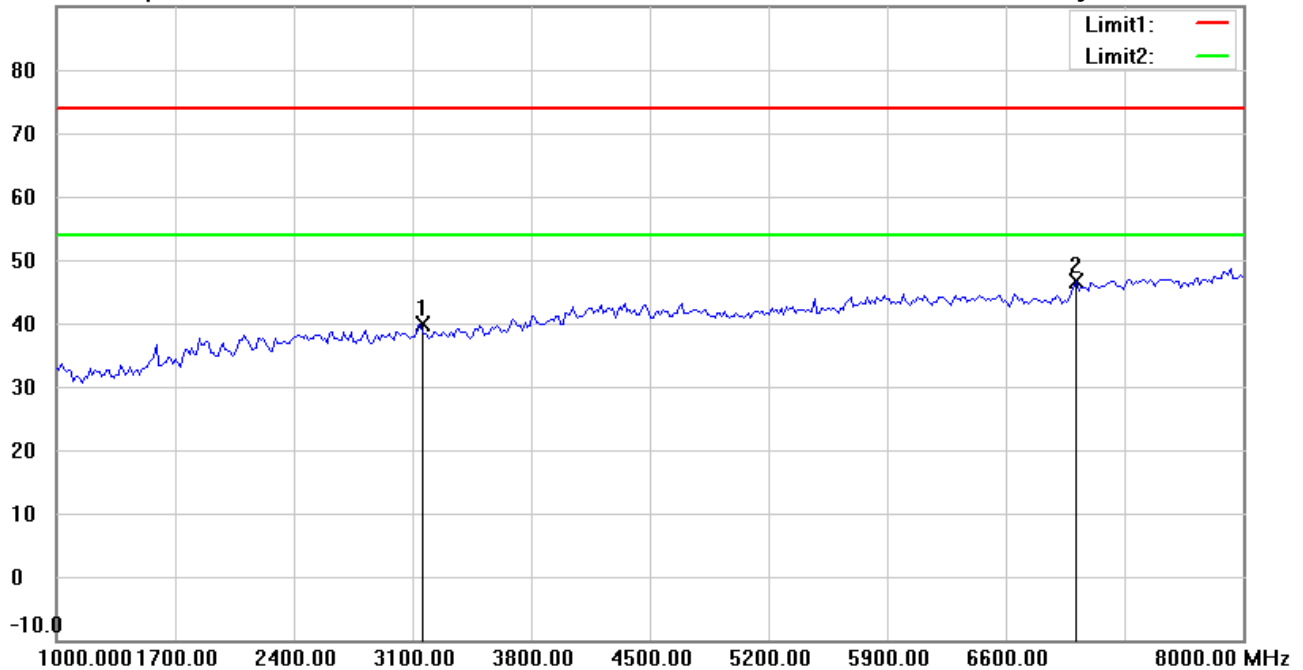
Site : Chamber

Condition : FCC\_part 15 RE-Class B\_Above 1GHz\_PK

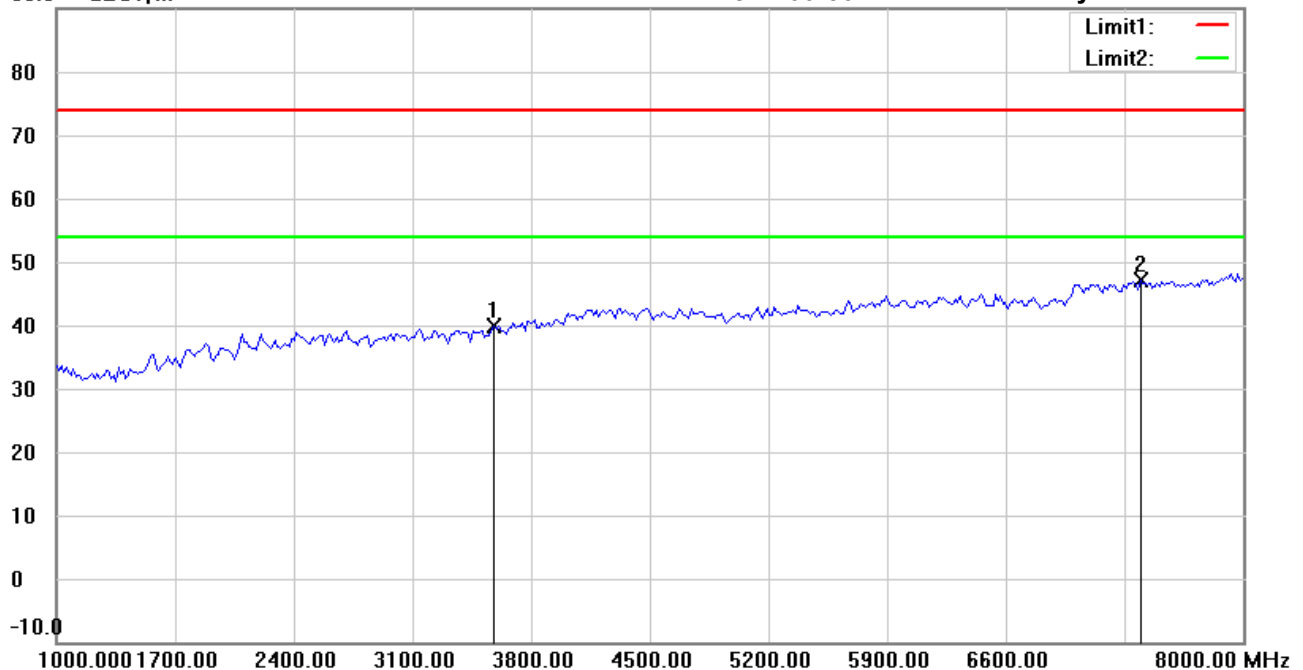
Site : Chamber

Condition : FCC\_part 15 RE-Class B\_Above 1GHz\_PK
