# **47 CFR PART 15 SUBPART E TEST REPORT**

**Panel PC**

**Model No.: TD-107XXXXXX (where "X" may be any  
alphanumeric, blank "\_" or "-" for marketing purpose only)**

**Report No.: W6M22203-21702-C-4**

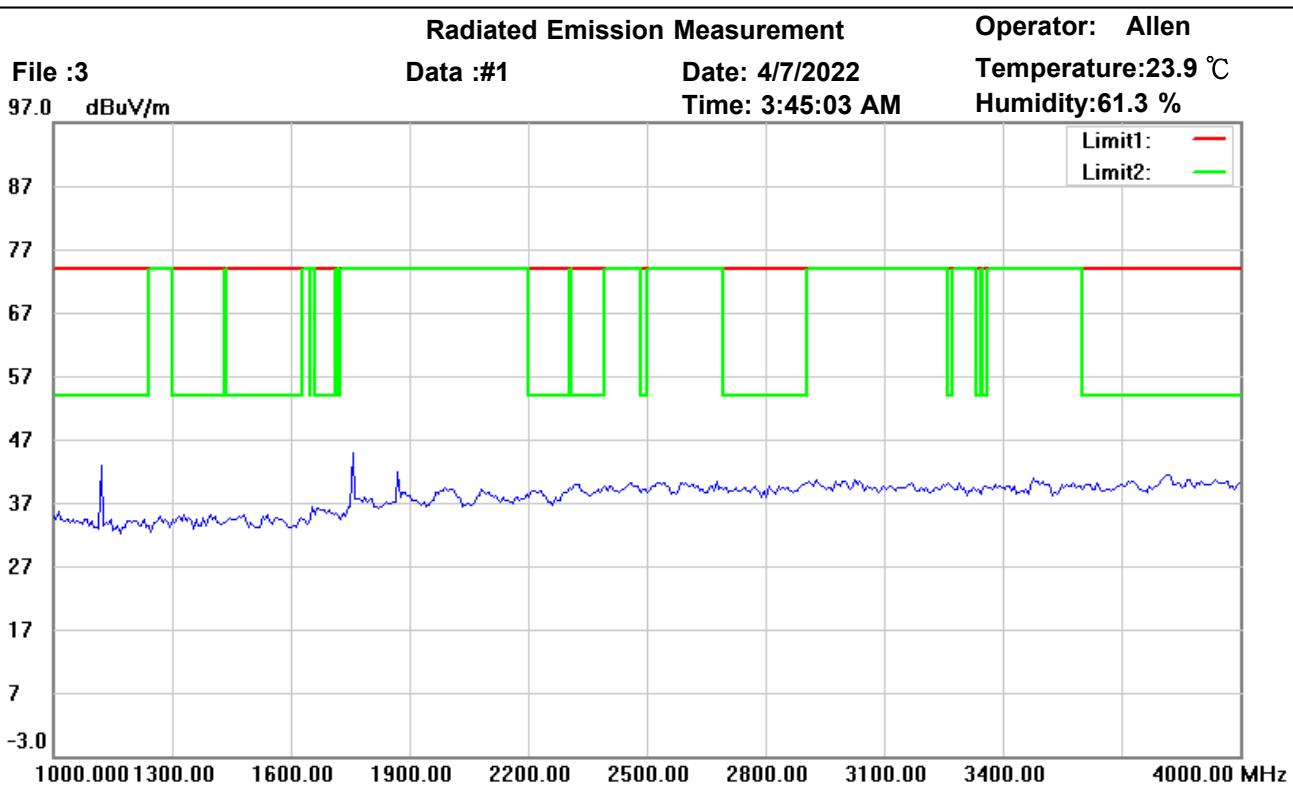
Site : Chamber

Condition : FCC\_part 15E RE\_Above 1GHz\_PK

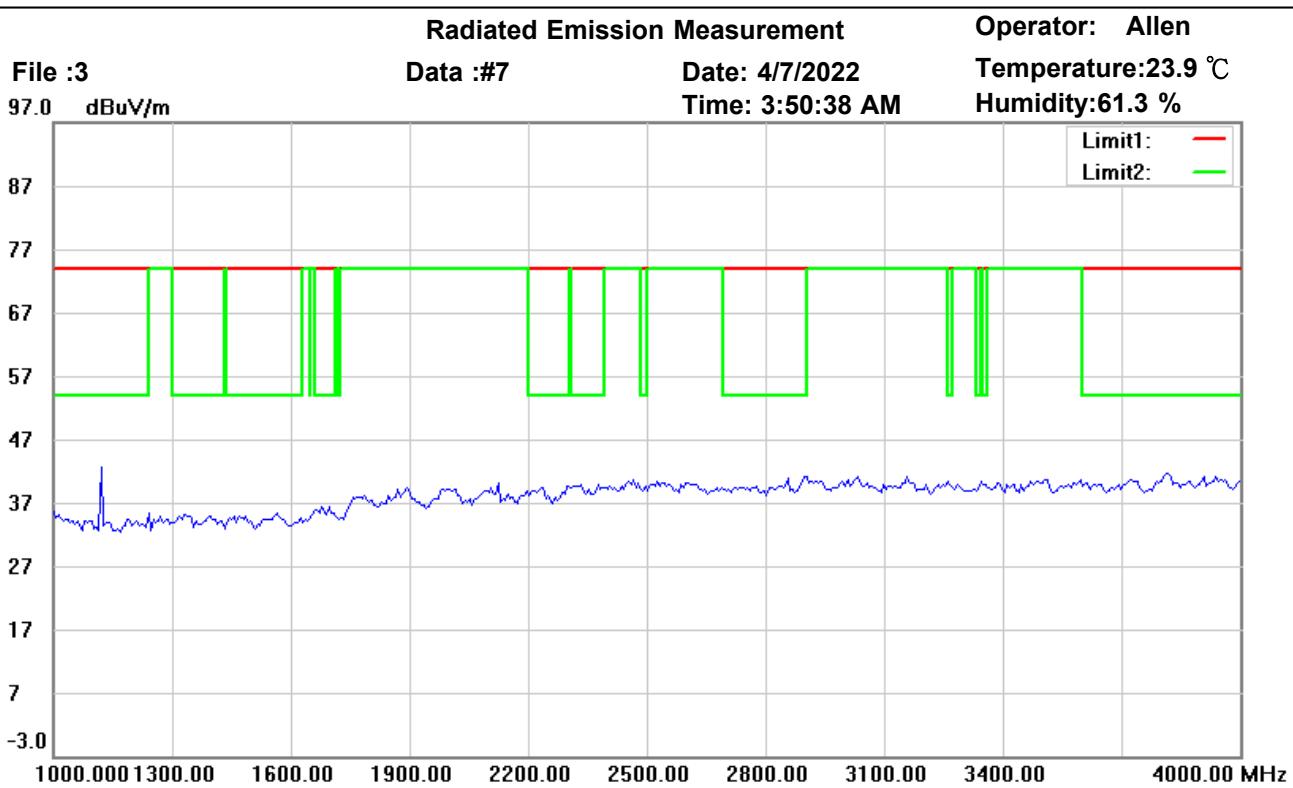
Site : Chamber

Condition : FCC\_part 15E RE\_Above 1GHz\_PK

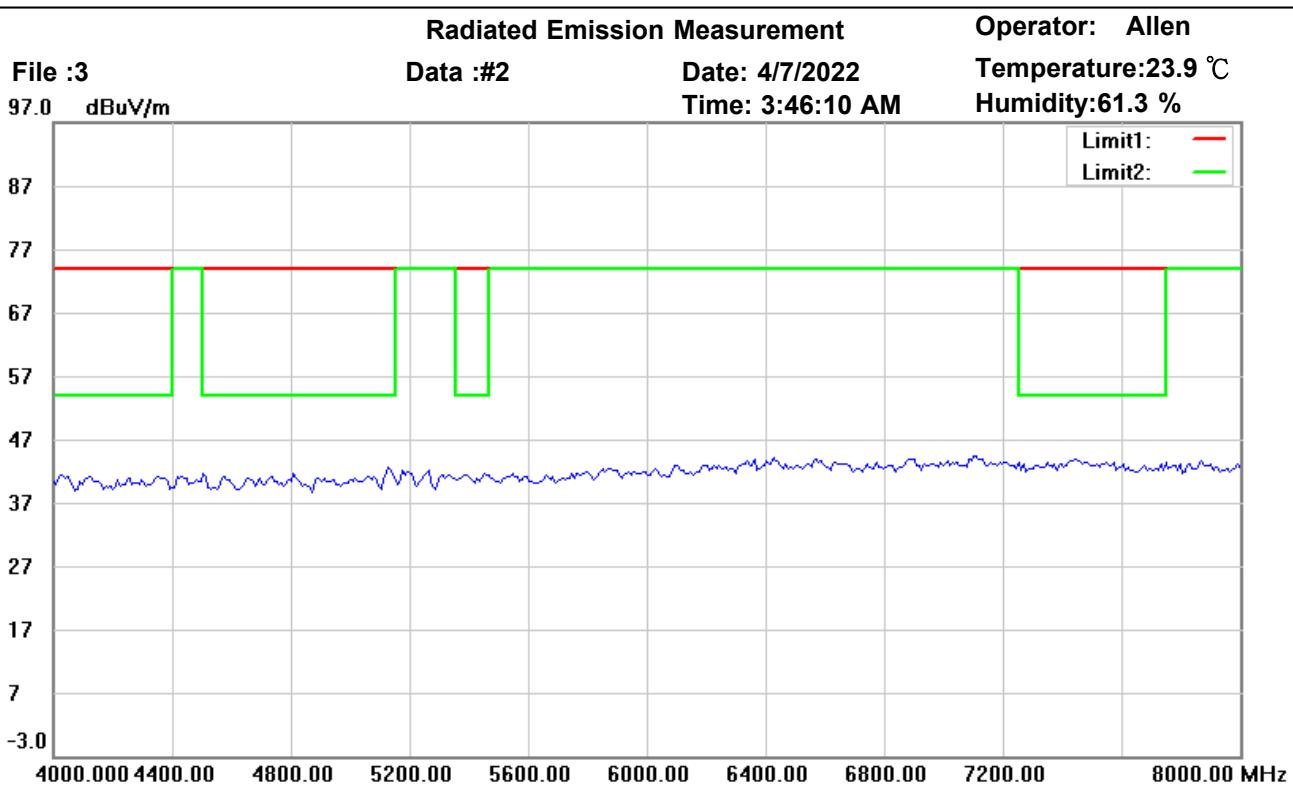
Site : Chamber

Condition : FCC\_part 15E RE\_Above 1GHz\_PK

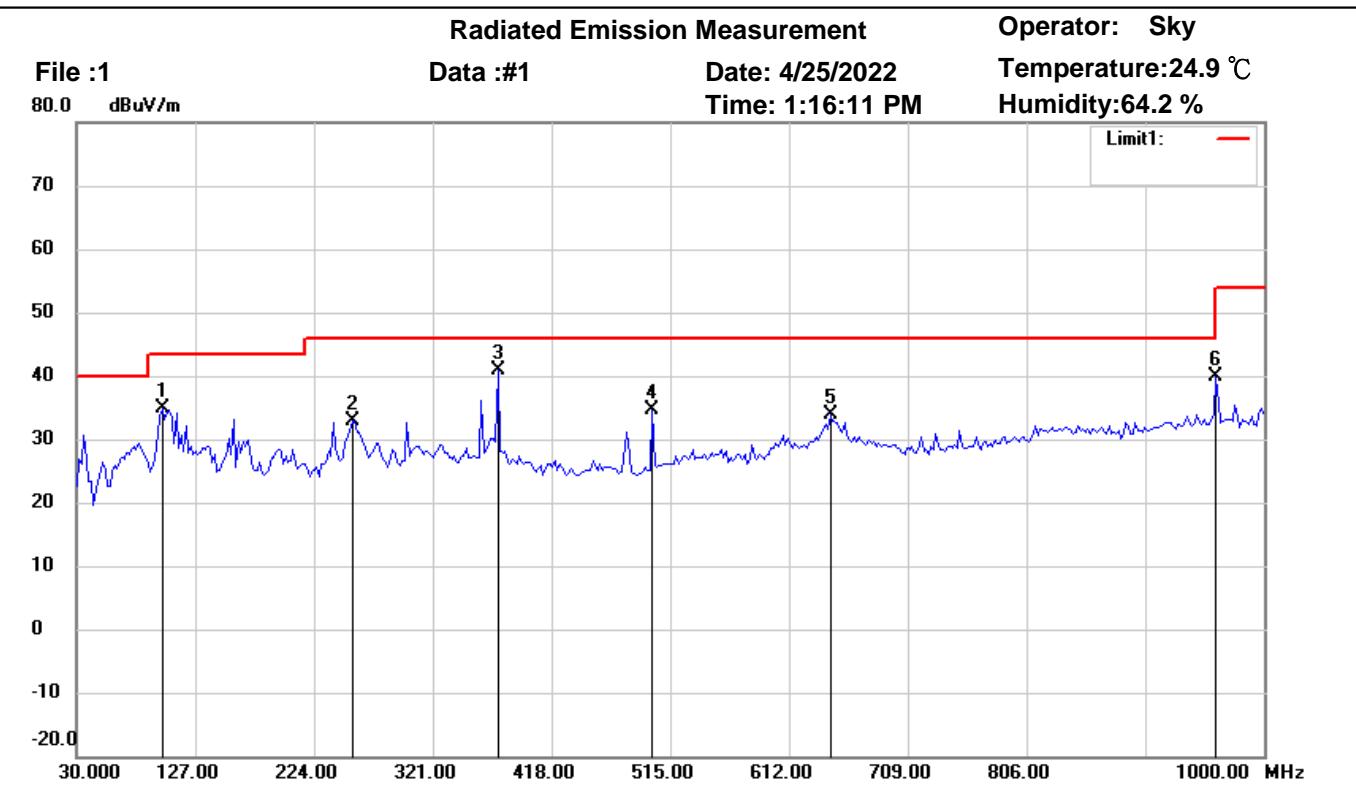
Site : 966 Chamber
