### Exhibit 7B MPE Test Report Photographs

**Motorola Solutions Inc.**

**EME Test Laboratory**

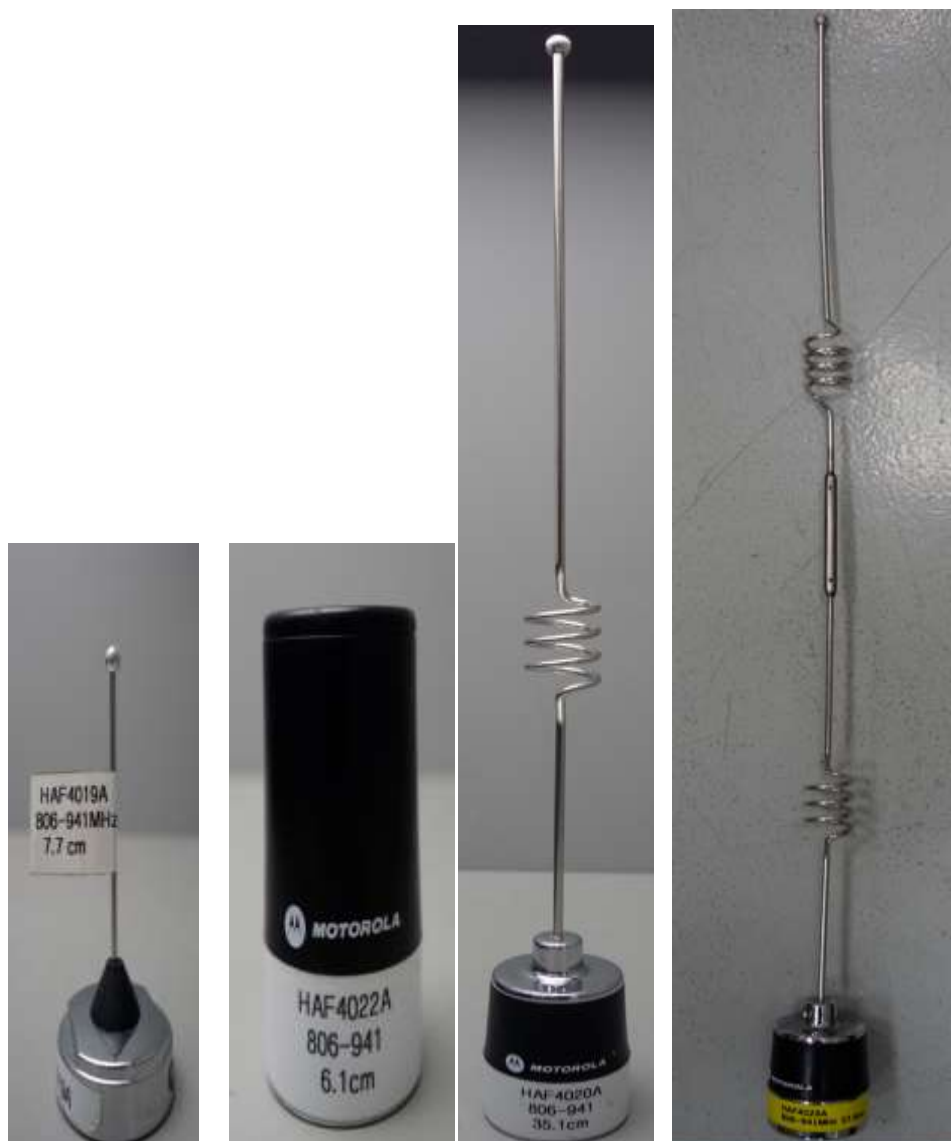
**8/900 Antenna kit numbers, from left to right**  
HAF4019A, HAF4022A, HAF4020A, HAF4023A

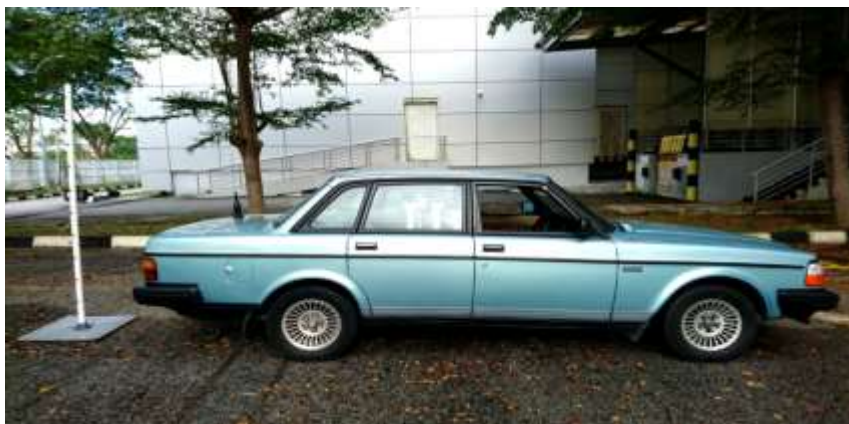
Test measurement setup for Bystander, trunk mount antenna behind vehicle

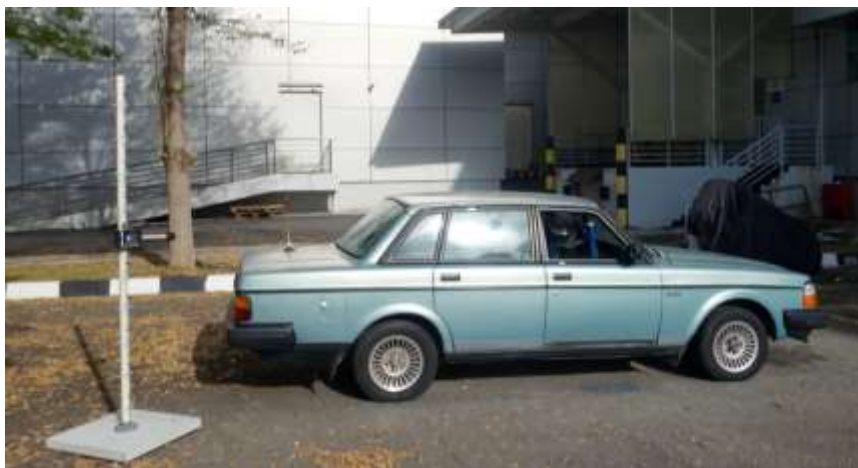
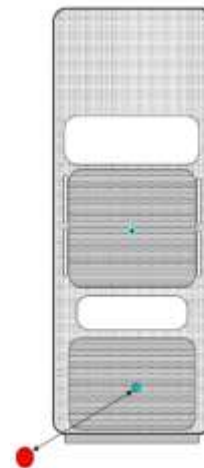
Test measurement setup for Bystander 45 degree (diagonal) trunk mount antenna

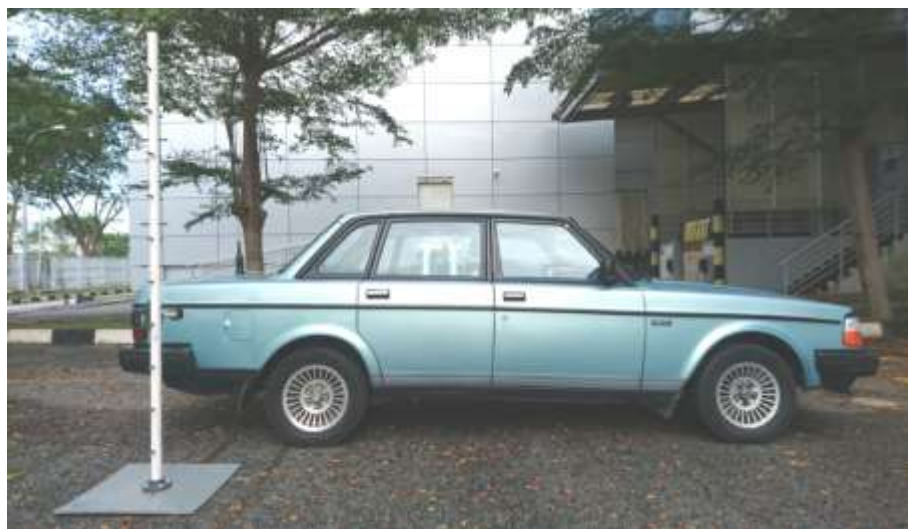
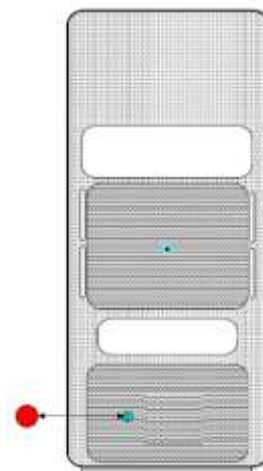
Test measurement setup for Bystander 90 degree (side) trunk mount antenna

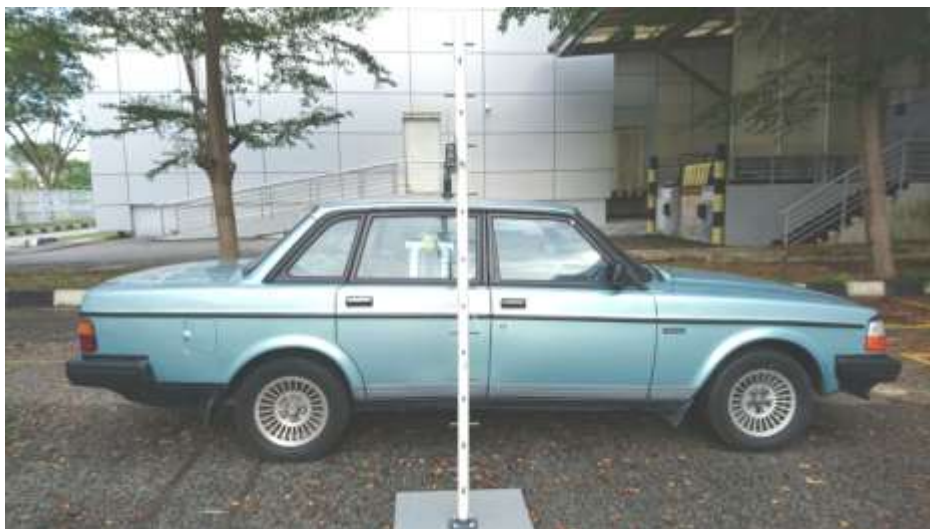
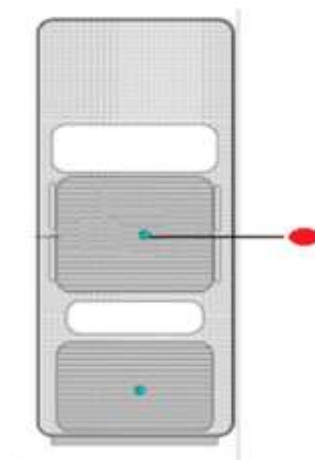
Test measurement setup for Bystander roof mount antenna

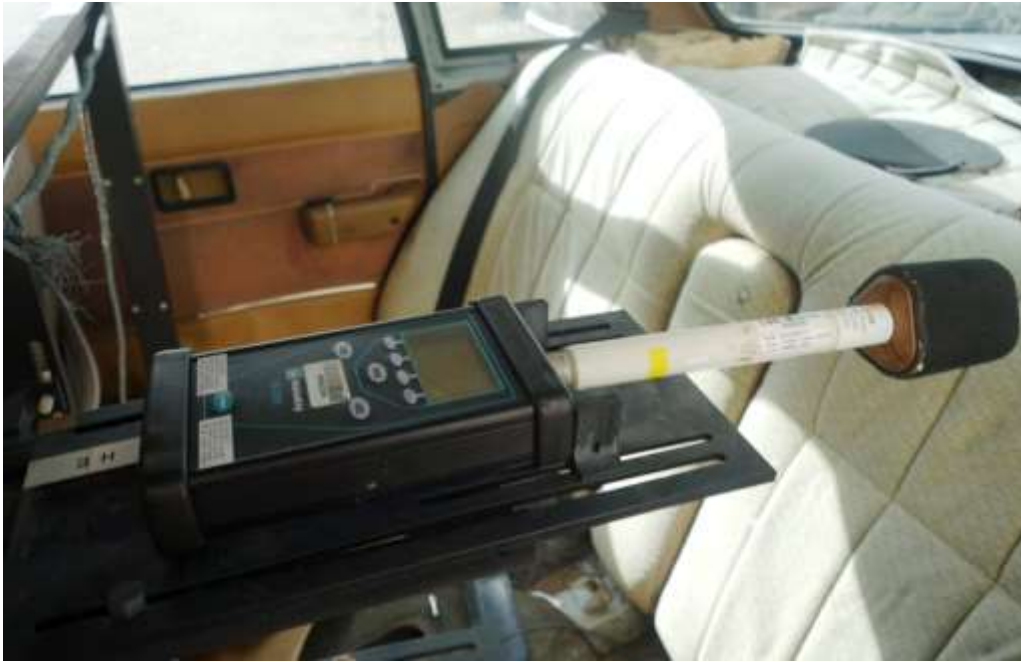
Test measurement setup for Passenger Back

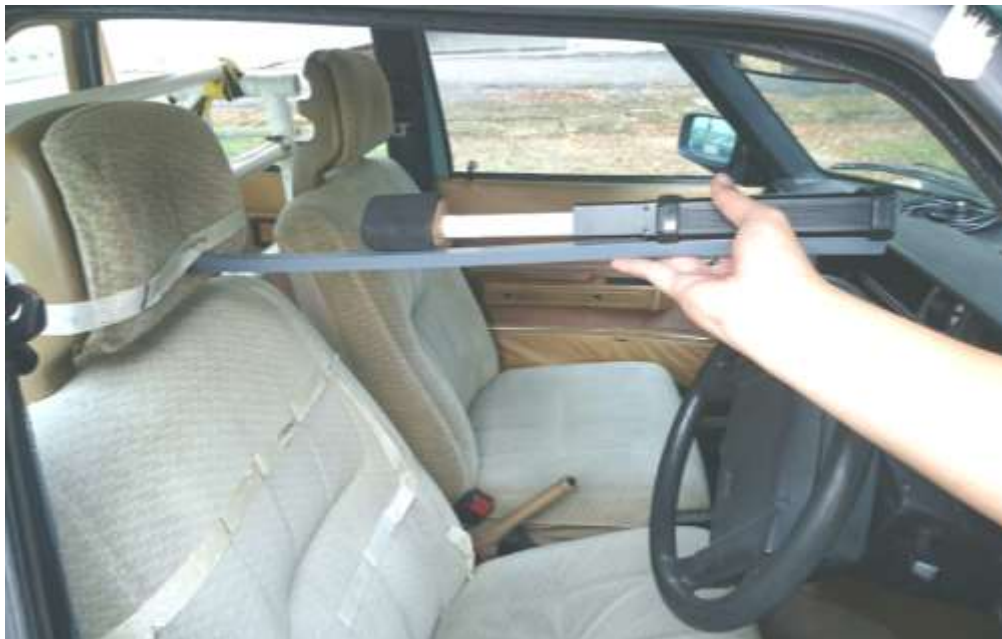
Test measurement setup for Passenger Front

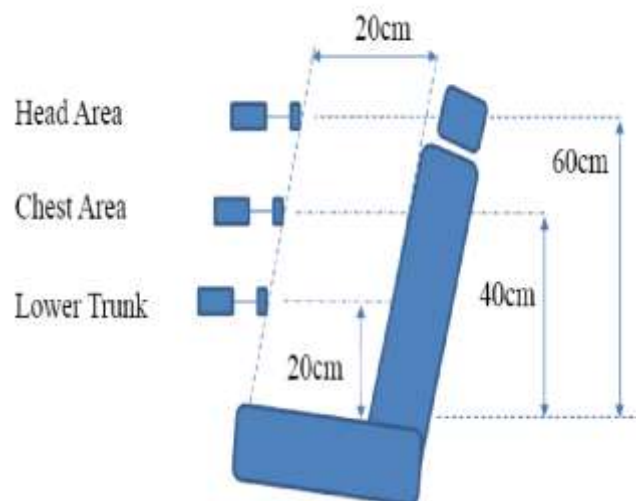
Test positions for Passenger Back and Front

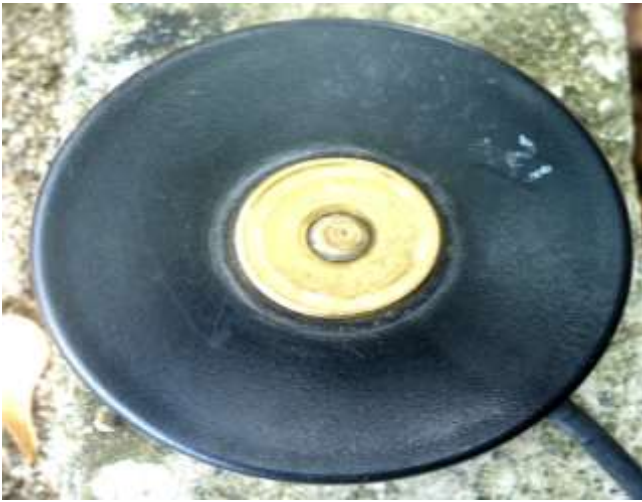
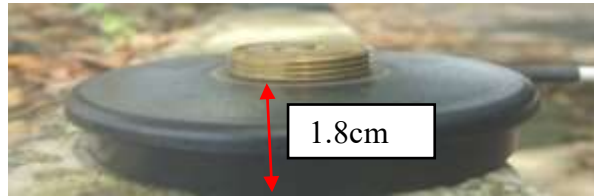
**Magnetic mount base (top and side view)**
