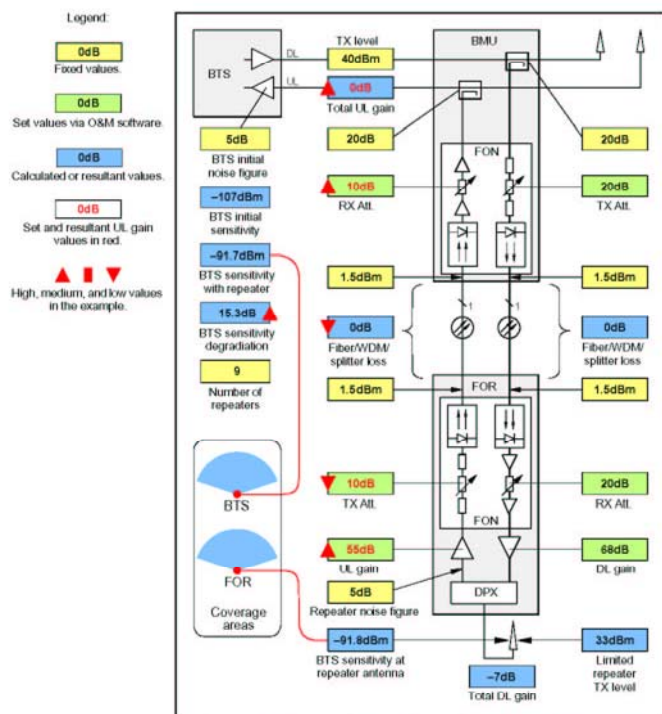
Figure 6-8. Nine FORs, low optical loss, high uplink gain and attenuation

Figure 6-8 shows one of nine FORs connected to one of three FON units in the BMU with low optical loss, high uplink gain and high uplink attenuation. The *BTS sensitivity degradation* is high.

High total uplink gain and a *BTS sensitivity with repeater* very close to the *BTS sensitivity at the repeater antenna* indicates a similar coverage area for the BTS and the FOR.
