### **APPENDIX 3: Photographs of test setup**

#### **Radiated Emission**

## 4.2 Configuration and peripherals

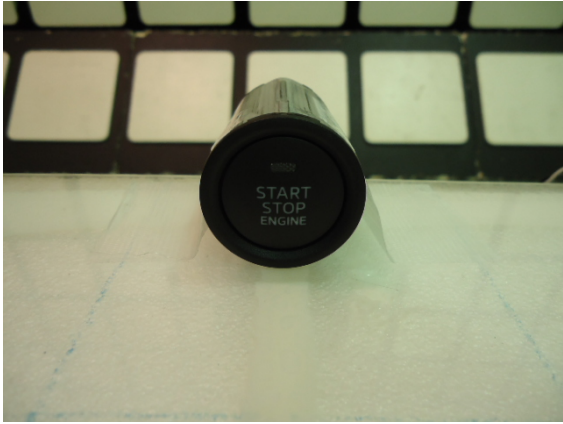
##### **X-axis**

#### **Ant**

**Below 30MHz: X-axis**  
**Above 30MHz Hori:Z / Vert:Z**
