Report No. :FA7O0620-01

Issued Date : Jan. 08, 2018 Form version. : 170509 FCC ID: PY7-13007N Page D1 of D3

Appendix D. SAR Test Setup Photos

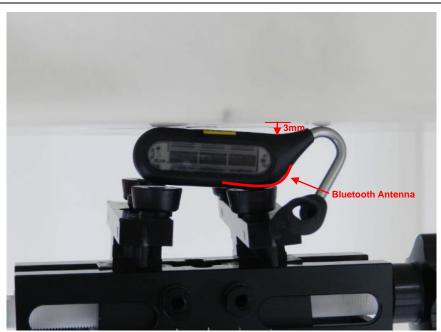
Note: Since the devices with form factors that do not conform to a flat phantom, and iron tube gets in the way of Right Side positioning, therefore the whole Right Side of Bluetooth headset was slant and touch the flat phantom for the SAR testing, additional separation introduced by the SAR peak location against to flat phantom is <5 mm and 1g reported SAR is relative low and <1.2W/kg, therefore, the back SAR test position is compliance with RF exposure requirement.

Right side (Flat phantom), additional separation introduced by the contour against a surface of the Flat phantom is 3 mm
