# Radiated Emission Measurement

Condition : FCC\_part 15 RE-Class C\_Above 1GHz\_PK

EUT : W6M22311-23090

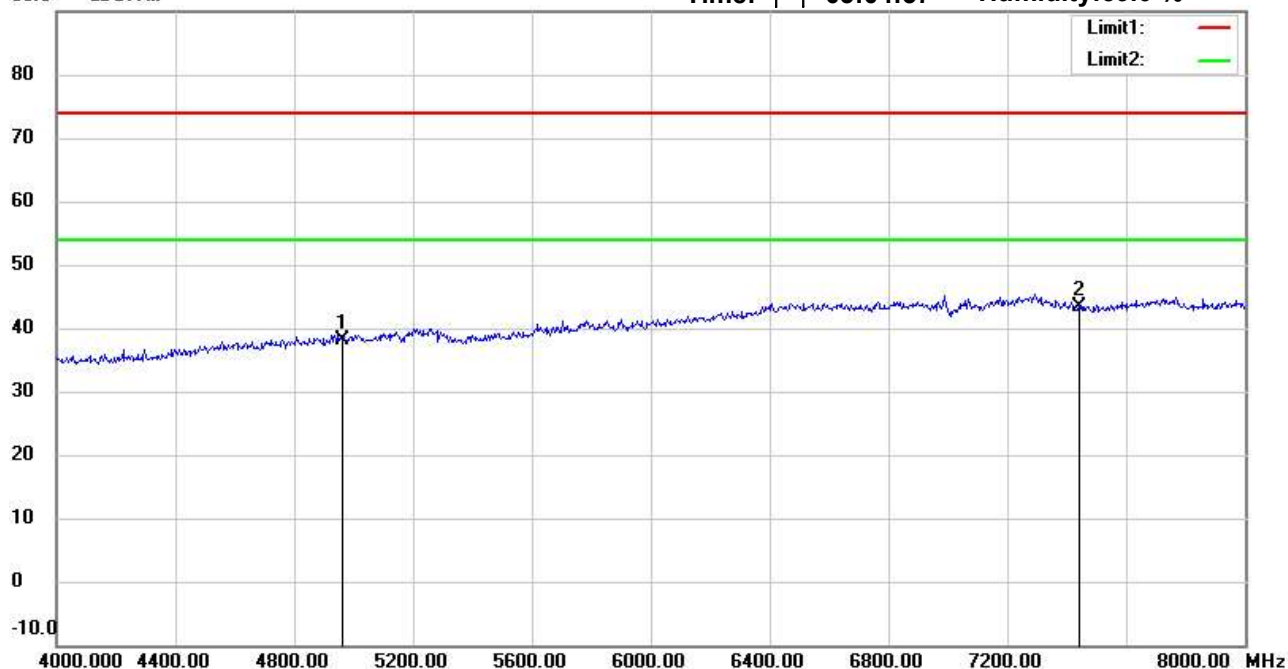
Data :#7

Test Mode : TX 2480MHz

Polarization: **Vertical**

| Mk. | Frequency (MHz) | Reading (dBuV) | Detector | Corr. factor (dB/m) | Result (dBuV/m) | Limit (dBuV/m) | Ant.Pos (cm) | Tab.Pos (deg.) | Margin (dB) | Comment |
|---|---|---|---|---|---|---|---|---|---|---|
| | 4960.000 | 32.53 | peak | 5.53 | 38.06 | 74.00 | 150 | 14 | -35.94 | |
| * | 7440.000 | 31.93 | peak | 11.41 | 43.34 | 74.00 | 150 | 323 | -30.66 | |

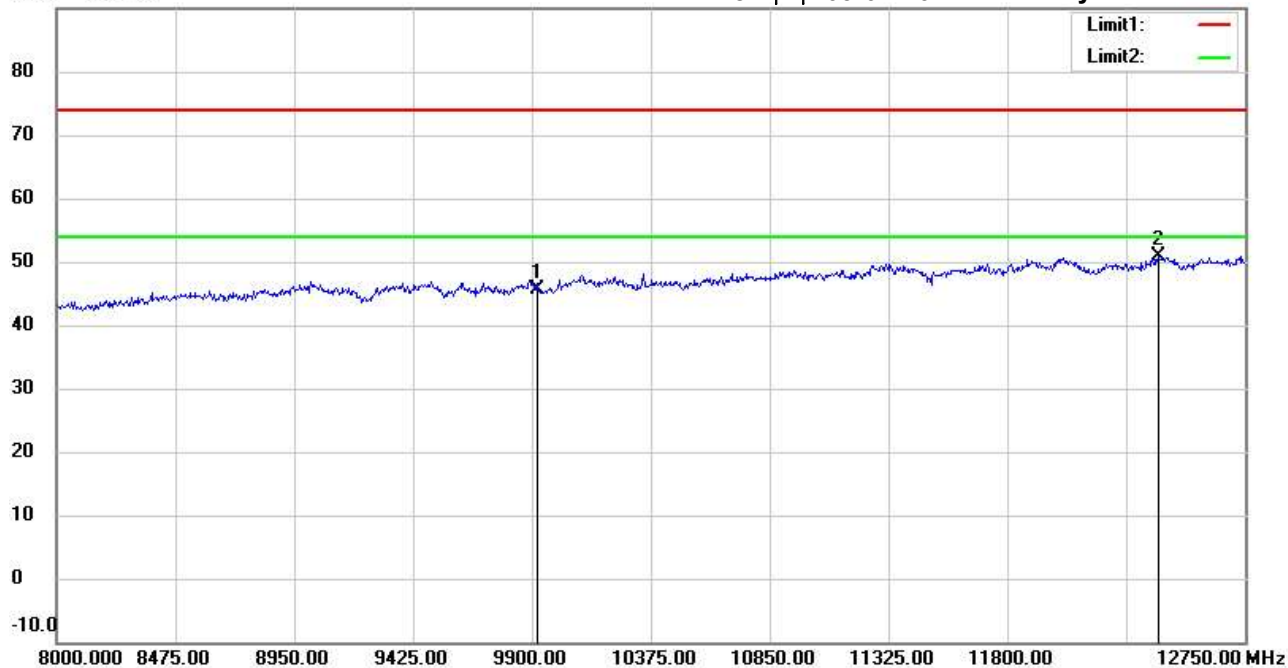
Data : #3

Condition : FCC\_part 15 RE-Class C\_Above 1GHz\_PK

Test Mode : TX 2480MHz

Polarization: **Horizontal**

| Mk. | Frequency (MHz) | Reading (dBuV) | Detector | Corr. factor (dB/m) | Result (dBuV/m) | Limit (dBuV/m) | Ant.Pos (cm) | Tab.Pos (deg.) | Margin (dB) | Comment |
|---|---|---|---|---|---|---|---|---|---|---|
| | 9920.000 | 31.56 | peak | 14.00 | 45.56 | 74.00 | 150 | 254 | -28.44 | |
| * | 12400.000 | 33.27 | peak | 17.55 | 50.82 | 74.00 | 150 | 140 | -23.18 | |

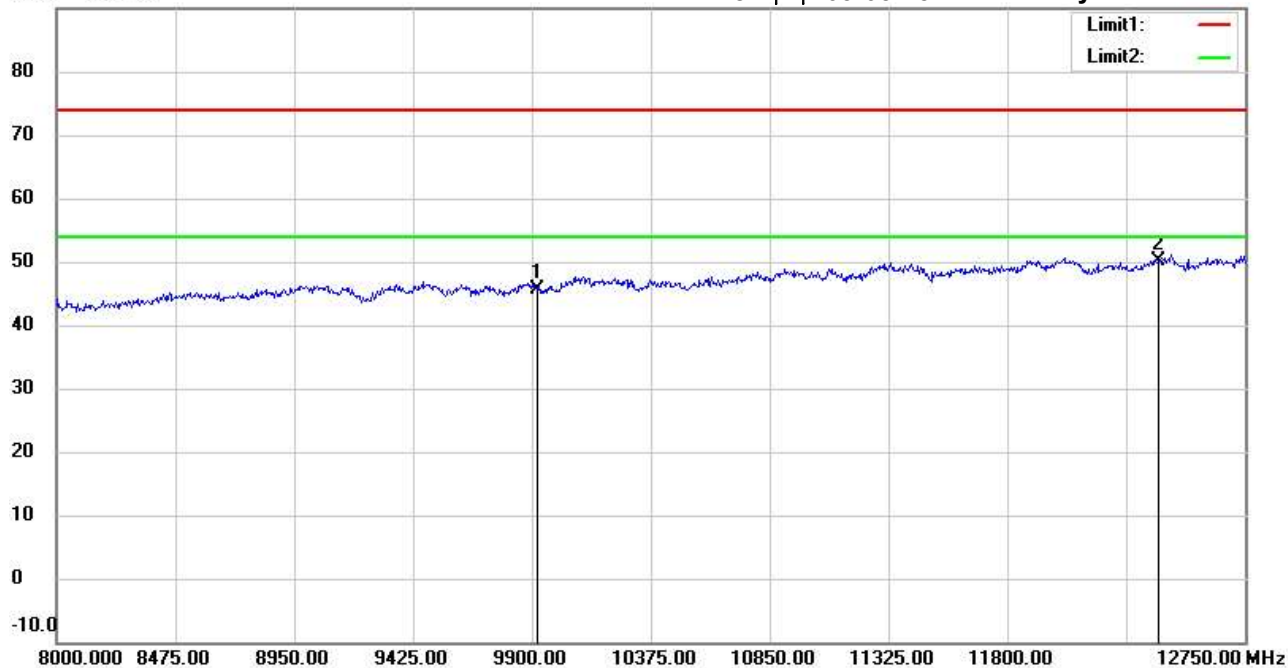
Data : #8

Condition : FCC\_part 15 RE-Class C\_Above 1GHz\_PK

Test Mode : TX 2480MHz

Polarization: Vertical

| Mk. | Frequency (MHz) | Reading (dBuV) | Detector | Corr. factor (dB/m) | Result (dBuV/m) | Limit (dBuV/m) | Ant.Pos (cm) | Tab.Pos (deg.) | Margin (dB) | Comment |
|---|---|---|---|---|---|---|---|---|---|---|
| | 9920.000 | 31.73 | peak | 14.00 | 45.73 | 74.00 | 150 | 206 | -28.27 | |
| * | 12400.000 | 32.52 | peak | 17.55 | 50.07 | 74.00 | 150 | 5 | -23.93 | |

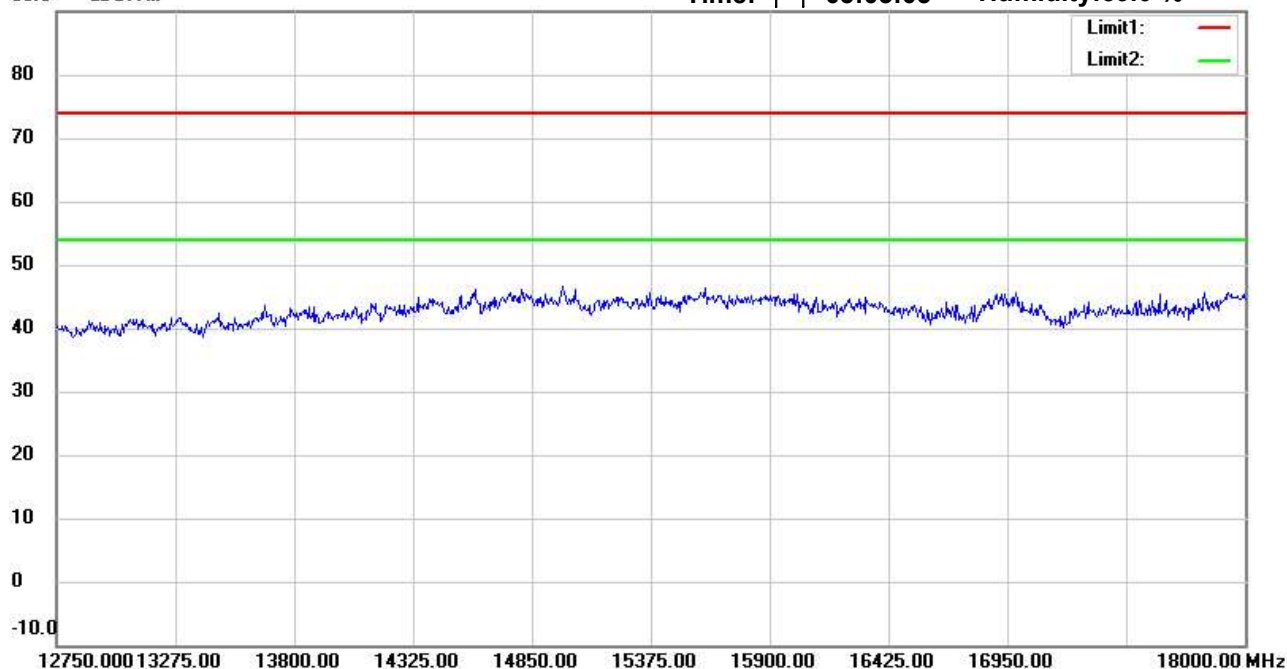
Condition : FCC\_part 15 RE-Class C\_Above 1GHz\_PK

Test Mode : TX 2480MHz

Polarization: Horizontal

Distance: 3m

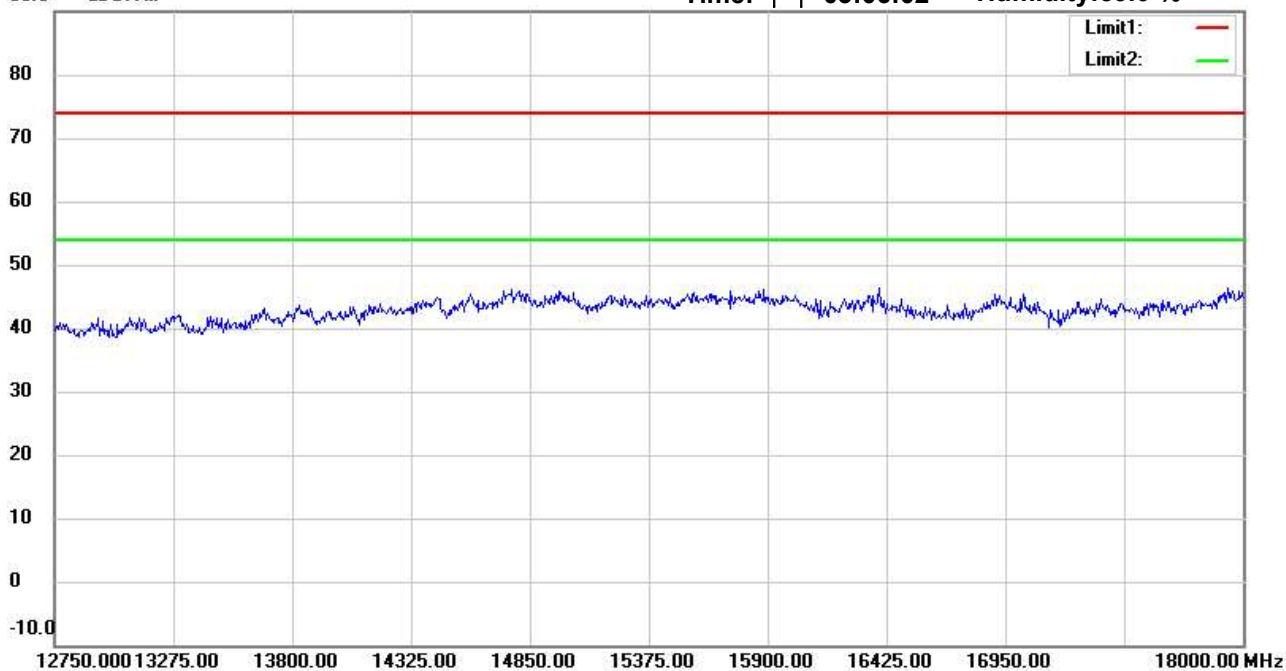
Data :#9

Condition : FCC\_part 15 RE-Class C\_Above 1GHz\_PK

Test Mode : TX 2480MHz

Polarization: **Vertical**

Distance: 3m

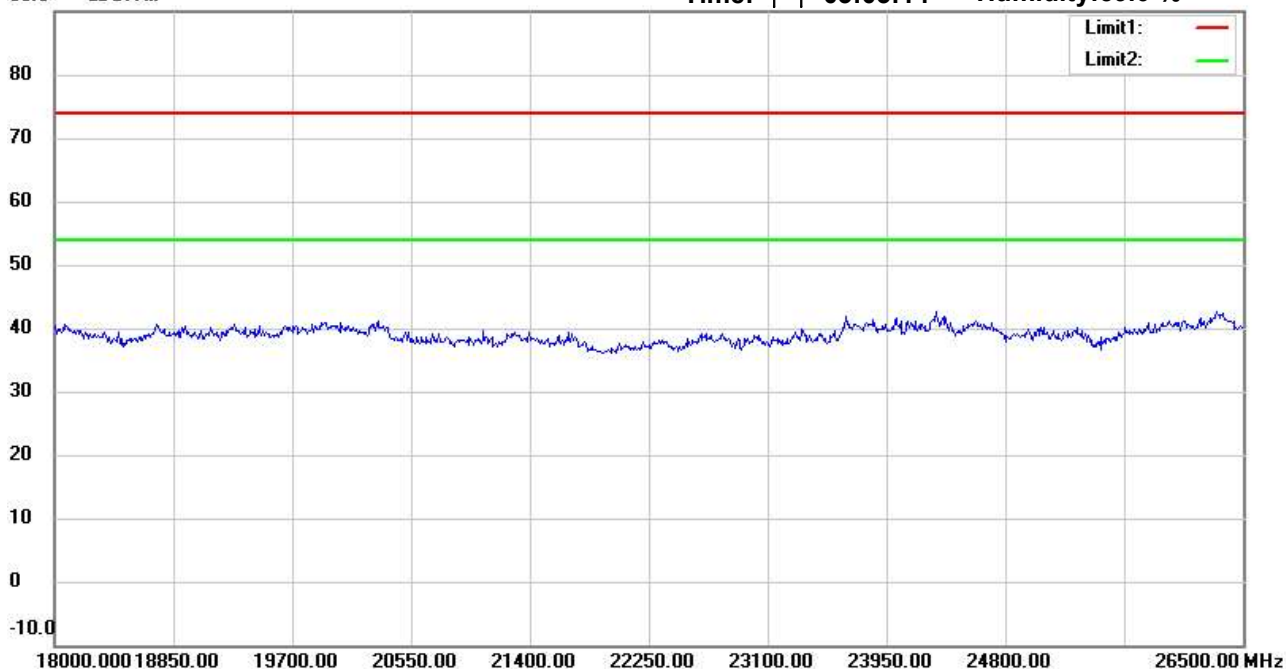
Data :#5

Condition : FCC\_part 15 RE-Class C\_Above 1GHz\_PK

Test Mode : TX 2480MHz

Polarization: **Horizontal**

Distance: 3m

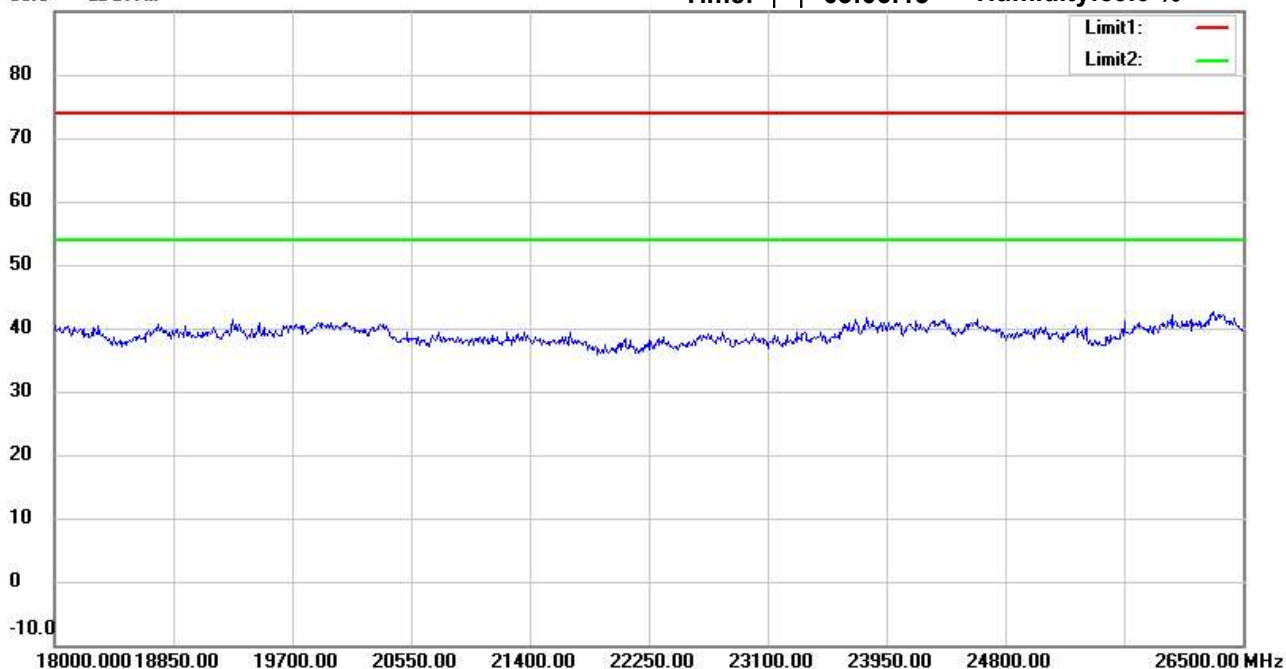
Data :#10

Condition : FCC\_part 15 RE-Class C\_Above 1GHz\_PK

Test Mode : TX 2480MHz

Polarization: **Vertical**

Distance: 3m

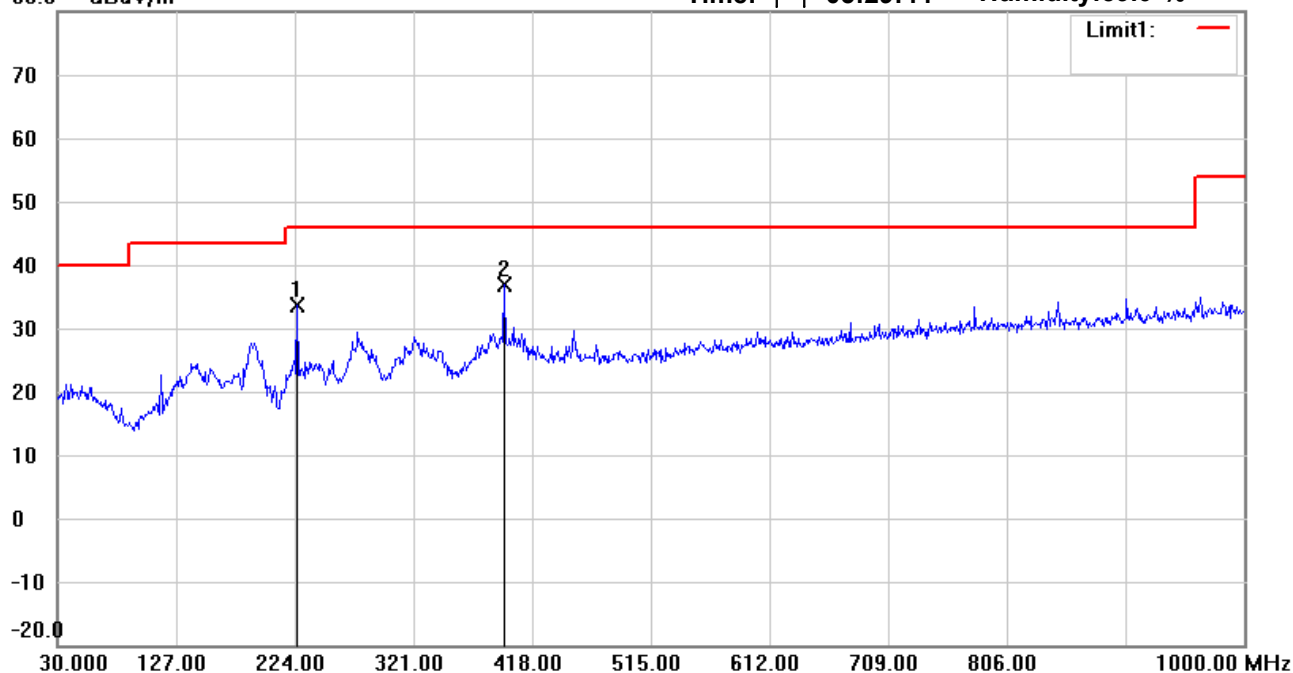
File : 1\_BLE(1M)\_TX 2402MHz Data : #1

Condition : FCC\_part 15 RE-Class C\_30-1000MHz

Polarization: *Horizontal*

Test Mode : TX 2402MHz

| Mk. | Frequency (MHz) | Reading (dBuV) | Detector | Corr. factor (dB/m) | Result (dBuV/m) | Limit (dBuV/m) | Ant.Pos (cm) | Tab.Pos (deg.) | Margin (dB) | Comment |
|---|---|---|---|---|---|---|---|---|---|---|
| | 225.9400 | 47.68 | peak | -14.13 | 33.55 | 46.00 | 100 | 358 | -12.45 | |
| * | 395.2050 | 45.64 | peak | -8.85 | 36.79 | 46.00 | 100 | 337 | -9.21 | |

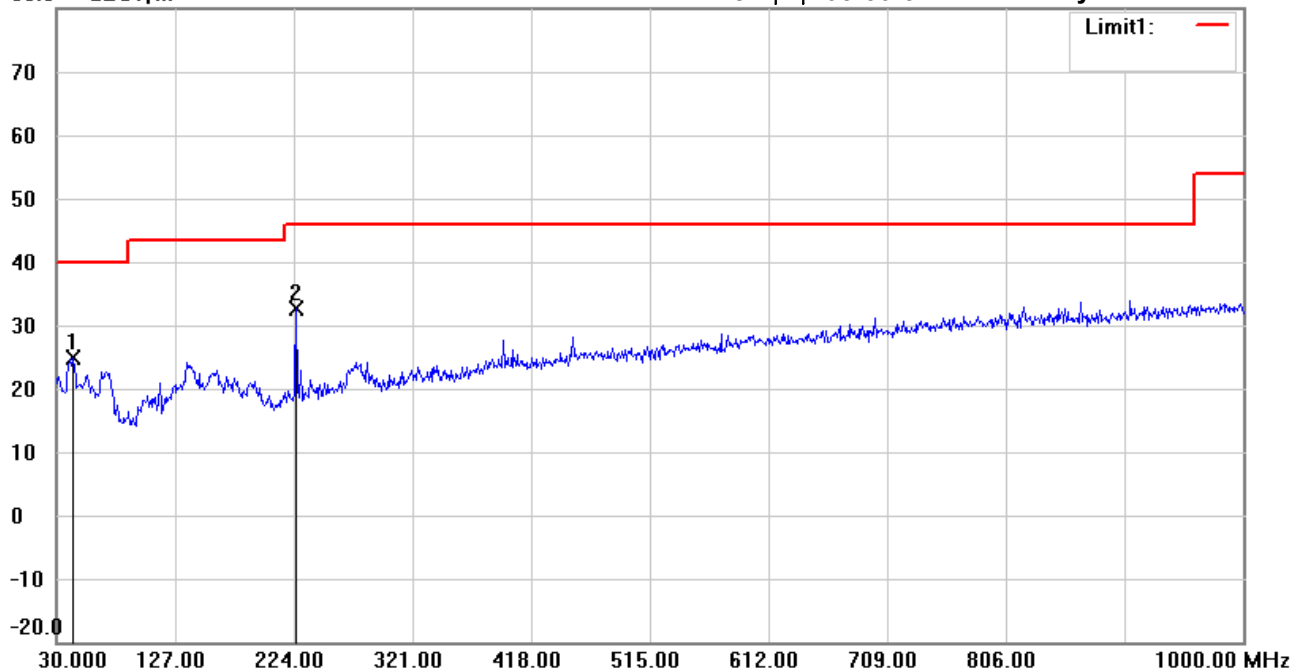
File : 1\_BLE(1M)\_TX 2402MHz Data : #2

Condition : FCC\_part 15 RE-Class C\_30-1000MHz

Polarization: Vertical

Test Mode : TX 2402MHz

| Mk. | Frequency (MHz) | Reading (dBuV) | Detector | Corr. factor (dB/m) | Result (dBuV/m) | Limit (dBuV/m) | Ant.Pos (cm) | Tab.Pos (deg.) | Margin (dB) | Comment |
|---|---|---|---|---|---|---|---|---|---|---|
| | 43.5800 | 37.26 | peak | -12.44 | 24.82 | 40.00 | 100 | 339 | -15.18 | |
| * | 225.9400 | 46.85 | peak | -14.13 | 32.72 | 46.00 | 100 | 37 | -13.28 | |

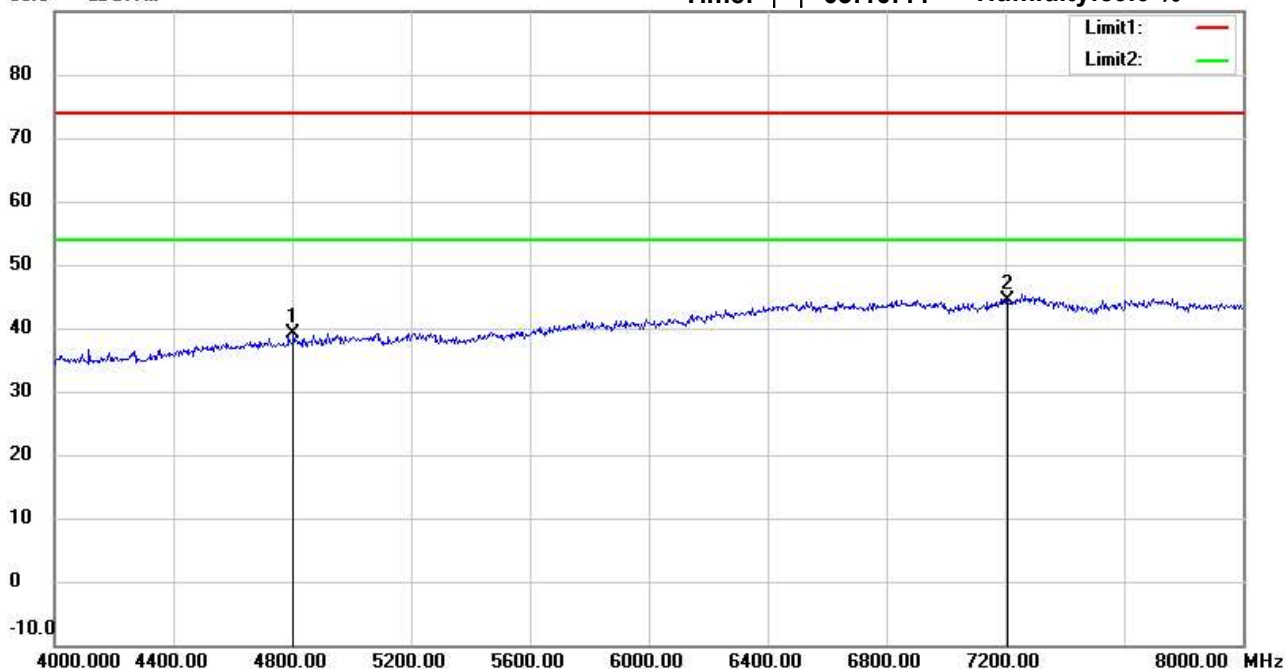
Data :#2

Condition : FCC\_part 15 RE-Class C\_Above 1GHz\_PK

Test Mode : TX 2402MHz

Polarization: **Horizontal**

| Mk. | Frequency (MHz) | Reading (dBuV) | Detector | Corr. factor (dB/m) | Result (dBuV/m) | Limit (dBuV/m) | Ant.Pos (cm) | Tab.Pos (deg.) | Margin (dB) | Comment |
|---|---|---|---|---|---|---|---|---|---|---|
| | 4804.000 | 34.02 | peak | 5.03 | 39.05 | 74.00 | 150 | 36 | -34.95 | |
| * | 7206.000 | 32.90 | peak | 11.38 | 44.28 | 74.00 | 150 | 210 | -29.72 | |

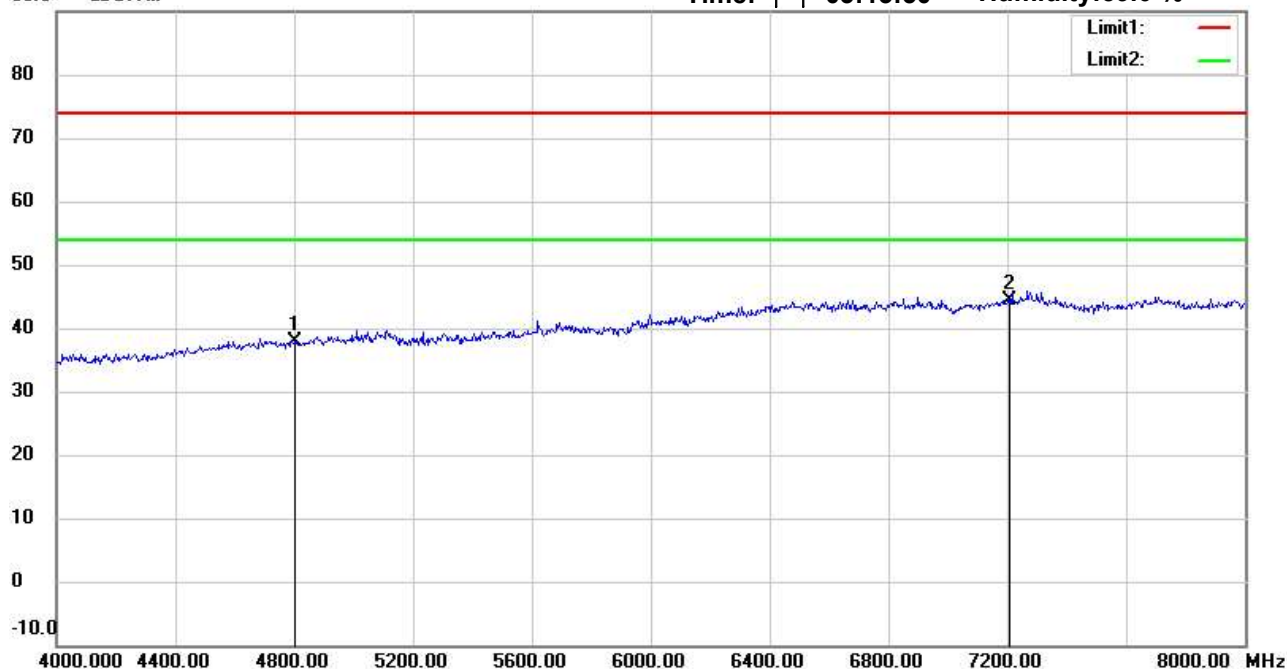
Data :#7

Condition : FCC\_part 15 RE-Class C\_Above 1GHz\_PK

Test Mode : TX 2402MHz

Polarization: **Vertical**

| Mk. | Frequency (MHz) | Reading (dBuV) | Detector | Corr. factor (dB/m) | Result (dBuV/m) | Limit (dBuV/m) | Ant.Pos (cm) | Tab.Pos (deg.) | Margin (dB) | Comment |
|---|---|---|---|---|---|---|---|---|---|---|
| | 4804.000 | 32.82 | peak | 5.03 | 37.85 | 74.00 | 150 | 10 | -36.15 | |
| * | 7206.000 | 33.07 | peak | 11.38 | 44.45 | 74.00 | 150 | 119 | -29.55 | |

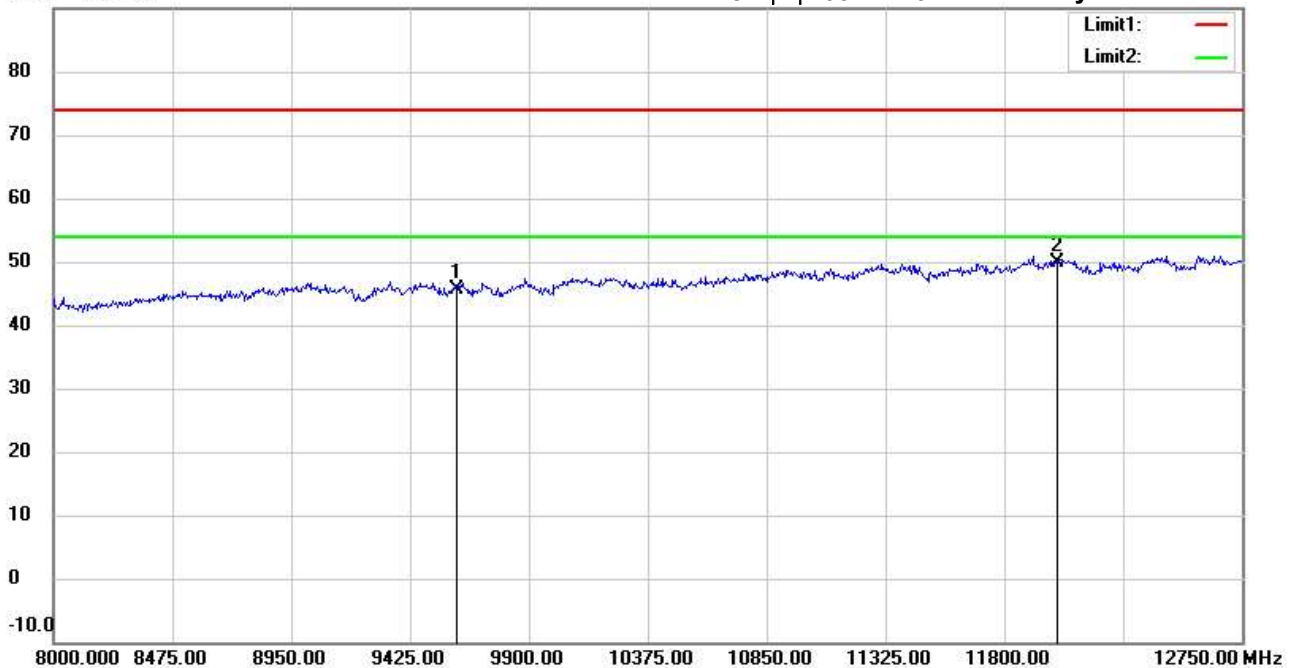
Data : #3

Condition : FCC\_part 15 RE-Class C\_Above 1GHz\_PK

Test Mode : TX 2402MHz

Polarization: **Horizontal**

| Mk. | Frequency (MHz) | Reading (dBuV) | Detector | Corr. factor (dB/m) | Result (dBuV/m) | Limit (dBuV/m) | Ant.Pos (cm) | Tab.Pos (deg.) | Margin (dB) | Comment |
|---|---|---|---|---|---|---|---|---|---|---|
| | 9608.000 | 32.12 | peak | 13.39 | 45.51 | 74.00 | 150 | 284 | -28.49 | |
| * | 12010.000 | 32.51 | peak | 17.28 | 49.79 | 74.00 | 150 | 5 | -24.21 | |

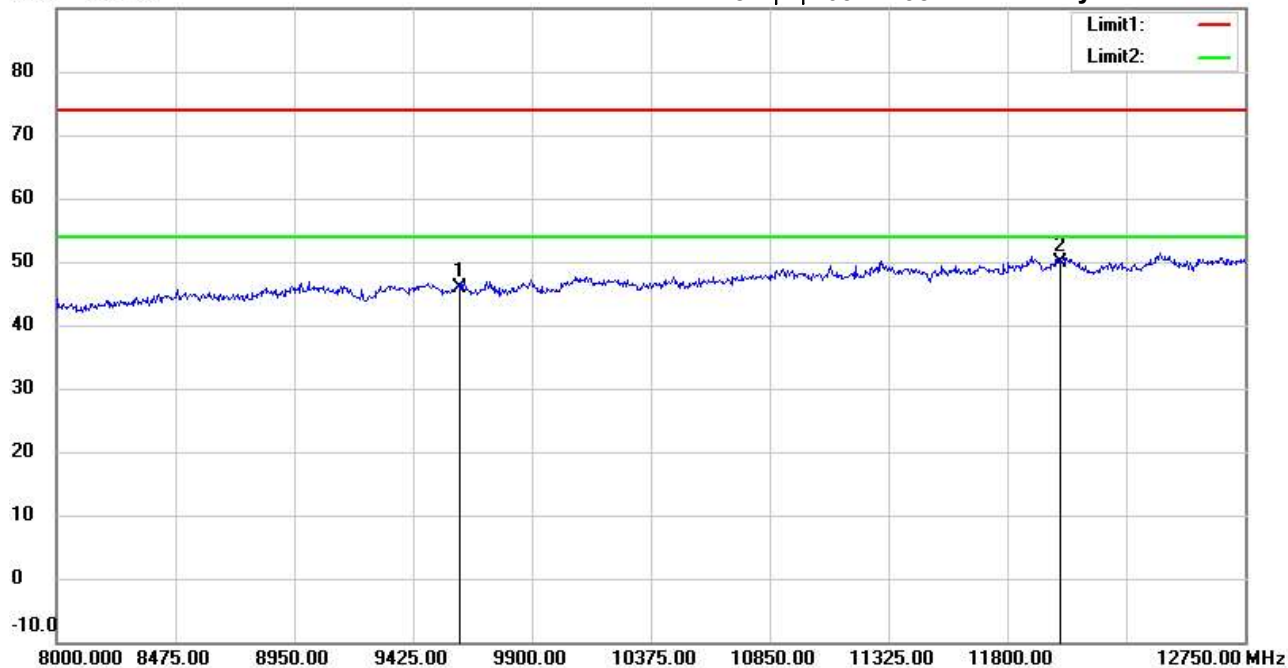
Data : #8

Condition : FCC\_part 15 RE-Class C\_Above 1GHz\_PK

Test Mode : TX 2402MHz

Polarization: Vertical

| Mk. | Frequency (MHz) | Reading (dBuV) | Detector | Corr. factor (dB/m) | Result (dBuV/m) | Limit (dBuV/m) | Ant.Pos (cm) | Tab.Pos (deg.) | Margin (dB) | Comment |
|---|---|---|---|---|---|---|---|---|---|---|
| | 9608.000 | 32.49 | peak | 13.39 | 45.88 | 74.00 | 150 | 222 | -28.12 | |
| * | 12010.000 | 32.61 | peak | 17.28 | 49.89 | 74.00 | 150 | 5 | -24.11 | |

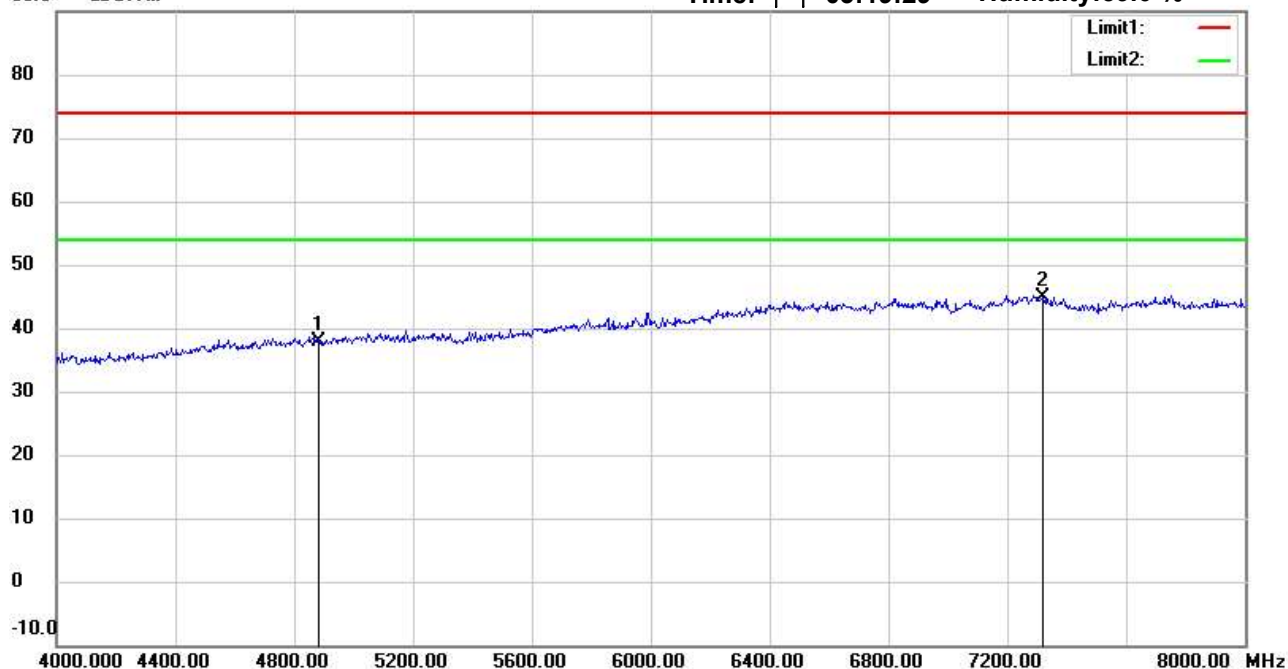
Data : #2

Condition : FCC\_part 15 RE-Class C\_Above 1GHz\_PK

Test Mode : TX 2440MHz

Polarization: **Horizontal**

| Mk. | Frequency (MHz) | Reading (dBuV) | Detector | Corr. factor (dB/m) | Result (dBuV/m) | Limit (dBuV/m) | Ant.Pos (cm) | Tab.Pos (deg.) | Margin (dB) | Comment |
|---|---|---|---|---|---|---|---|---|---|---|
| | 4880.000 | 32.61 | peak | 5.23 | 37.84 | 74.00 | 150 | 355 | -36.16 | |
| * | 7320.000 | 33.11 | peak | 11.67 | 44.78 | 74.00 | 150 | 133 | -29.22 | |

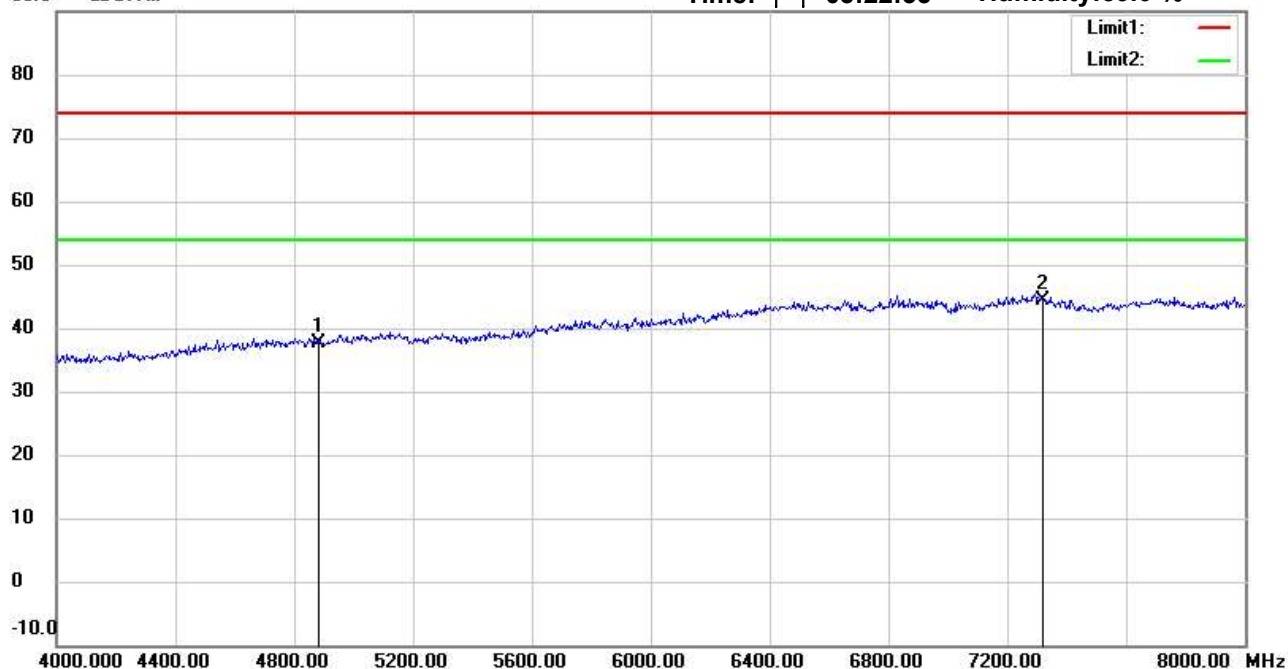
Data :#7

Condition : FCC\_part 15 RE-Class C\_Above 1GHz\_PK

Test Mode : TX 2440MHz

Polarization: **Vertical**

| Mk. | Frequency (MHz) | Reading (dBuV) | Detector | Corr. factor (dB/m) | Result (dBuV/m) | Limit (dBuV/m) | Ant.Pos (cm) | Tab.Pos (deg.) | Margin (dB) | Comment |
|---|---|---|---|---|---|---|---|---|---|---|
| | 4880.000 | 32.50 | peak | 5.23 | 37.73 | 74.00 | 150 | 158 | -36.27 | |
| * | 7320.000 | 32.74 | peak | 11.67 | 44.41 | 74.00 | 150 | 243 | -29.59 | |

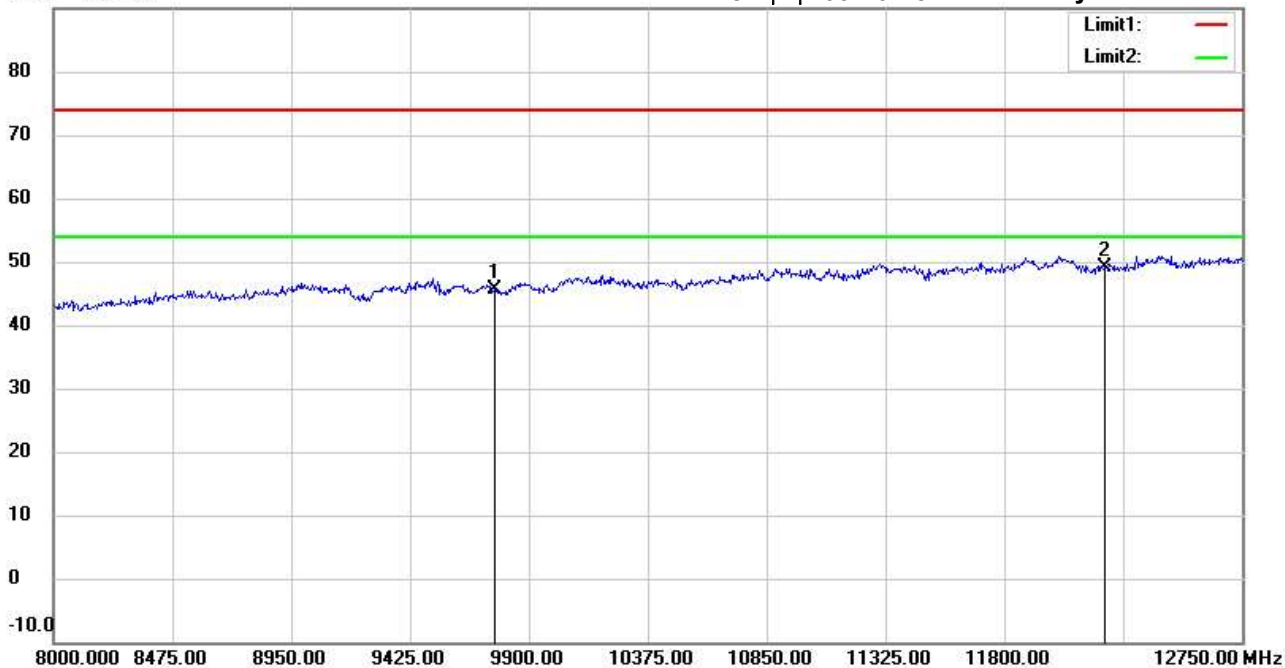
Data :#3

Condition : FCC\_part 15 RE-Class C\_Above 1GHz\_PK

Test Mode : TX 2440MHz

Polarization: **Horizontal**

| Mk. | Frequency (MHz) | Reading (dBuV) | Detector | Corr. factor (dB/m) | Result (dBuV/m) | Limit (dBuV/m) | Ant.Pos (cm) | Tab.Pos (deg.) | Margin (dB) | Comment |
|---|---|---|---|---|---|---|---|---|---|---|
| | 9760.000 | 31.85 | peak | 13.75 | 45.60 | 74.00 | 150 | 211 | -28.40 | |
| * | 12200.000 | 32.14 | peak | 17.03 | 49.17 | 74.00 | 150 | 315 | -24.83 | |

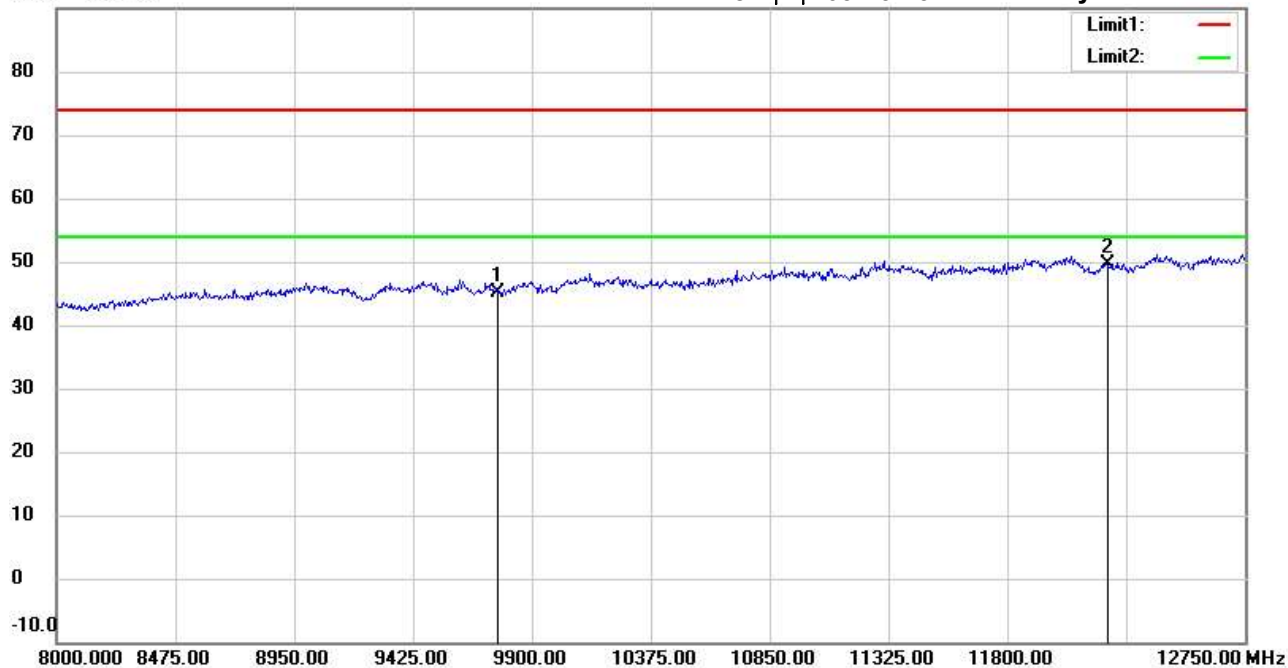
Data : #8

Condition : FCC\_part 15 RE-Class C\_Above 1GHz\_PK

Test Mode : TX 2440MHz

Polarization: Vertical

| Mk. | Frequency (MHz) | Reading (dBuV) | Detector | Corr. factor (dB/m) | Result (dBuV/m) | Limit (dBuV/m) | Ant.Pos (cm) | Tab.Pos (deg.) | Margin (dB) | Comment |
|---|---|---|---|---|---|---|---|---|---|---|
| | 9760.000 | 31.50 | peak | 13.75 | 45.25 | 74.00 | 150 | 216 | -28.75 | |
| * | 12200.000 | 32.50 | peak | 17.03 | 49.53 | 74.00 | 150 | 343 | -24.47 | |
